LEADER BUILDING

1853 HAMILTON STREET, REGINA, SK

CONSERVATION PLAN

MAY 2021

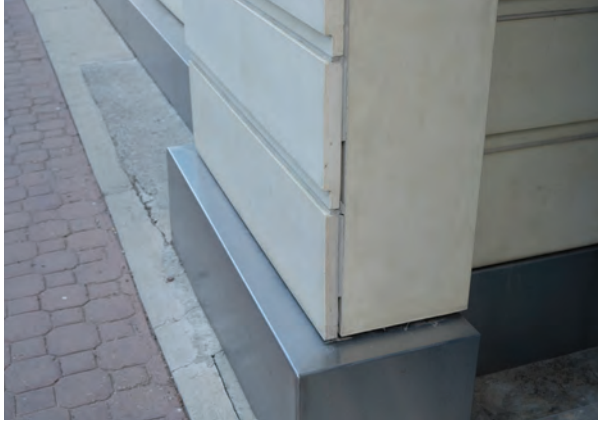
Additionally, the arched front entrances have been altered to have a flat top. The partially restored storefront is presumably constructed with terra cotta cladding. This area is in poor to fair condition, with several instances of mortar deterioration (*figures 5.3.1 & 5.3.3*).

Figure 5.3.1 Mortar missing in numerous masonry unit joints

- Review terra cotta condition and preserve any units possible.
- Review brick masonry condition and repoint the brick façades
- Repairs to the terra cotta façade should only utilize materials specifically designed for terra cotta repairs. It is important that any material with greater compressive strength than terra cotta not be used for repairs.

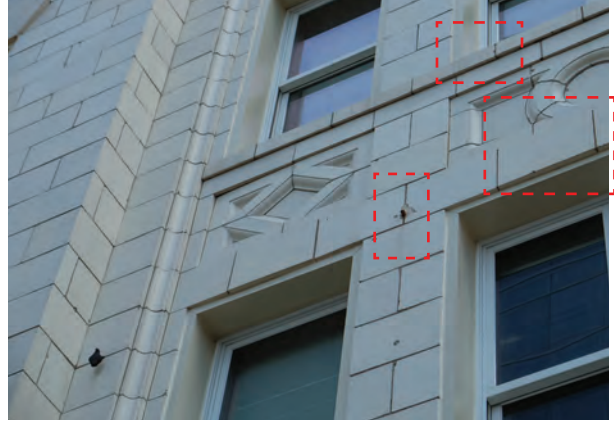
The terra cotta appears to be in fair condition, with a few units cracking and some mortar joints requiring repointing (*figures 5.3.1, 5.3.2 & 5.2.5*). Currently, the exterior bricks are painted white. The brick façade appears to be in overall poor condition, with several instances of step cracking and mortar deterioration. Additionally, The brick walls appear to stagger vertically in areas of the south and east façades. The brick masonry should be inspected in further detail, as the current paint on the façade could potentially be obscuring some of its condition. Special consideration should be given to the implementation of weepholes in addition to vertical and horizontal control joints for compartmentalization to control water and air movement within the wall system.

Figure 5.3.2 West terra cotta façade; outlining spalled and chipped terra cotta units.

- Should there be any terra cotta blocks that are irreparable, a replicated terra cotta block with the same cream coloured glazing, identical molding and profile should be used to replace the existing block. Terra cotta repairs should be undertaken by skilled masons with knowledge of terra cotta conservation.

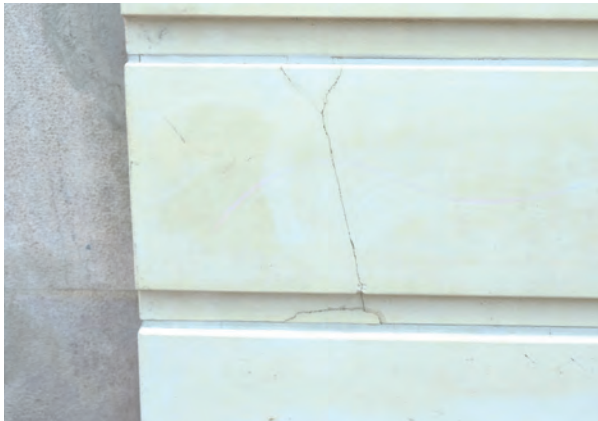
Figure 5.3.3 Cracked masonry unit to be repaired or replaced.

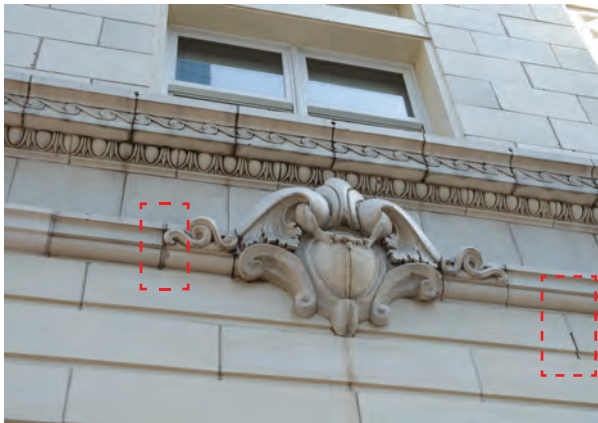
Figure 5.3.4 West terra cotta façade; outlining spalling, stained masonry, gaps and cracks in mortar

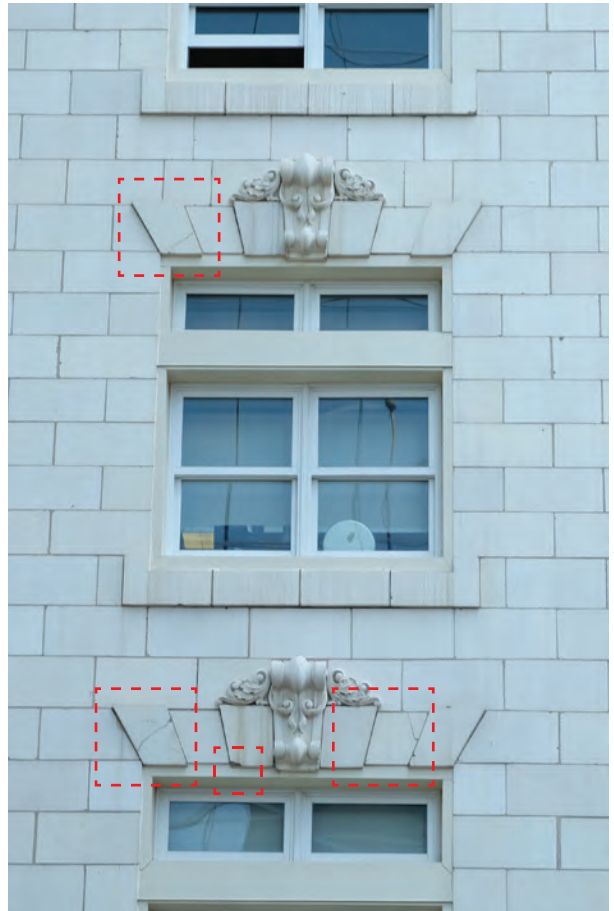
Figure 5.3.5 West terra cotta façade; outlining cracked and spalled terra cotta units

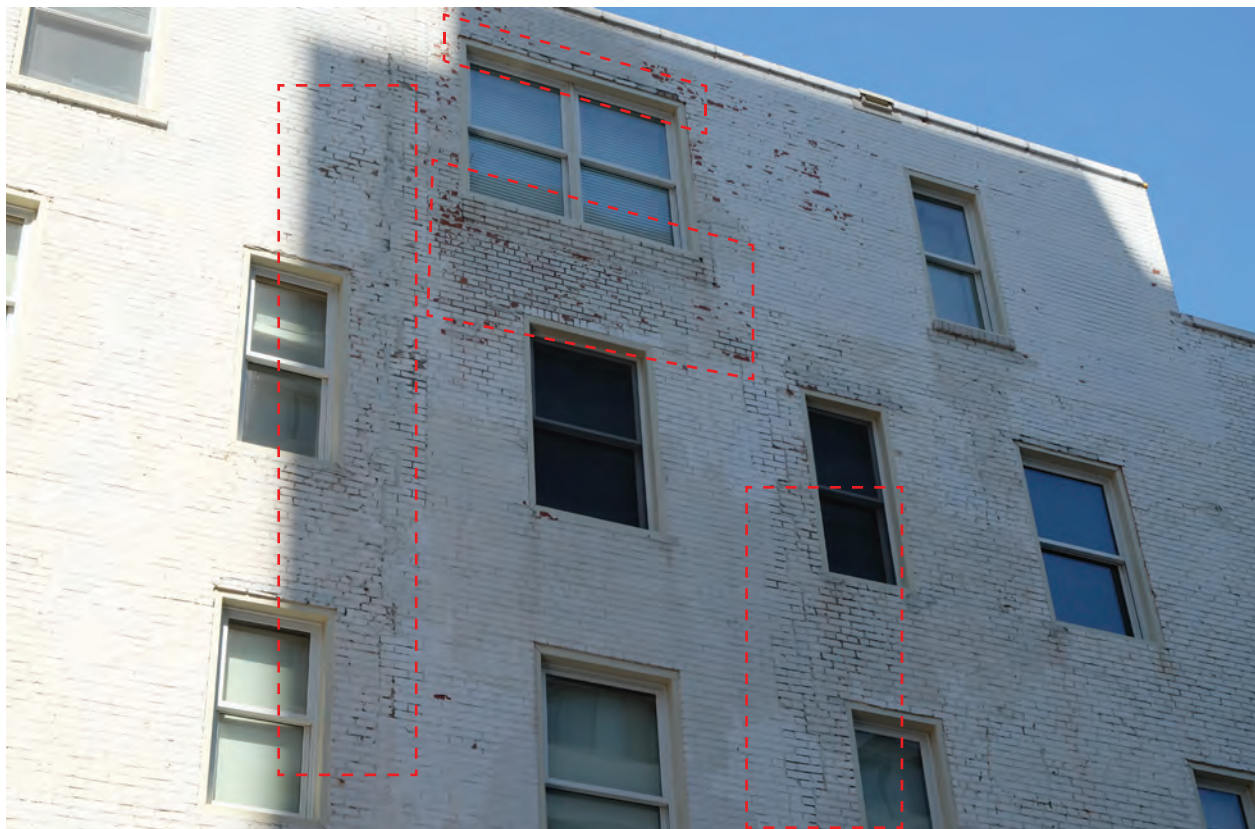
Figure 5.3.5 Mortar and brick cracking on south façade, particularly at the previously infilled portion (not limited to the areas outlines in red)

- Weepholes in addition to vertical and horizontal control joints to be implemented.
- Remove paint off brick masonry at earliest possible opportunity using gentlest means possible.

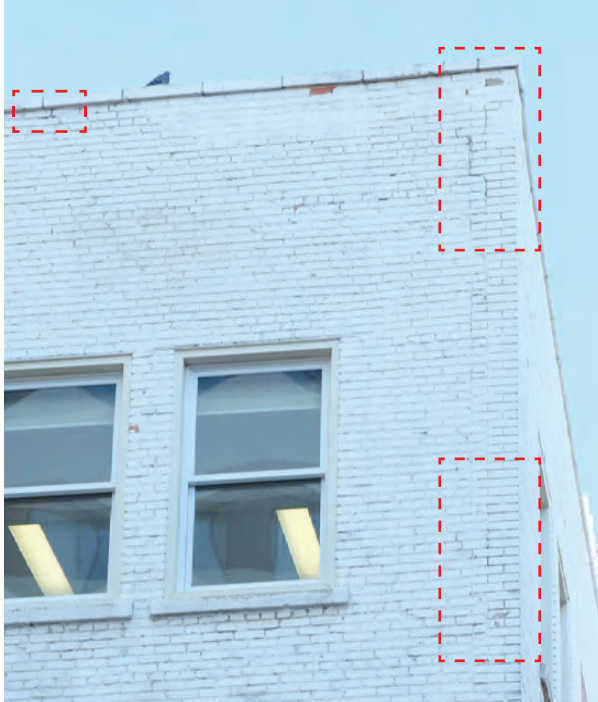
Figure 5.3.6 South façade; outlining instances of step cracking, spalling and mortar deterioration.

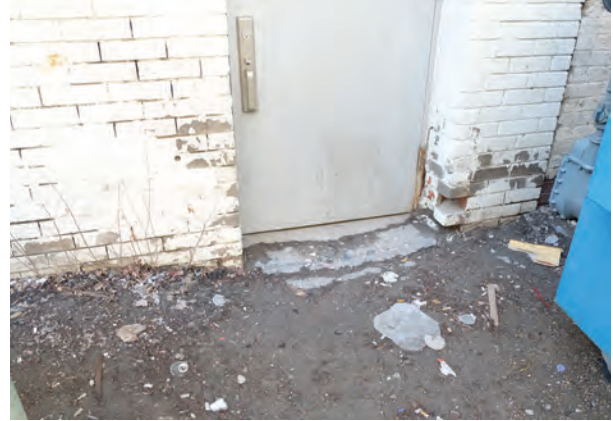
Figure 5.3.7 Discolouration and deterioration of brick masonry at the ground level.

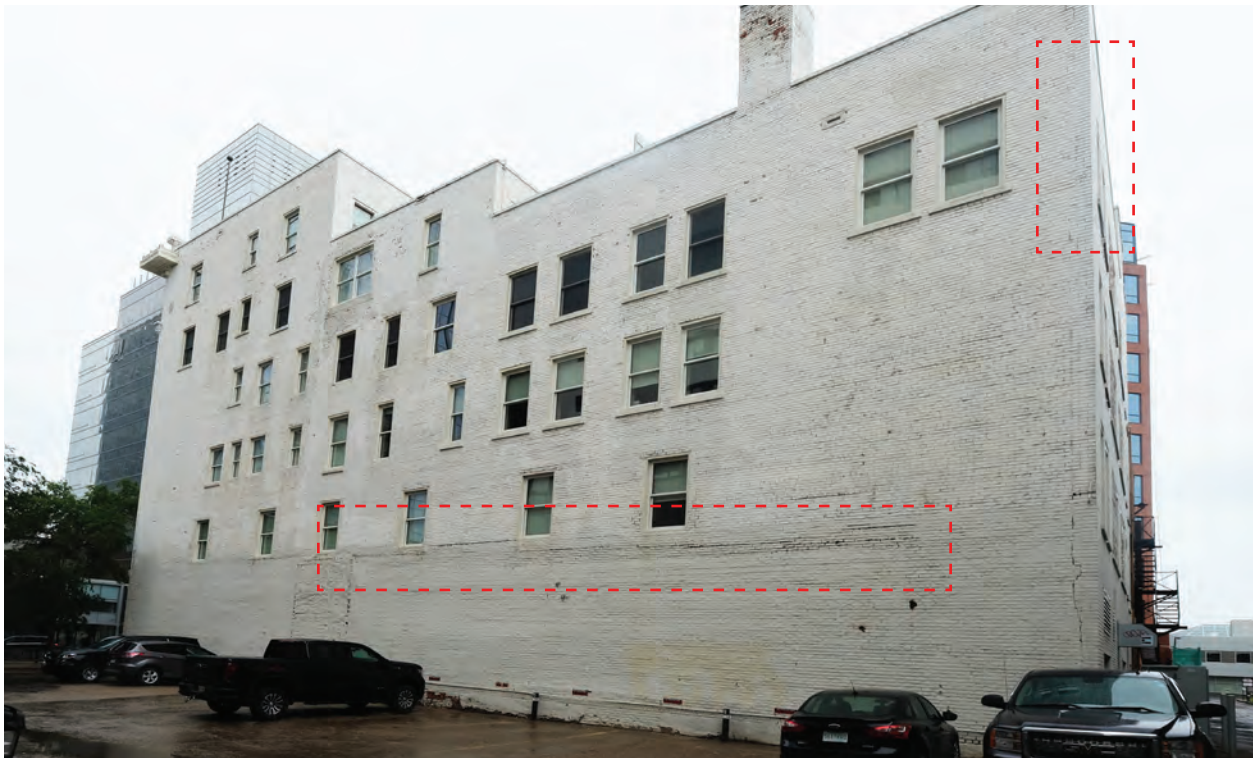
Figure 5.3.8 South brick façade, outlining areas of the façade where brick staggers vertically. Brick above windows at the southeast corner appears to be bowing and pulling away from the structure (right dashed outline)

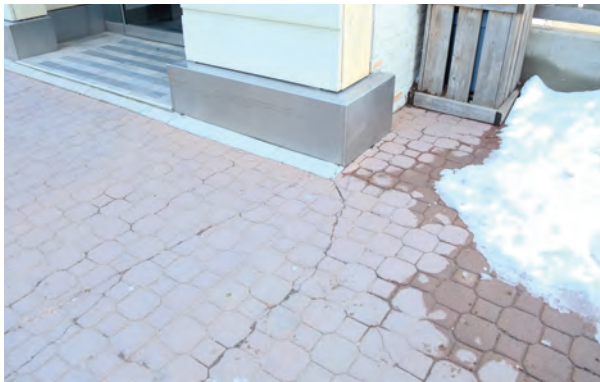
Figure 5.3.9 Cracking sidewalk at southwest entrance.

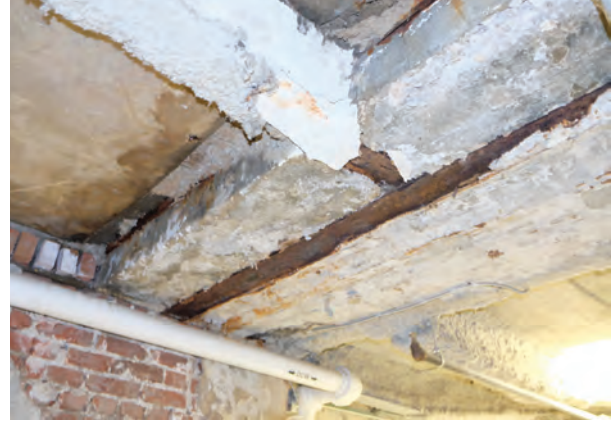
5.3.10 Concrete crumbling off of rusted steel beam

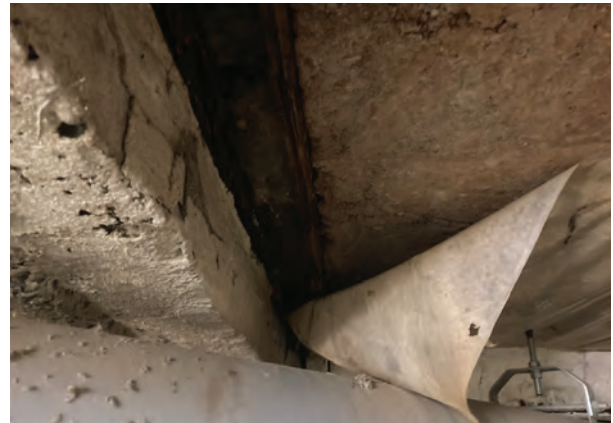
Figure 5.3.12 Membrane has peeled off of concrete slab, rusted steel beam exposed

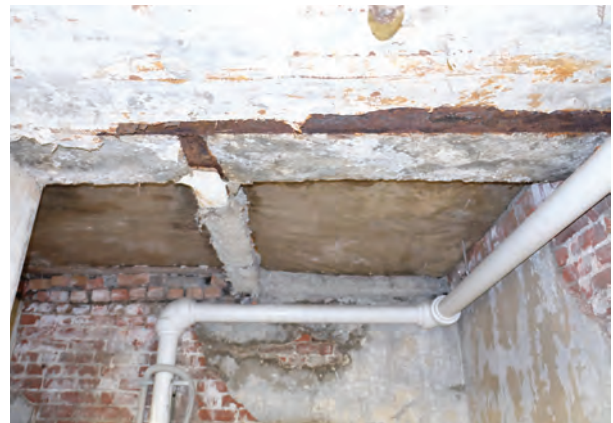
The foundation walls are constructed of infill brick masonry. More recently installed structural steel columns in addition to existing cast-in-place concrete columns and slabs, appear to make up the primary support. The sidewalk at the northwest entry has cracked and allowed water penetration at the building's foundation. The northwest foundation wall has deteriorated significantly and is in need of replacement. There are several loose bricks, structural steel rusting, and instances of staining caused by the water infiltration from above.

Figure 5.3.13 Loose bricks at foundation wall (looking west), discolouration and deterioration due to water infiltration.

The existing northwest brick foundation walls are deteriorating due to water infiltration from the sidewalk above. It is critical to remediate and replace the deteriorated elements to prevent further damage to the structural integrity of the building.

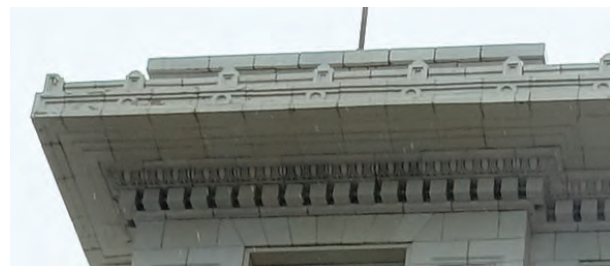
Currently, the west cornice is in poor condition as there is evidence of water infiltration through significant staining along the width, which also indicates its structural integrity could be compromised. The plan to remediate this is to remove and reconstruct the cornice as it is critical to stabilize its structure. The terra cotta on the parapet and cornice must be replicated and restored in the structural remediation to maintain the character-defining element of the building. The cornice is currently wrapped with mesh to prevent loose material from falling.

Figure 5.4.1 Ornamented cornice showing signs of water penetration

- Stabilize the deteriorated structure until the repair work is undertaken.
- Once scaffolding is erected, inspect the condition of masonry. Fully document the existing cornice and parapet and use the existing physical elements to accurately reproduce them.
- Create mock-ups of any recreated masonry elements prior to installation.
- Determine the cause of water infiltration.
- Improve any faulty details of roof elements that may be causing the water infiltration.
- Protect adjacent terra cotta elements from any accidental damage during repair work.

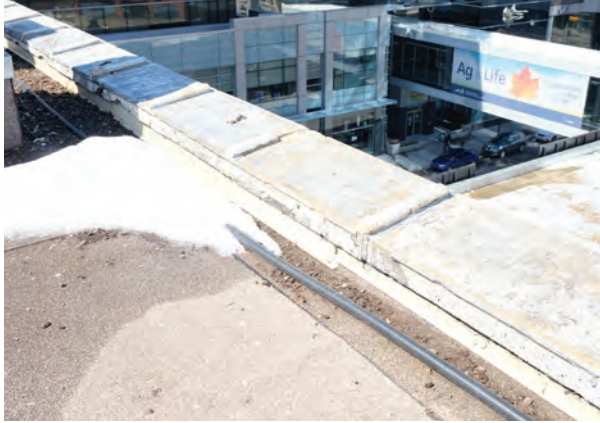
The east portion of the roof is now a patio for the residents of the building, with an exterior wood stair leading to the top storey of the front building via the centre portion of the roof. The general concrete parapets (figure 5.4.2) around the building are in fair condition, with a bit of surface staining. The east patio has an additional wall construction that is in poor condition and should be investigated and potentially redesigned as it could potentially be trapping water between it and the existing parapet.

Figure 5.4.2 Painted concrete parapet

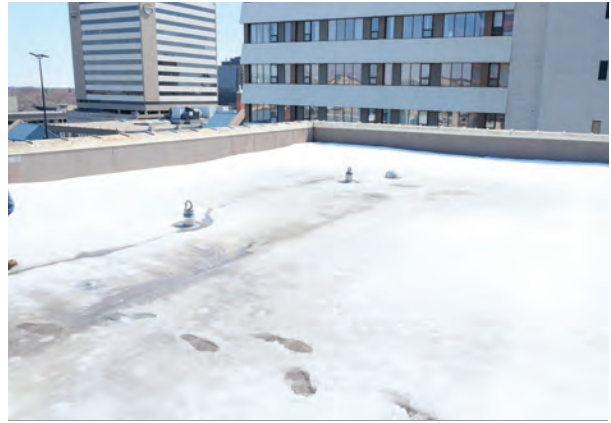
The Leader Building currently has three levels of flat roofs since the enclosure of the lightwell. The west and middle roofs are an SBS SBS Modified Bitumen Roofing System, and the east roof is a raised paticblock over presumably an SBS system. The elevator shaft penthouse remains on the front building, with its east, south, and west façades clad in aluminum siding. Overall, the general roofing system is in fair condition. That being said, the roof appears to have an insufficient drainage system, and should be monitored for any failure throughout its remaining lifespan (approximately 5-10 years).

Figure 5.4.3 West SBS Modified Bitumen Roofing System

- Do not alter the building's original roofline, except to remove elements added in periods other than the original construction.
- Assess condition of the roof and replace if required. Rehabilitation of the roof is acceptable to mitigate any concerns of snowmelt and water infiltration, as long as there is minimal impact to the historical fabric of the penthouse and parapet.

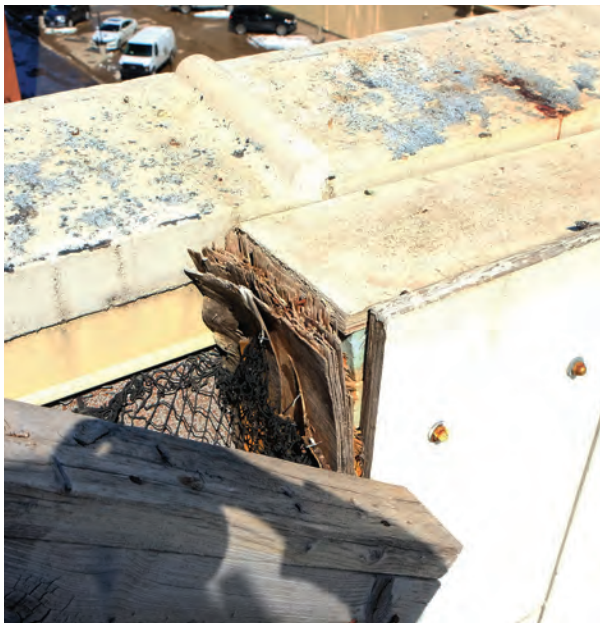
The parapets at the east roof patio should be investigated for potential water infiltration. The existing wall construction on the interior could potentially be trapping moisture between it and the parapet. Overall, the roofs are in fair condition but should be monitored for any failure.

Figure 5.4.4 Wall construction of the interior face of the parapet on the east side of the building

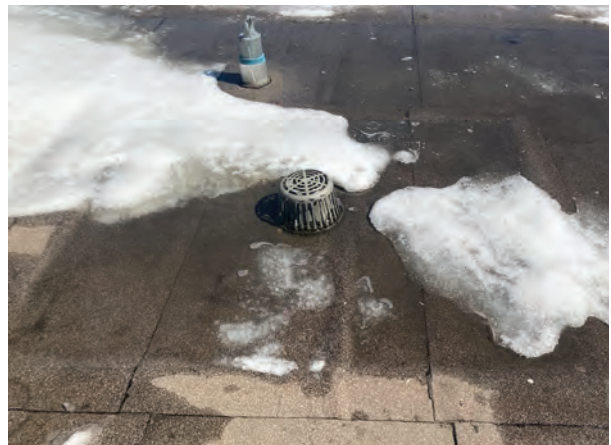
Figure 5.4.5 Roof drain is not located in the center of the roof which makes drainage less efficient. Ponding appears like it might be possible with ridges noticed in the top layer of the roofing.

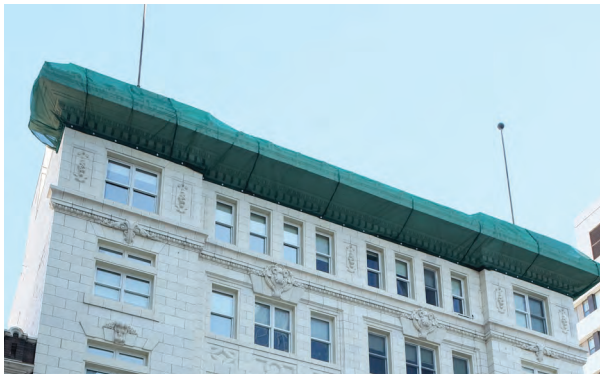
Figure 5.4.6 Cornice has been wrapped in netting as a preventative measure

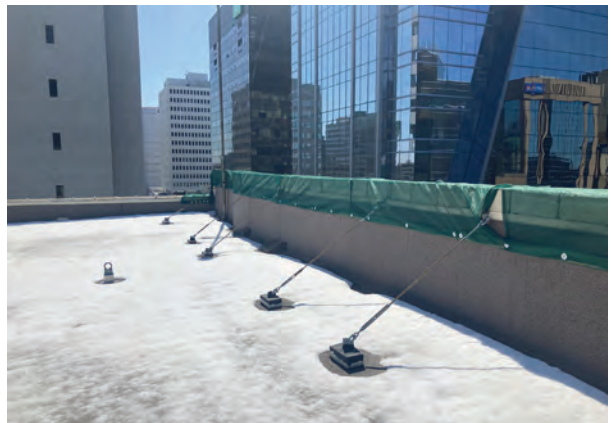
Figure 5.4.7 West parapet anchored onto roof

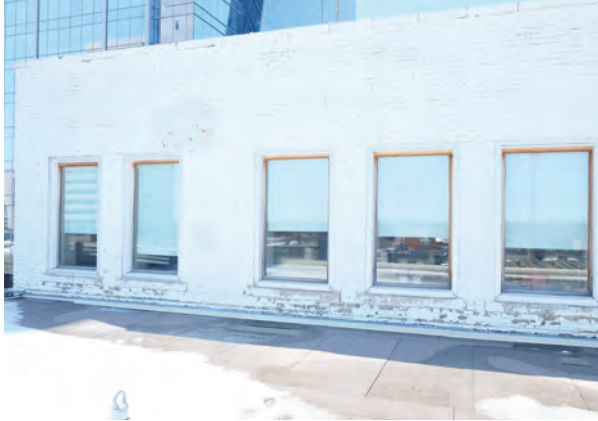
Figure 5.5.1 East elevation at the sixth level showing wood frame windows.

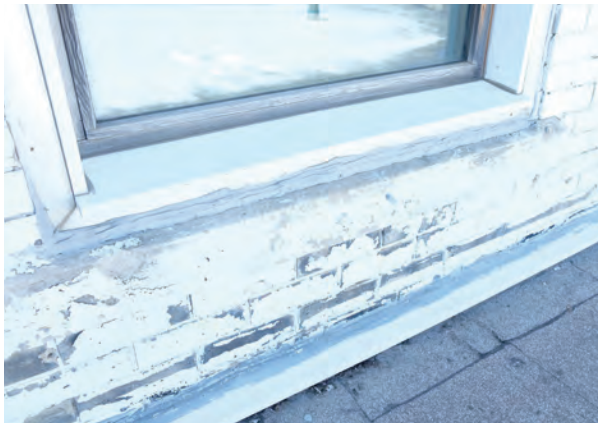
Figure 5.5.3 Some joints at the window sills on the upper east façade have been caulked over. Could mean that window replacement is required.

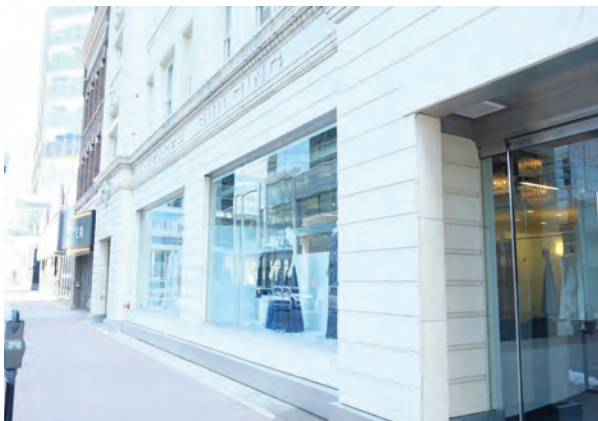
Figure 5.5.4 Storefront windows appear to be in good condition.

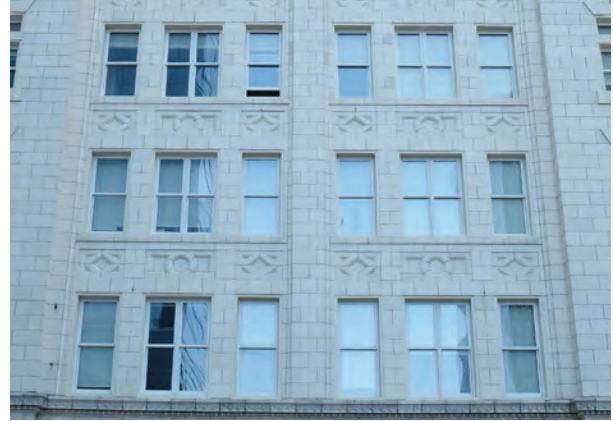
Figure 5.5.2 West elevation windows; levels 2-4. The majority of windows appear to be PVC (Polyvinyl Chloride) and should be replaced with wood windows when replacement is required.

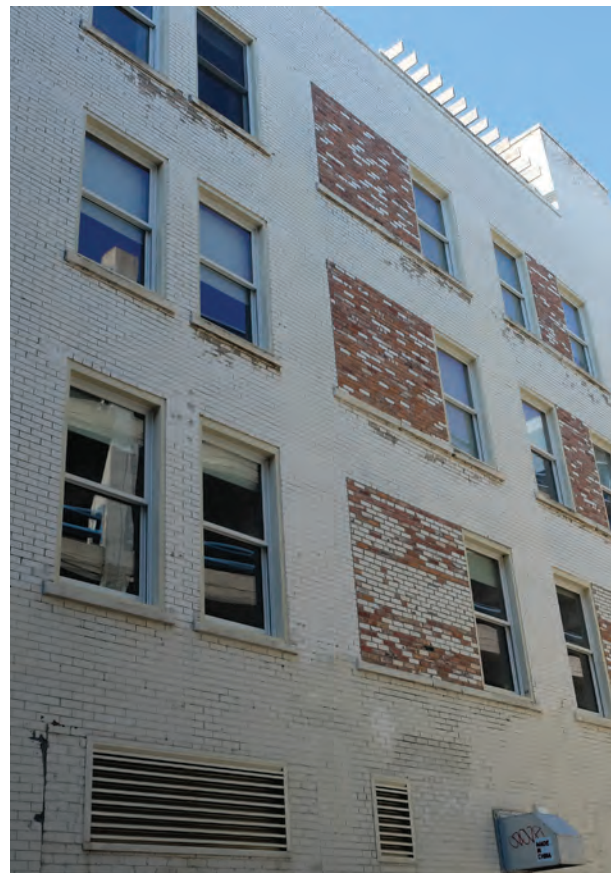
The window sills at the east façade are discoloured which means there is possible water infiltration occurring. This should be investigated further to determine if a full window replacement is required.

Figure 5.5.5 Potential water infiltration at the east elevation windows is evident from the discolouration at the concrete window sills.
