3. Chimney Repairs - (Revised Update)

Cathedral Courts Conservation Plan Amendment 1

2018-08-22

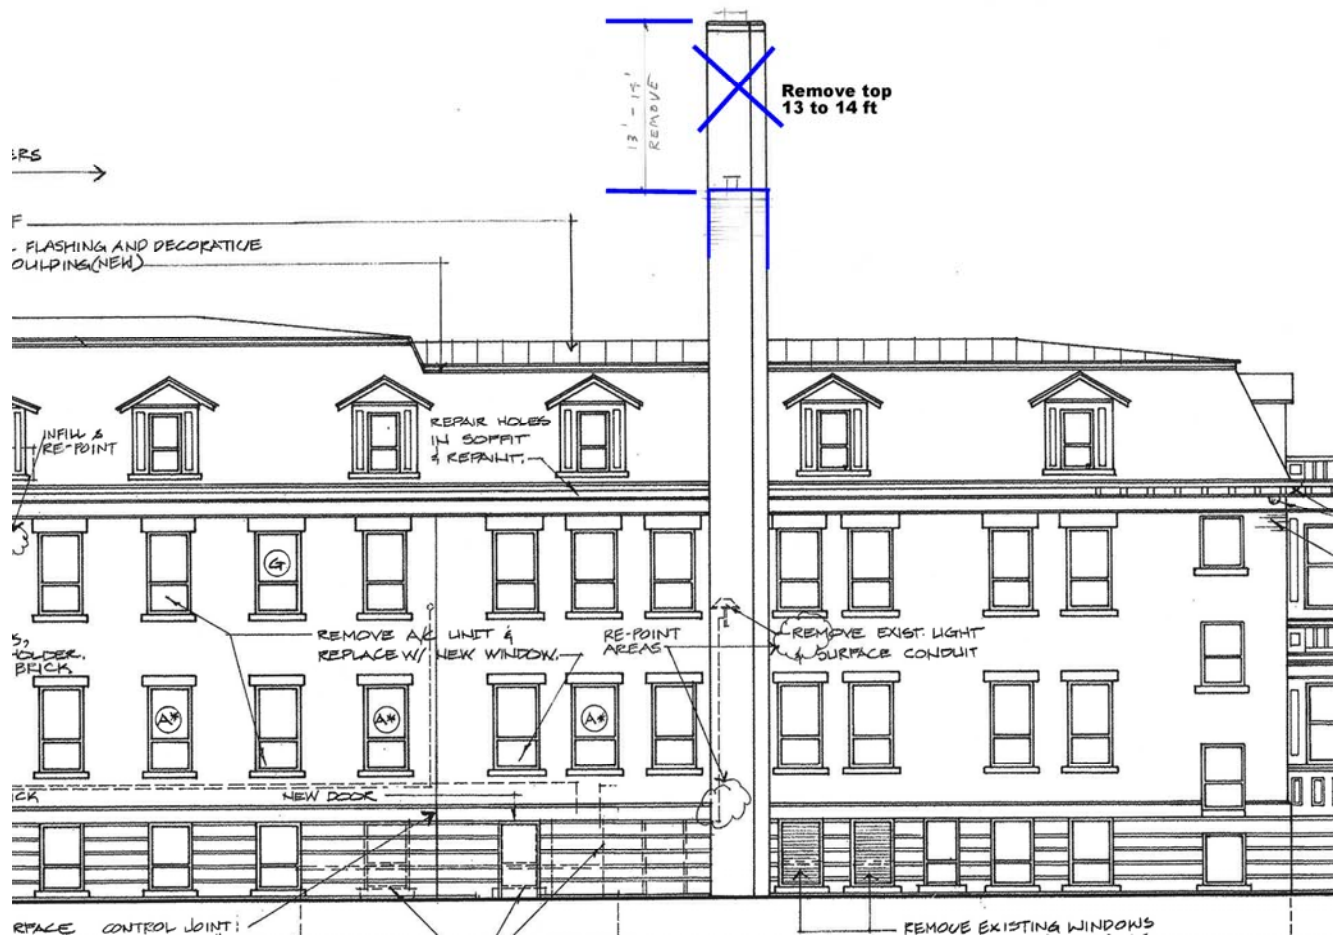
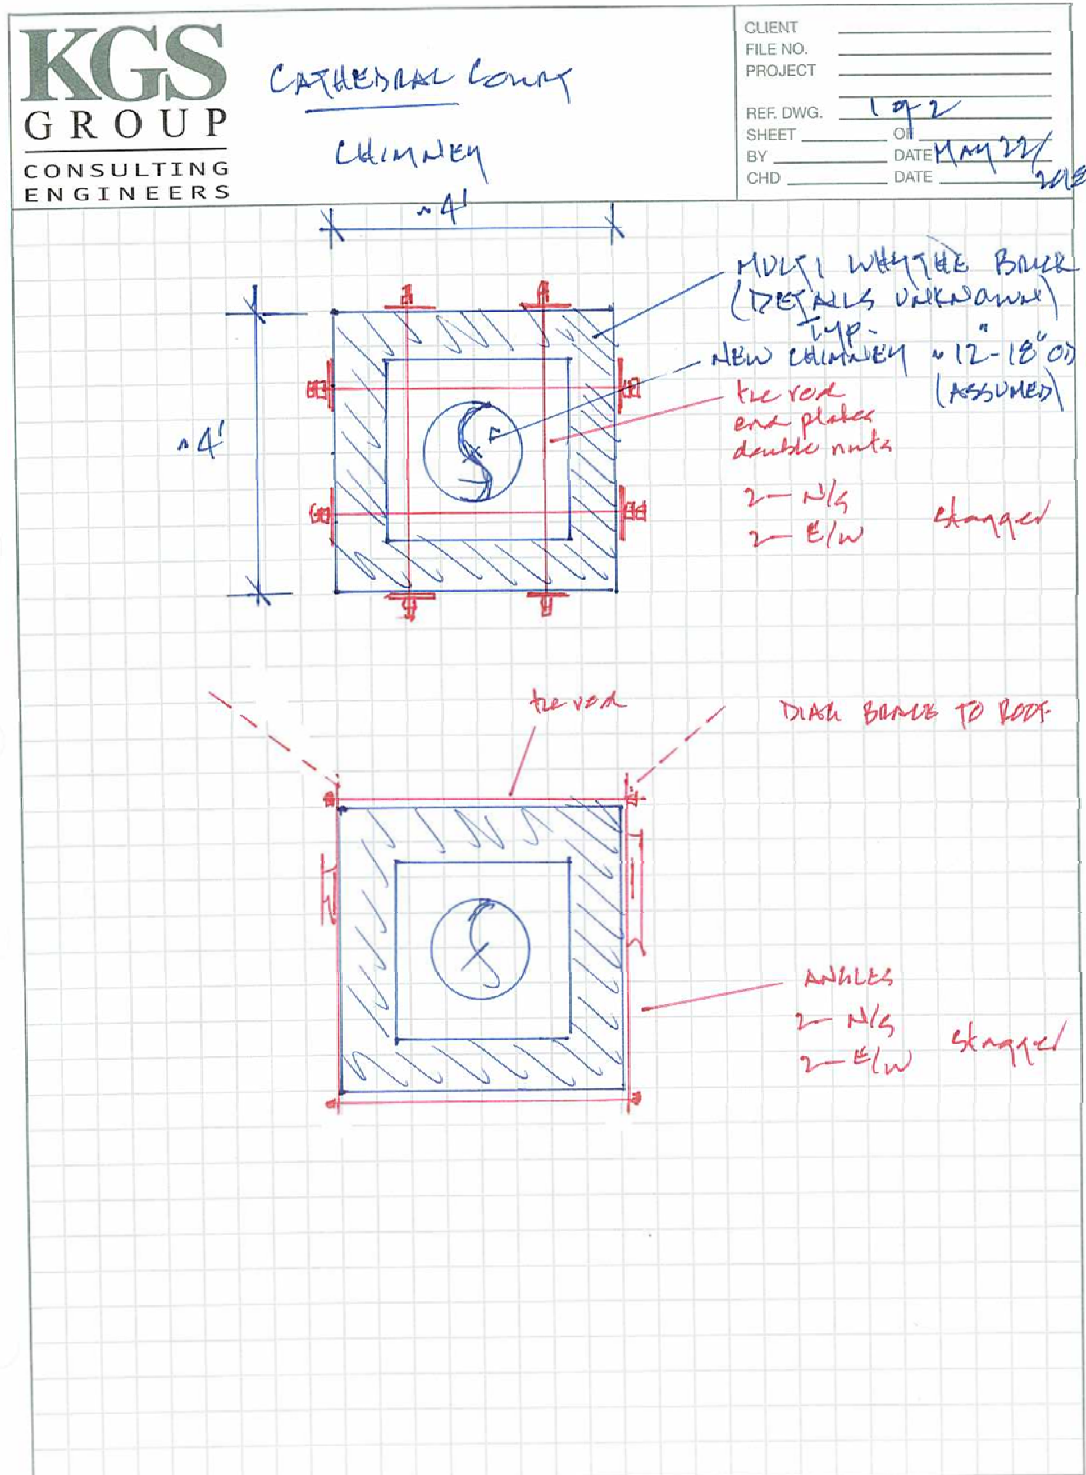
Flue gas leakage (condensation) was visible along the height of the chimney, as well as moisture on the exterior surface of the bricks. Brickwork appears to be displaced along the height of the chimney.

Assuming the new chimney does not have to be as high as the existing, from a structural perspective, it would be beneficial to remove the upper portion of the brickwork no longer required. The deterioration is most pronounced in the upper sections. There would be less wind exposure area, and thus less vertical and lateral loading on the brick chimney construction. There would be less area required to replace / repoint / reinforce.

Attached are a few conceptual sketches for consideration. There were several assumptions noted in developing the sketches. Materials and finish of materials will need to be reviewed. Stainless steel offers the most protection to the elements. Galvanized or epoxy coated would be next, but all damaged surfaces need to be repaired or the corrosion concentrates at the point of the imperfection. Rusting surfaces will stain the brick. It may be preferable to match the color / finish / profile to be as least visible as possible.

The reinforcing could be installed in pair, staggered vertically and rotated. It would be prudent to tie the chimney back to the roof.
