Heritage Conservation Plan for St. Chad's Chapel and College.

Prepared for: The City of Regina

Prepared by: Jessica Gibson, Designer

February 15, 2018

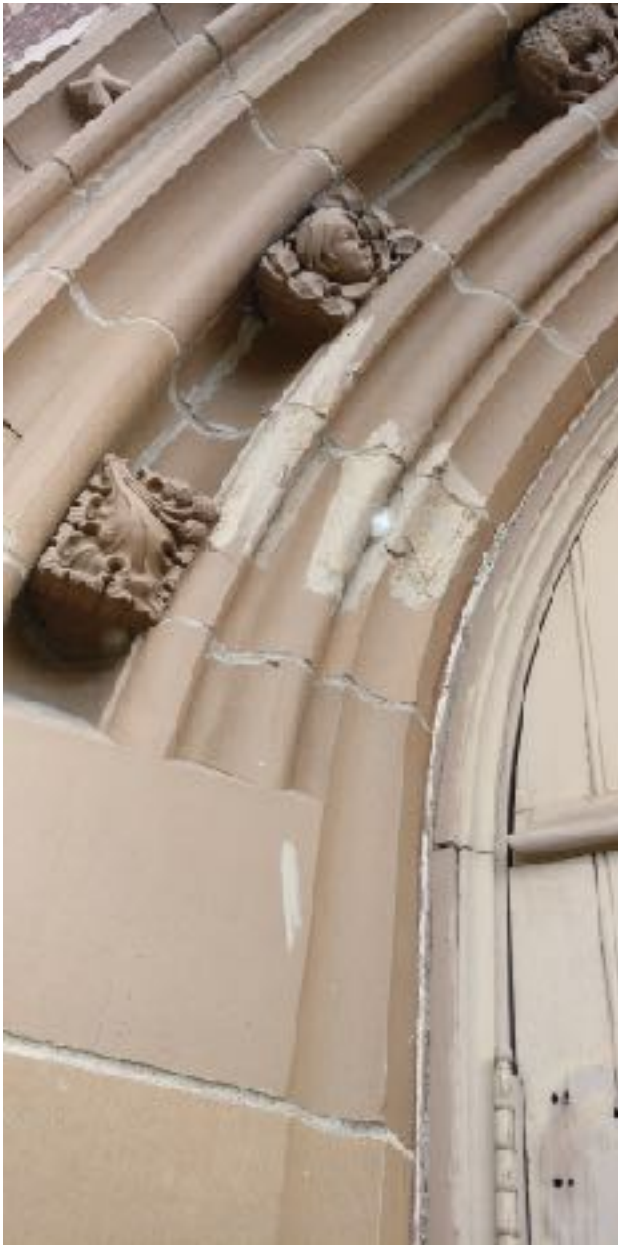
Incorrect repair or patch of terracotta archway.

There is evidence of inappropriate or substandard repairs to terra-cotta elements, particularly on the West entry archway of the Chapel. In some instances the wrong mortar type has been utilized to patch and repair mortar joints and cracks in the terra-cotta archway. The mortar is incorrect in colour and is likely of a portland cement mixture, which is inappropriate for the application. Cracking, chips and spalls due to moisture penetration and freezing is present in some of the terra-cotta components, along with deterioration of many mortar joints.

Repair of the architectural terra-cotta to the north, west and south facades to include cleaning, crack repair, deep spalling repair, surface repair and glazing. All patching, repair mortars and glaze coatings are to be from a single manufacturer's product line and are to be compatible with each other, as well as with the existing facade materials. For surface repairs Edison Coatings Thin-Fill 55 Re-profiling mortar is to be utilized. For crack repairs Edison Coatings Flexi-Fill 530 or Custom System 45 are to be utilized. For deep repairs to terra-cotta elements Edison Coatings Custom System 45 TC with Restoration Latex RL-1 and RL-2 are to be utilized. Glazing of all terra-cotta elements to be done with Edison Coatings Aquathane UA210 Type NCL with Type G Bonding Additive. Where re-pointing, placing or setting large terra-cotta elements is deemed to be required, Helix S.S. DryFix Terra-cotta Ties. In the instance that a terra-cotta piece is deemed to be too damaged to be repaired and a replacement is deemed necessary, the replacement terra-cotta piece may be replaced with a new terra-cotta element. This new piece must be replaced in kind, shape, and glaze type and colour matched.

Areas where the mortar is found to be deteriorated or missing will require re-pointing in order to prevent further moisture penetration into the terra-cotta facade elements and wall system. A third party mortar assessment is to be completed prior to construction in order to determine the physical and chemical makeup of the existing mortar. An appropriate and matching mortar will be chosen for construction upon the results of the mortar assessment. All deteriorated mortar will be removed by hand raking and a test panel will be completed by the contractor in order demonstrate all aspects of the repair procedure for the repointing of the terra-cotta.

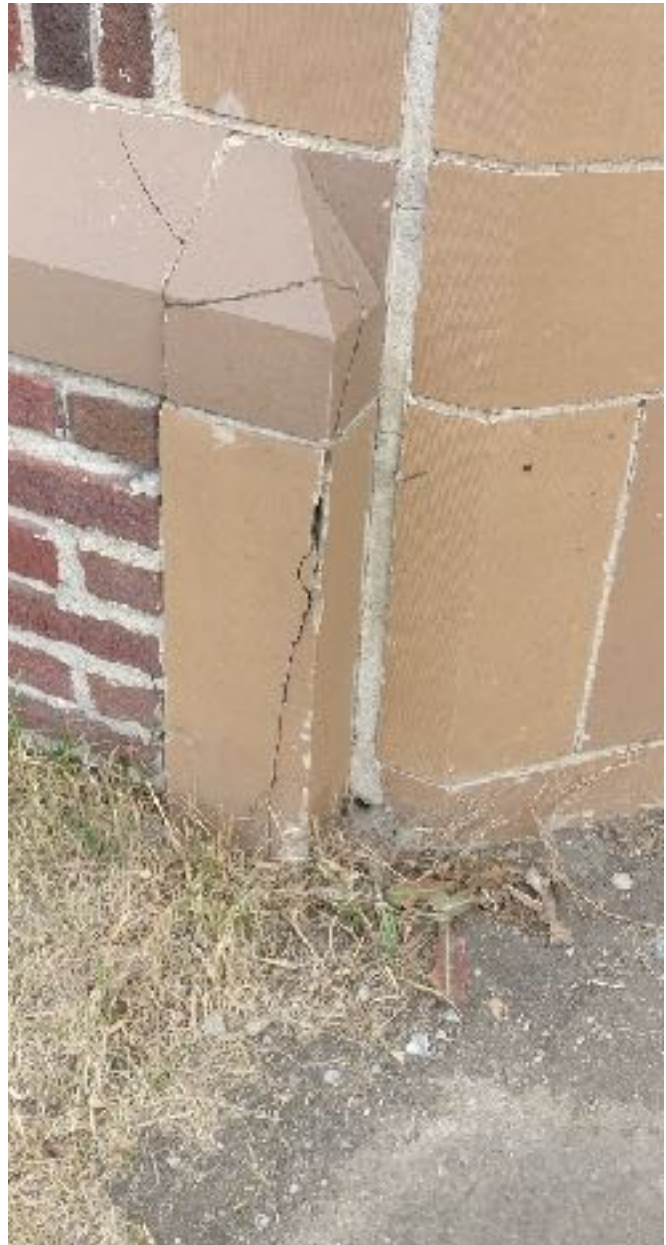
Cracked and spalling terra-cotta on west

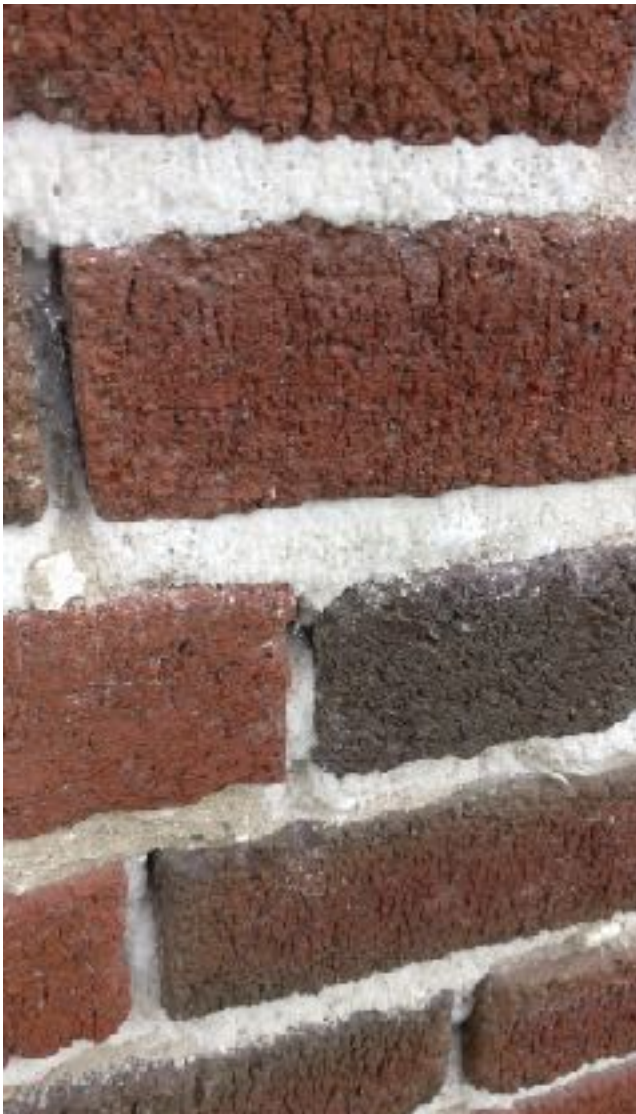
All facades feature the same dark red brick that are a character defining element of the Collegiate Gothic style in Saskatchewan. The brick at approximately the 4 foot mark above grade is showing large amounts of efflorescence on the exterior of the building, indicating water damage on the interior of the building. Also, a number of mortar joints throughout the facade are deteriorated or missing and will require re-pointing. A previous re-pointing job was done incorrectly with a Portland cement based mortar, throughout the facades of both St. Chad's College and St. Chad's Chapel. Bricks appear to be broken or missing in some places, and will need to be appropriately repaired or replaced. There are a number of points where electrical conduit and fittings were brought through the face of the building, these items will have to be cut back or removed in order to repair the mortar joint.

Efflorescence in the mortar joints

Cleaning of the face brick elements are to be undertaken as needed with with low pressure hot water, type "B" surfactant manufactured by Chemfax MS Cleaner and natural bristle brushes. A cleaning test panel will first be completed for review and approval in order to determine that methods utilized are appropriate.

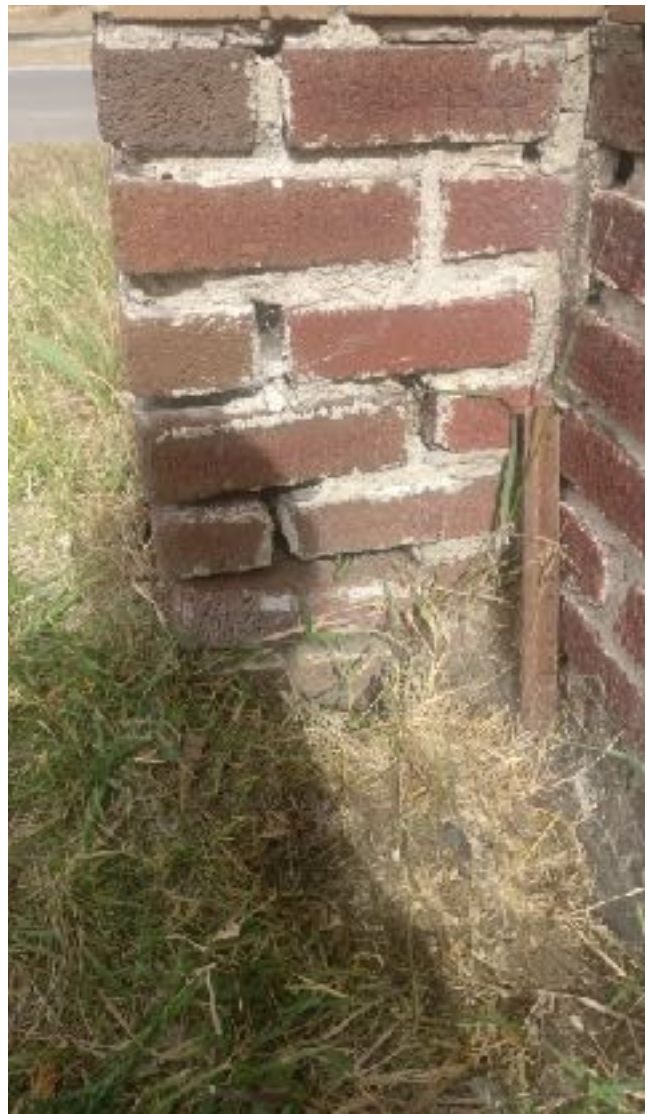
Missing and deteriorated masonry joints

Throughout the north, south and west facades the mortar was found to be deteriorated or missing. Missing or deteriorated mortar will require re-pointing in order to prevent further moisture penetration into the brick facade elements and wall system. A previous repointing of the brick facade was done with an incorrect mortar type, which appears to be of a portland cement mixture. A third party mortar assessment is to be completed and submitted to the City of Regina Heritage Department within two months of Council approval. This mortar assessment and brick compression testing must be completed in order to determine the physical and chemical makeup of the existing and original mortar, as well as to the strength of the brick so that an appropriate mortar selection can be made. An appropriate and matching mortar will be chosen for construction upon the results of the mortar assessment. The new mortar shall match the original in strength, colour and tooling. All deteriorated and incorrect mortar types will be removed by hand raking and a test panel will be completed by the contractor in order demonstrate all aspects of the repair procedure for the repointing of the face brick.

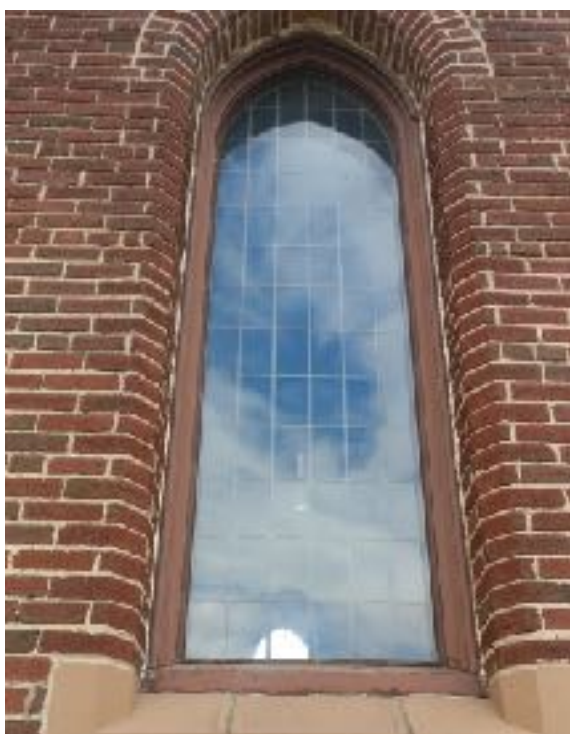
Existing chapel windows.

The windows in the Chapel are the original windows and are mostly in good condition, particularly the interior windows with multi-paned glazing. A few panes are broken or cracked, but otherwise the existing storm windows have protected the interior multi-paned glazing. The wooden frames are showing some disrepair with possible water and frost damage. Damage to frames appears to be minimal, and is primarily due to age. The Chapel window frames are currently painted a dark red-brown colour, and the existing paint is flaking and pulling away from the frame.

Due to the condition and original nature of the multi-paned windows and wooden frames it is recommended that the existing windows be repaired and restored to their original state. Where the windows show general weathering, splitting or rotting the frames should be allowed to dry, and then treated with a fungicide and weatherproofing material such as boiled linseed oil. All cracks and holes should be filled with an appropriate putty, and finished to manufacturer's specifications.

In areas where the wooden frames are too badly deteriorated for stabilization, splicing and parts replacement may be utilized as necessary. In these instances wood parts matching the original construction shall be utilized and the original moulding profile should be replicated. An experienced craftsman shall be utilized to make repairs of this nature. In the instance that a window frame is deemed too damaged for repair and restoration a new wooden window frame may be utilized. In the method of rehabilitation the new window frame shall be of wood construction and will replicate the original moulding profile and original wood type. All work is to be completed by a professional with experience in heritage wooden windows. All proposed and necessary repairs are to be documented in shop drawings by contractor, and approved by consultant prior to any repair or restoration work to be completed.

A colour matching of the paint and historic paint colours of the time shall be conducted in order to determine the most appropriate colours for the wooden frame, sashes and other elements.

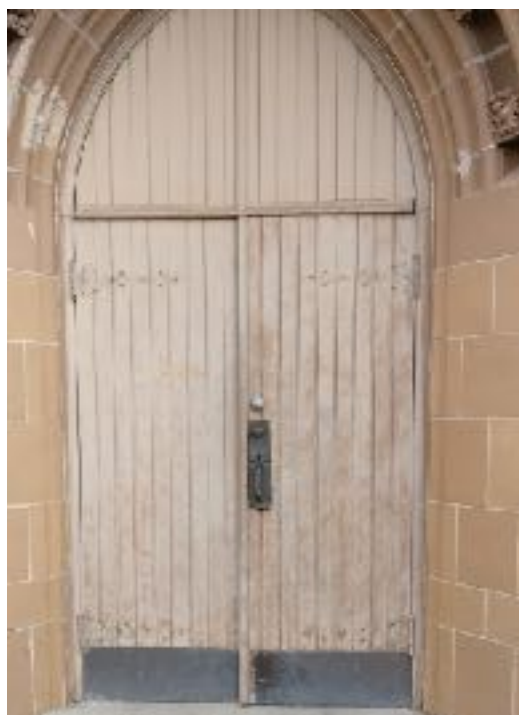
Existing west entry doors.

The main entryway to St. Chad's Chapel is located to the west of the Chapel. The main entryway doors to the West appears to be the original wooden doors. The existing doors are in disrepair, with nails poking through from the interior as well as possible water damage. The doors are not weather resistant, and are quite unstable. The door was painted a light colour and the paint is partially worn off. The existing kick plates do not appear to be original, and the metal is uneven and in disrepair. The metal kick plate appears to be currently helping to hold the existing wooden door slats together. The original door hardware and hinges were removed, possibly when the church was de-sanctified in 2005.

The west entry door is in disrepair with the historical hinges and door handles removed. For reasons of compliance to current building codes and regulations, the conformance to the environmental and energy conservation standards as well as the desirability for revitalizing St. Chad's Chapel with a contemporary use, rehabilitation will prove to be the most viable intervention method for the west entry door. A further structural assessment of the door by a qualified contractor should be conducted in order to determine if repair or replacement is the best solution.

If replacement is deemed necessary the historic appearance of the west entry can be recreated with a suitable wooden gothic arched doorway. The west entryway can be augmented and celebrated via the introduction of a new door, along with appropriate hinges and hardware. It should be enhanced to the proper character of the building. The replacement door must be a double door and reinterpret the original swing, style, size and central astragal. It is the recommendation that the replacement door reinterpret the original wood slatting, at least on the bottom half of the door. The top arched wooden spandrel should also be re-introduced and re-created in the instance of door replacement. The spandrel should be constructed of wood, and should utilize the same moulding profile as the original. The spandrel should be of the same size, shape and general construction of the original. A qualified contractor certified in historical repair or replacement work should be utilized.

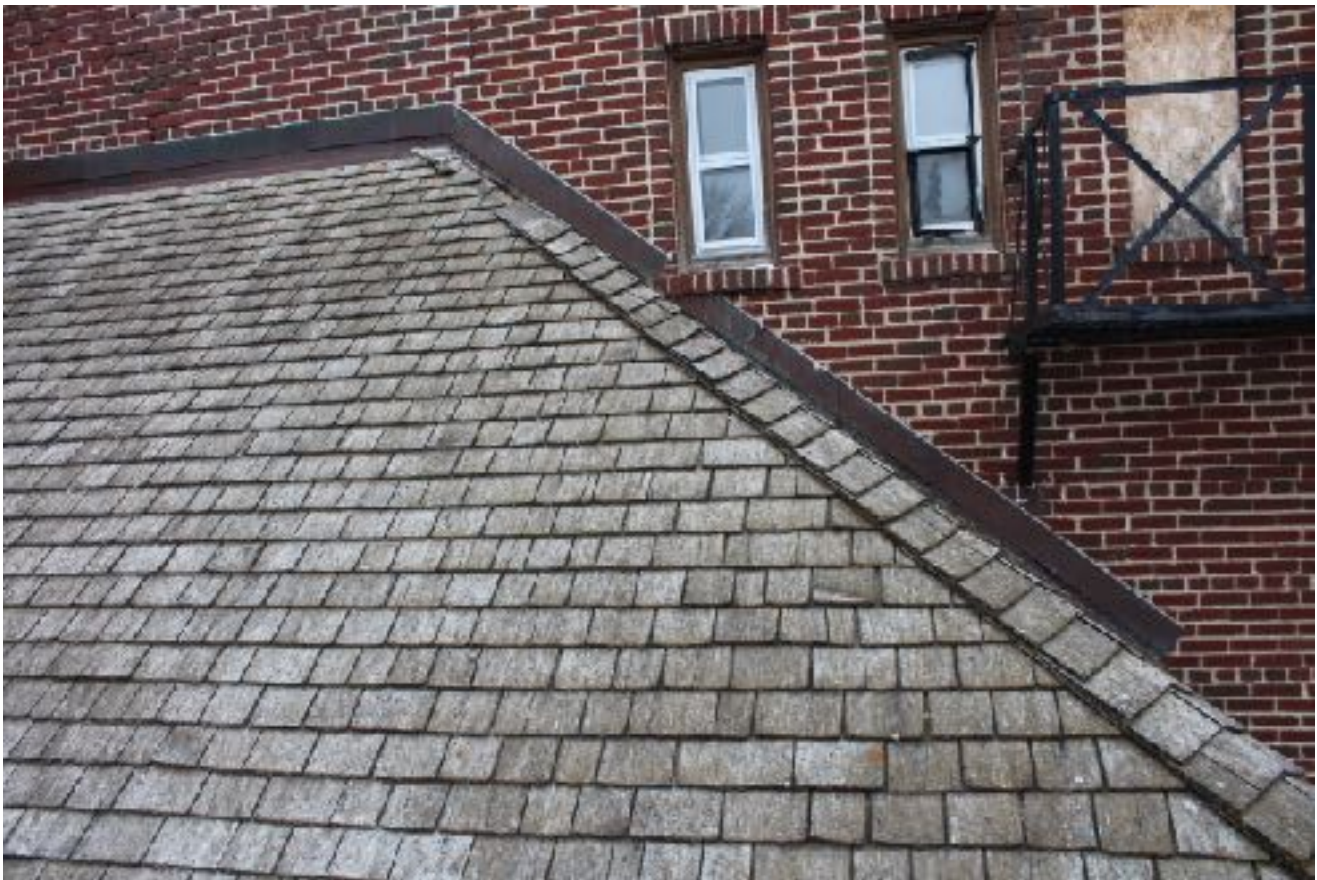
St. Chad's Chapel features the traditional wood shingled, sloped roof of Collegiate Gothic architecture. The south roof wooden shakes are in fairly decent, though worn condition. The north roof wooden shakes are in less desirable condition, showing extensive moss growth due to water collection within the wooden shakes themselves. The existing shakes have been documented as being western cedar, approximately 19" in length, varying 5-10" in width and with a 5.5" overlap.

The moss that has grown on the existing shakes should be removed gently in order to not damage the existing wooden shakes. Cleaning should be done with a mixture of sodium percarbonate and water. It is best to use the weakest strength of cleaner and to apply it with a sprayer or soft bristle brush to minimize damage to the existing wood surface. Power washing should not be utilized due to the potential for excessive damage to the wood surface.

Water-repellant preservative (WRP) or water-based stain should be utilized to treat the shakes after cleaning has occurred. It is recommended that the moisture content of the wood should not be above 20% prior to the application of WRP or stain.

It is recommended that St. Chad's College and Chapel sloping wood-shingled roofs are replaced over the next five to ten years in kind with a preservative treated wooden shingle in order to increase the longevity of the roof. As we

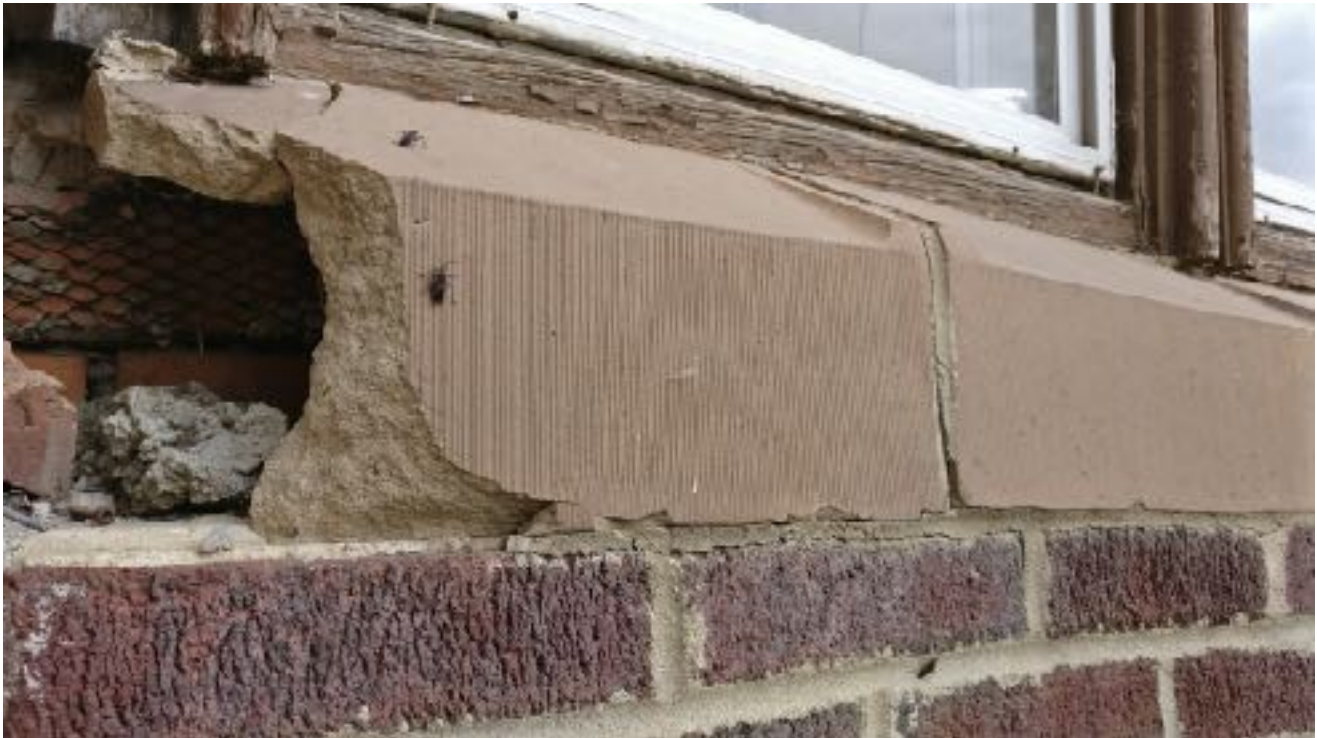
The mortar is incorrect in colour and is likely of a portland cement mixture, which is inappropriate for the application. Cracking, chips and spalls due to moisture penetration and freezing is present in some of the terra-cotta components, along with deterioration of many mortar joints. Some elements, such as window lintels appear to be damaged beyond repair.

Damaged terracotta lintel on south facade

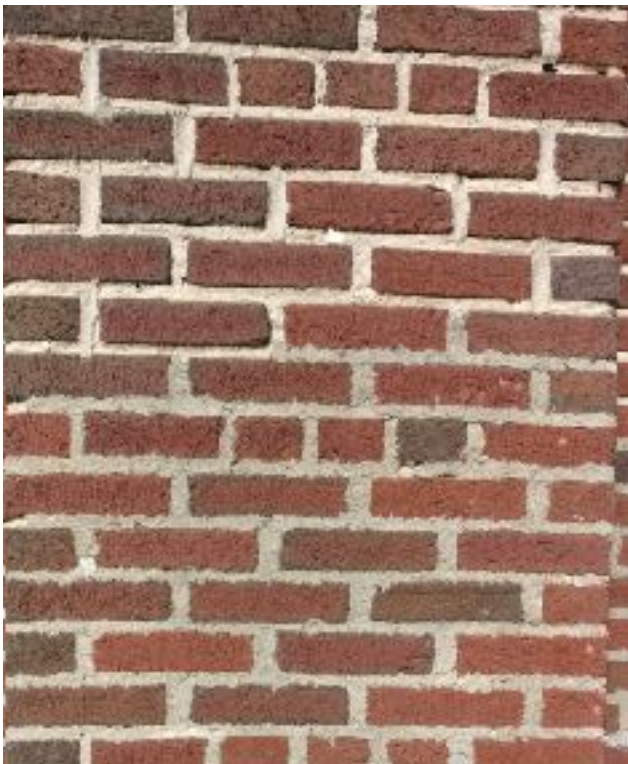
Portland cement mortar repointing.

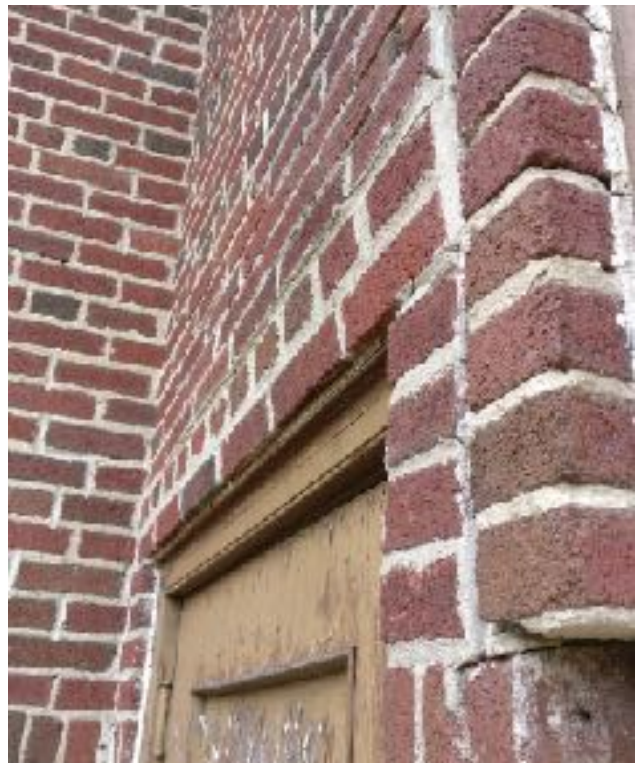
Pushed face brick on south facade

Where the brick is showing pushed face brick, the brick will be removed carefully by hand and retained in order to reveal the cause of the pushed brick. If the brick is pushed due to the rust jacking of the steel lintel or header this will require the removal of rusted areas, as well as potential replacement steel where required if the steel is deemed too damaged for lasting repair. If the pushed brick is due to excessive compressive loading or the brick no longer being securely attached to the backing then further investigation and solutions will be required in order to mitigate the issue. In any situation where brick is removed, it must be removed carefully and retained. Retained brick will be reset with mortar that is compatible and matches existing.

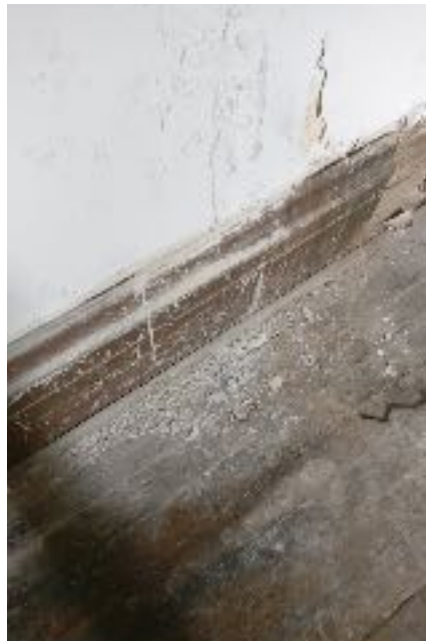
The majority of the interior finishes in St. Chad's chapel are in extreme disrepair. The plaster has cracked, peeled and separated from the lath in most areas due to repeated water damage. The wooden floors have also heaved in many places due to water damage. The east stage of the chapel is not original and the wood does not match in finish, grain or type to the original wood flooring of the chapel.

Water damaged flooring

The chapel floors are also extremely water damaged and show a substantial amount of bubbling and heaving throughout. The stage on the east side of the chapel is not original and shows a newer wood type, size and finish. The original wood flooring of the chapel is mostly considered to be damaged beyond repair with many areas near the walls having warped over one inch in height. As it will be nearly impossible to match the existing wooden flooring in species, and dimension we believe that rehabilitation is the best methodology for repair. The proposed replacement flooring should be hardwood, of a similar type and similar dimension. The rehabilitated floor should attempt to reinterpret the original decorative central aisle.

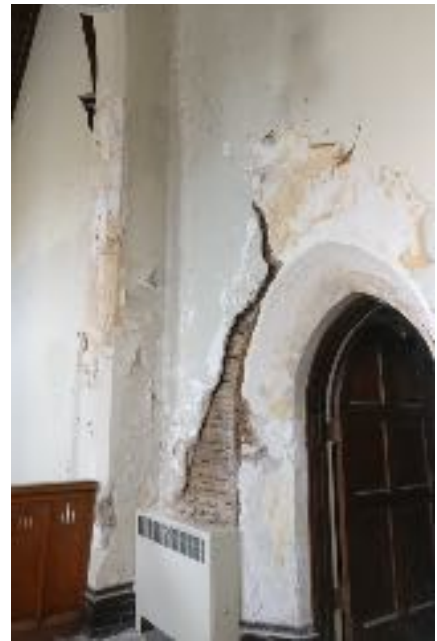
Water damaged plaster

The interior of St. Chad's Chapel has a substantial amount of water damage throughout. We recommend that all plaster is tested for asbestos, and that mold testing is done within the wall cavities. In the instance that asbestos and mold are found traditional remediation methods are appropriate. All windows, interior doors, and the chapel ceiling are required to be protected during any remediation efforts.

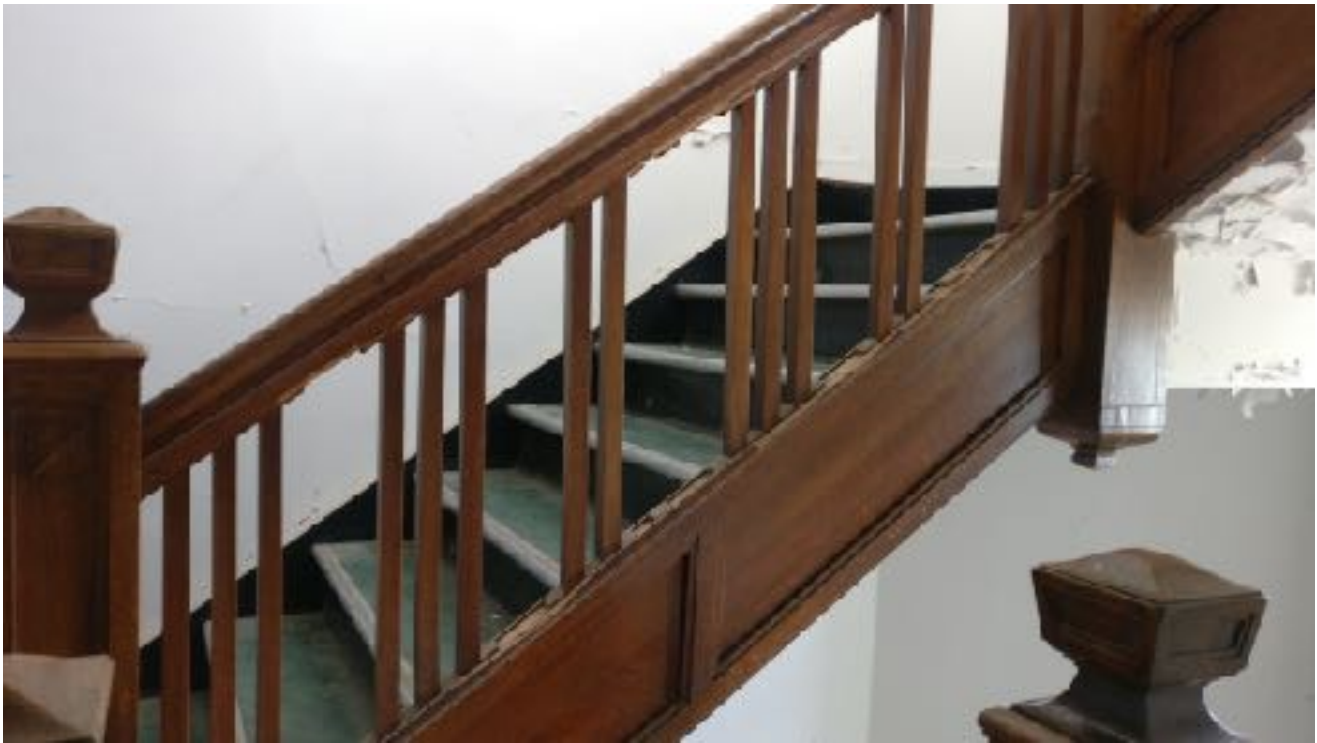
Section of stairwell with missing decorative stiles.

Located in the South-West end of the building the internal wooden stairwell is in good condition throughout most of the flights. The stair railings and decorative stiles are mostly intact except for a few areas where the stiles were broken or removed. The wood of the stairs and railings are in good condition with very little wear or tear.

The main stairs of St. Chad's College Stairwell is mostly in good condition, and as such we recommend restoration for the majority of the stairwell. The missing stiles will require a rehabilitation methodology. The missing stiles should be replaced with new stiles of the same wood type, grain, and dimension. The missing stiles should follow the same decorative pattern of the upper staircases, and should be finished with a colour matched stain or varnish as appropriate. The remainder of the stairwell is in good condition and should not require repairs. During repairs and renovations of the interior the stairwell shall be protected carefully in order to prevent damage.
