CATHEDRAL COURTS

Conservation Report
2018-04-05

The following Conservation Plan for the Cathedral Courts building, located at 3225 13th Avenue in the City of Regina has been prepared for Academy Housing by SEPW Architecture with the sub-consultant KGS for structural items.

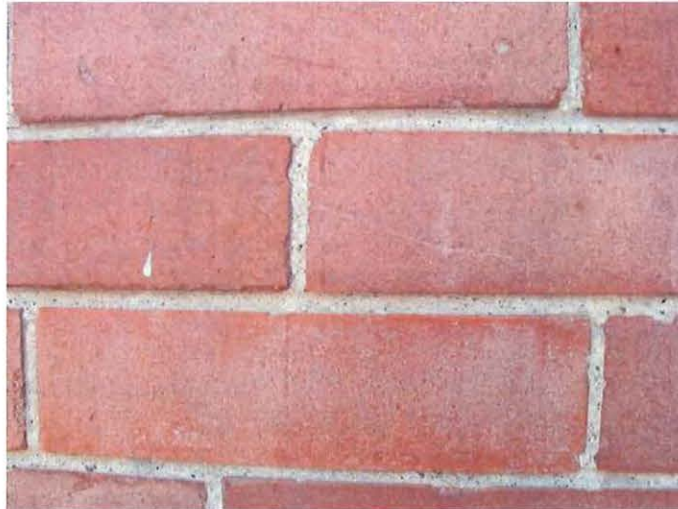
We should add the heritage defining characteristics of this building, the tooled mortar joint profile. Although this is a small thing it has a impact on the appearance of any repointing work, or repair work to the masonry wall. The original mortar joints on the building are tooled using a slightly “weathered” joint. This type of mortar joint leaves a slight recess at the top of the joint then slopes slightly outward to meet the top edge of the brick below the joint. It was also noted that the mortar joints of the 1909 and 1914 portions of the building are slightly narrower than typical modern joints are.

Figure 5a – “Weathered” mortar joint on east wall of 1909 portion.

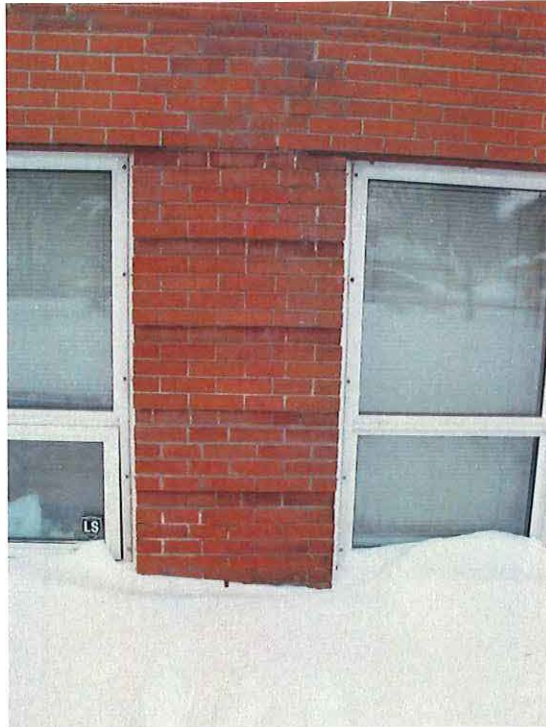
At some point in the past all except one of the brick arches of the lower windows of the 1909 portion was replaced with running bond brick supported on a steel lintel. There is still one arched brick opening just to the east of the main entrance projection. The brick arches still exist west of the main entrance on the 1914 portion.

Figure 9 – running bond on steel lintels (replaced brick arch lintel)

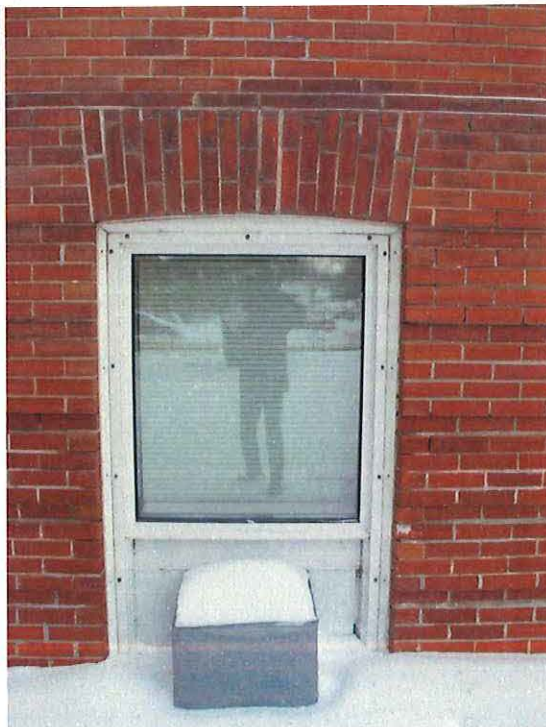
Figure 10 – remaining brick arch lintel on 1909 portion

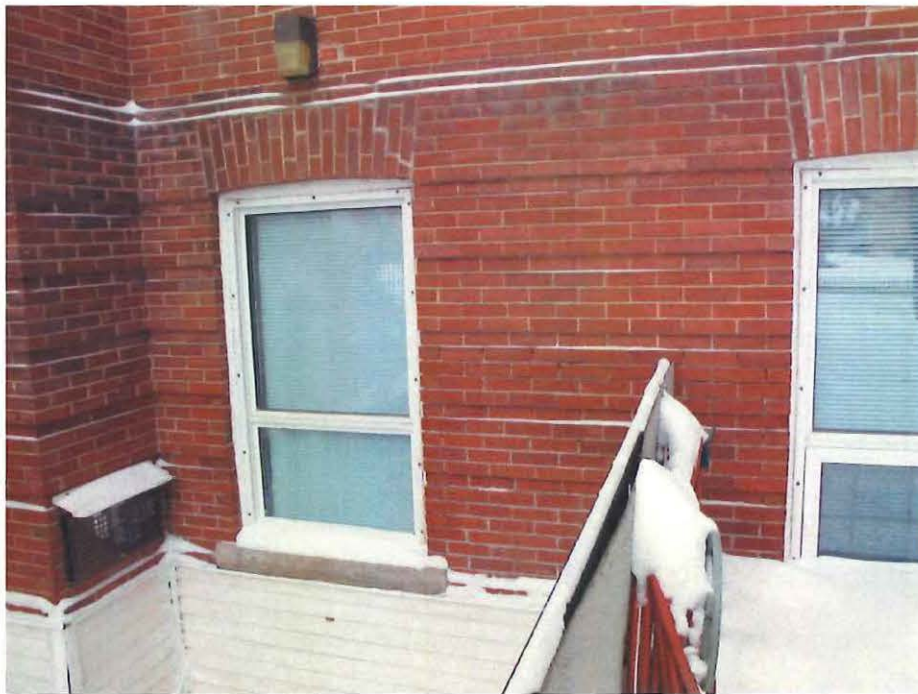
Mortar has been replaced at some time in the past at various locations along this façade, generally along the lower bands of rustication. Currently, the mortar joints on this façade have quite a bit of deterioration. Conditions observed include:

- Weathered vertical joints, especially along the top two stepped brick courses
- Deteriorated joints with a high degree of weathering both horizontal and vertical
- Localized areas of missing horizontal and vertical joints
- Very soft mortar (powder) localized in areas west of the main entrance
- Localized areas at the west end of the facade that has been previously raked out but mortar not replaced (appear to have been ground out as some damaged bricks noticed)
- Staining of brick between windows below stepped brick courses

Figure 11 – Area of 1914 portion with deteriorated mortar joints

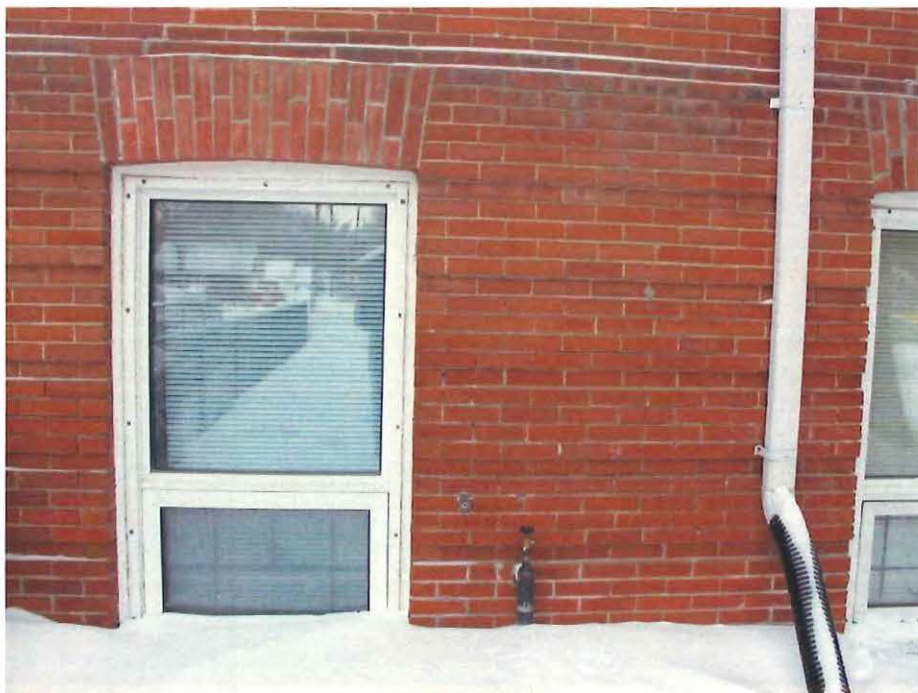
Figure 12 – Area of 1914 portion with deteriorated mortar joints (note dark staining at stepped bricks)

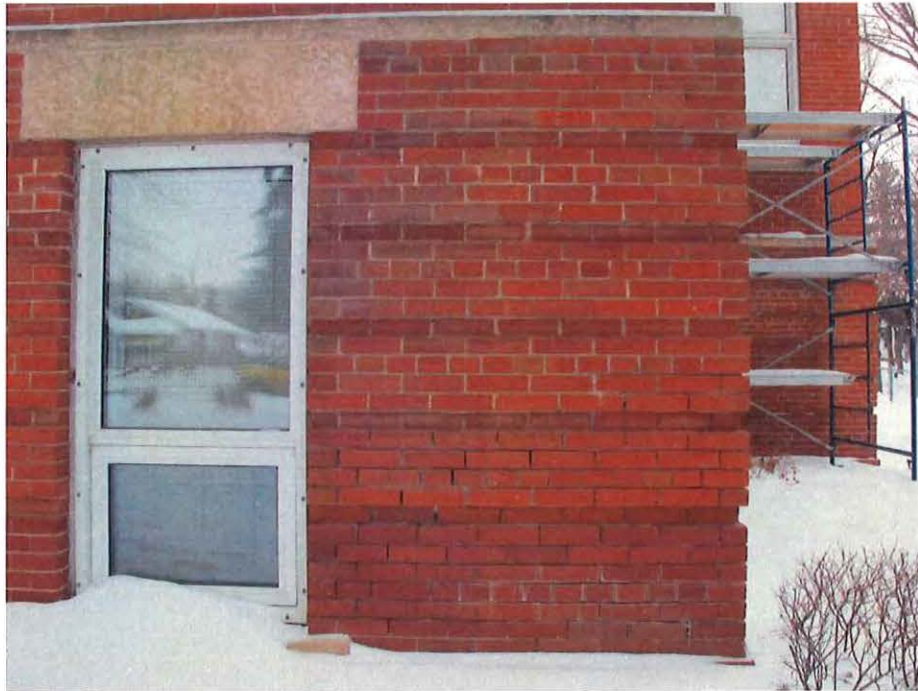
Note the headers in bond courses (below), typical in the 1924 portion but not in the 1909 or 1914 portions of the building (above). The 1909 and 1914 portions will likely rely on metal brick ties to

bond the face brick to the back up wall. The condition of the brick ties should be reviewed when the opportunity presents itself to determine if any remedial work needs to be done.

Figure 13 – Area of 1924 portion with raked out mortar joints

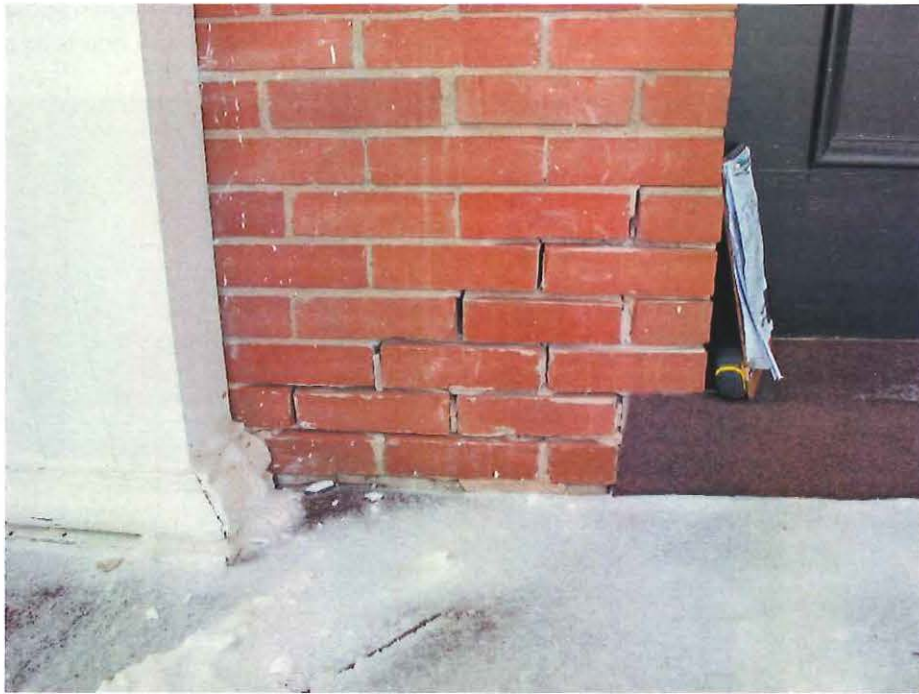
There are areas around the main entrance on the North side of the building where the brick has broken and fallen out, likely due to the differential movement between the stair structure and the masonry wall. Some areas of brick appear to have been replaced at some time in the past, such as at the west side of the stair, possibly when the ramp was installed. The pilasters on the east side of the stair are damaged. The small pedestals at the bottom of the stair need repointing below the stone cap.

Figure 14 – Damaged masonry at both sides of the main entrance doors at top of stairs

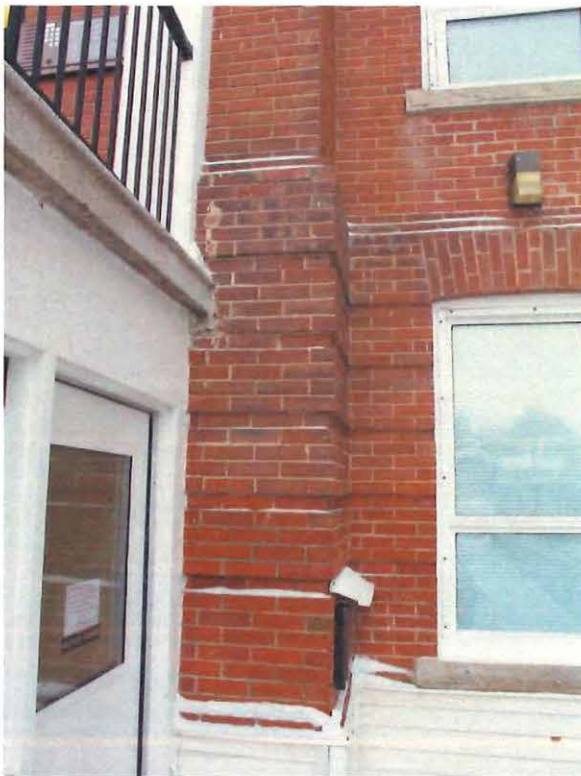
Figure 15 (left) – West side of stair – similar damage at landing both sides of main entrance

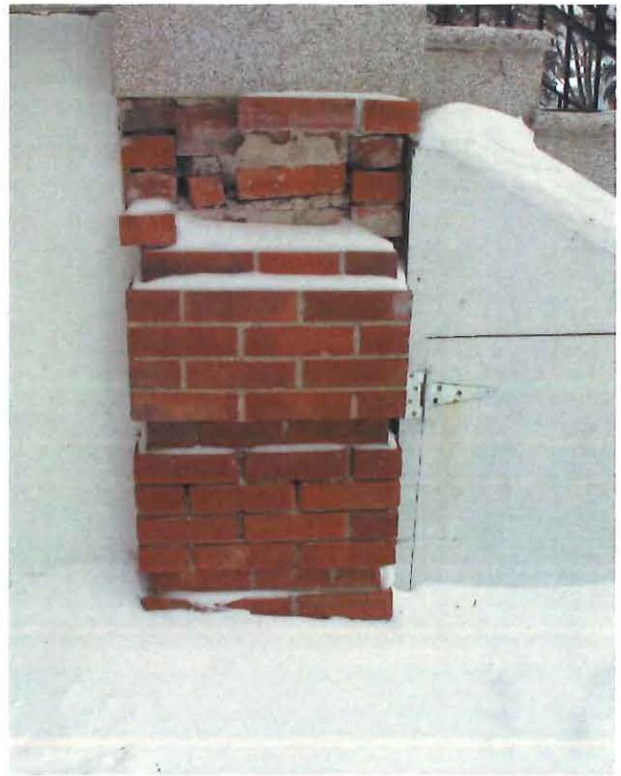
Figure 16 (right) – East side of stair – bricks missing on pilaster of main entrance

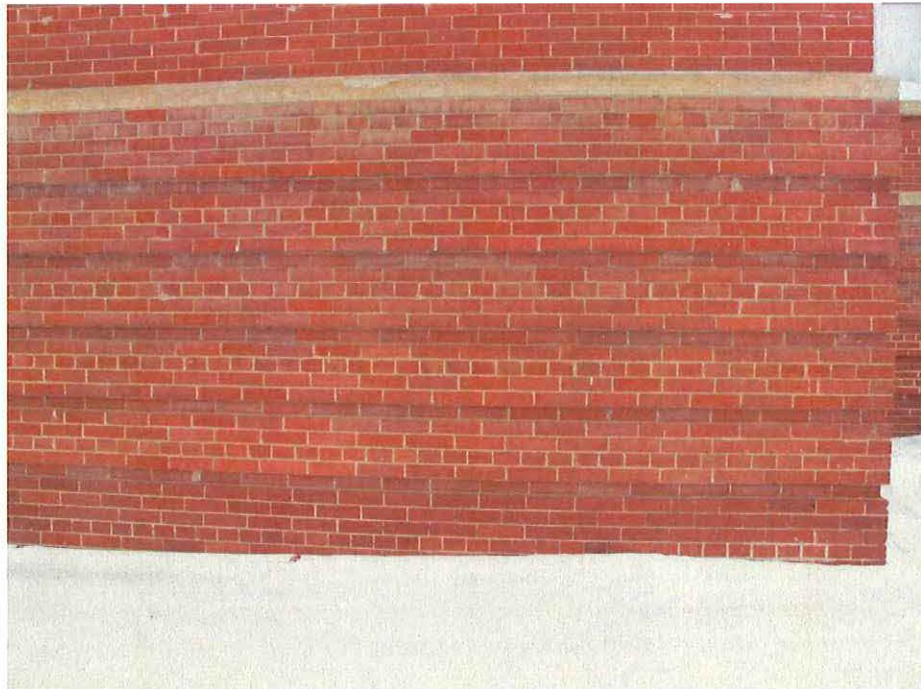
Figure 17 – Southwest corner of West façade – generally in good condition

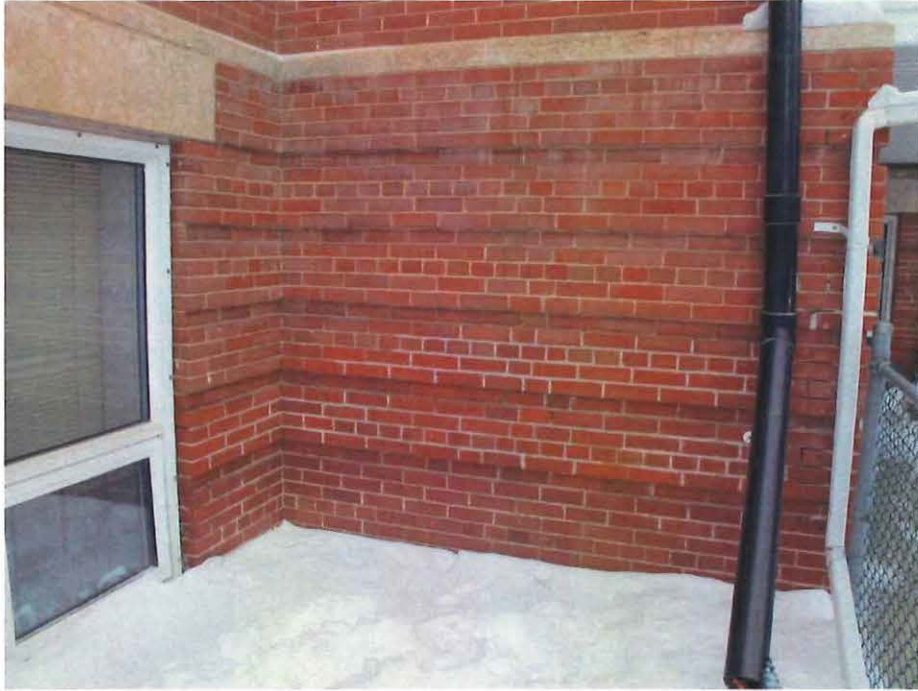
- Mortar in some areas was in fairly good condition
- Localized areas of missing horizontal and vertical joints
- Areas where up to 50% of the mortar requires repointing due to weathering

Figure 18 – Southwest corner of West façade – areas where more deterioration was noticed

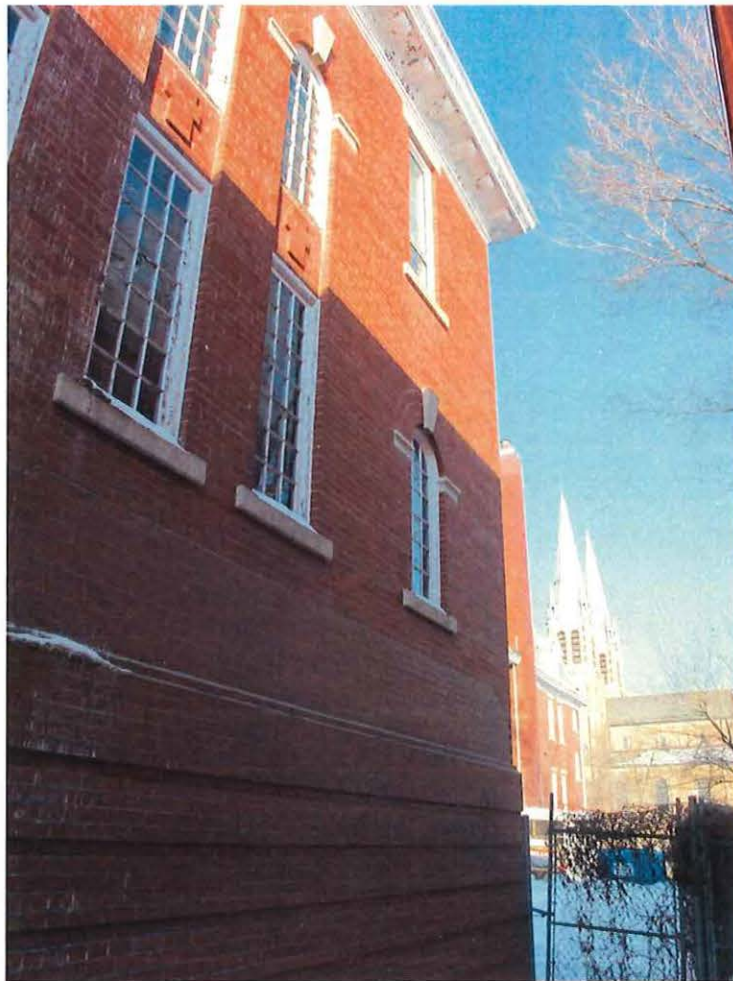
The South façade varies in condition. The area right around the west where the building begins to step back is in a similar condition as the west porch and surrounding faces. Where the building extends south (the 'L' shape created by the chapel) there is an area where the lower portion of the wall has had the masonry completely replaced at some point in the past. The bricks used in this area are more modern bricks, with harder Portland cement mortar used in the masonry. No header, bond course has been installed, rather all brick are laid in a running bond pattern. A vertical crack has appeared through the brick masonry below one of the arched windows. The vertical crack is likely caused by expansion and contraction of the harder masonry without any built in control joints. We do not know the reason why the masonry was replaced in this area of the wall.

Figure 19 – South face of the Chapel – note area of running bond where modern brick and mortar were used

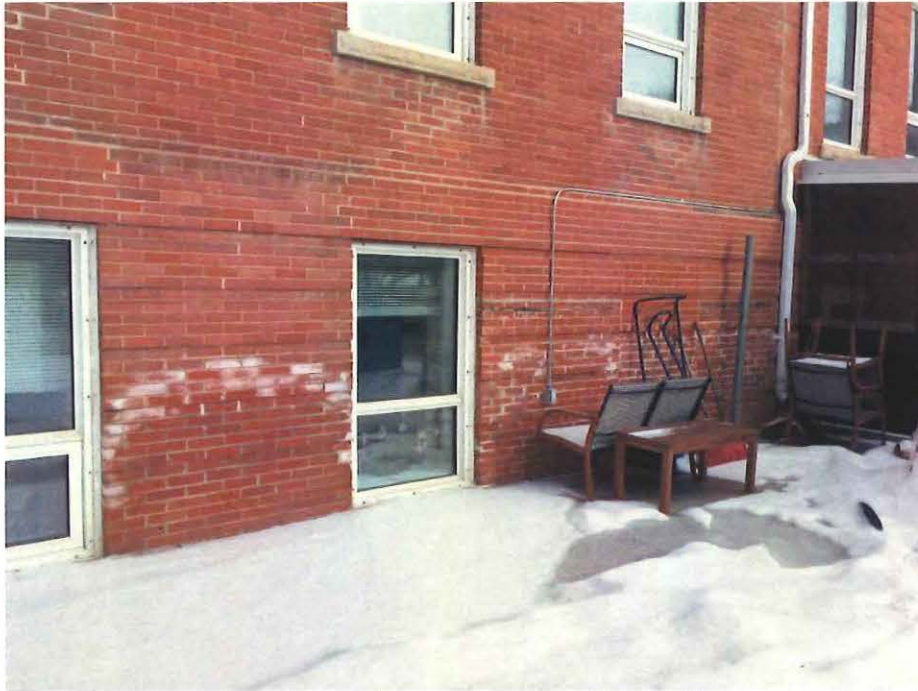
Hard surfacing and lack of positive grading along the south side of the building is contributing to wetting of the bricks through splashing of rain and melting snow, and wicking up of moisture into the brick masonry wall, evidenced by the staining pattern below windows on this façade.

The area bounded by the courtyard on the South, at the 1914 and 1909 portions of the building, appears to have a hard surface built right up to the building. There was noticeable splash up on windows at this location, and the brick was wet at the lower level, wicking moisture up from the ground. It should also be noted that the eaves of the cornice in this location are in poor condition, allowing water to drip off of the roof from three storeys above.

Figure 20 – South façade where wicking up of moisture is evidenced by the efflorescence on the bricks

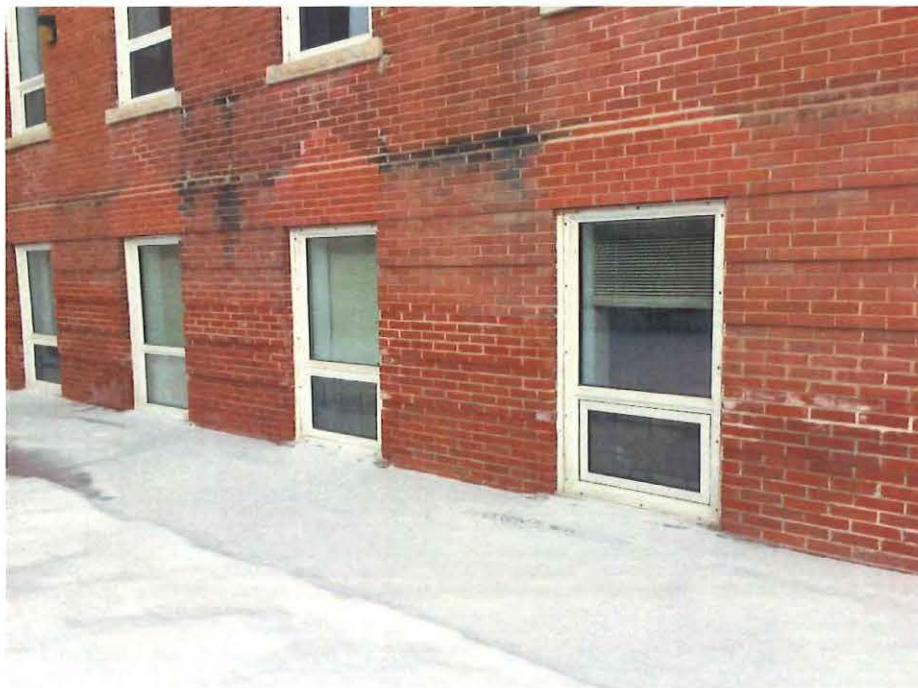
Figure 21 – South façade – note running bond above windows where original brick arches have been replaced

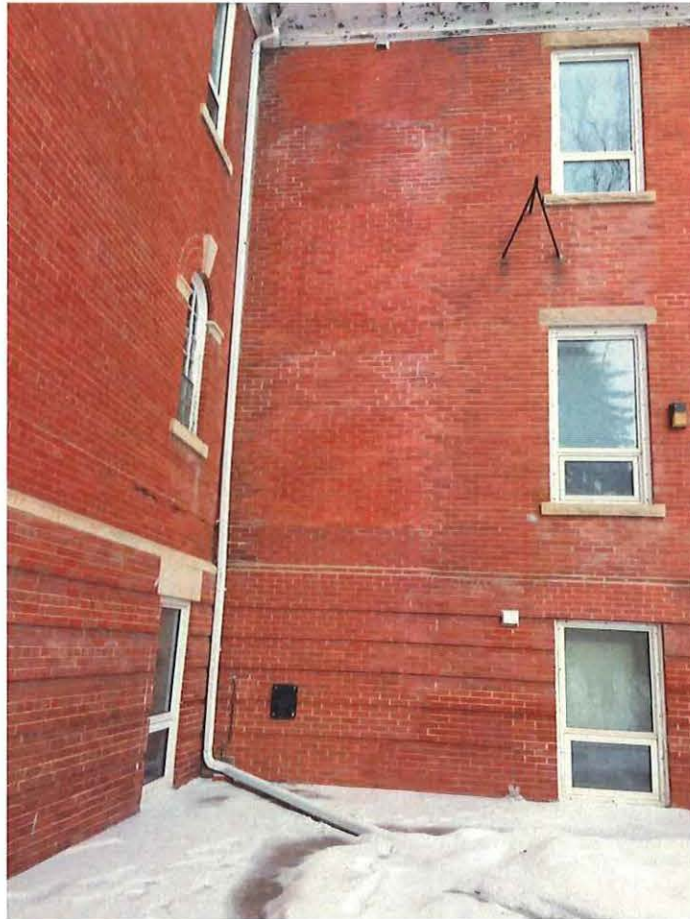
Figure 22 – Join of 1924 addition with 1914 building – water staining on masonry from roof area above

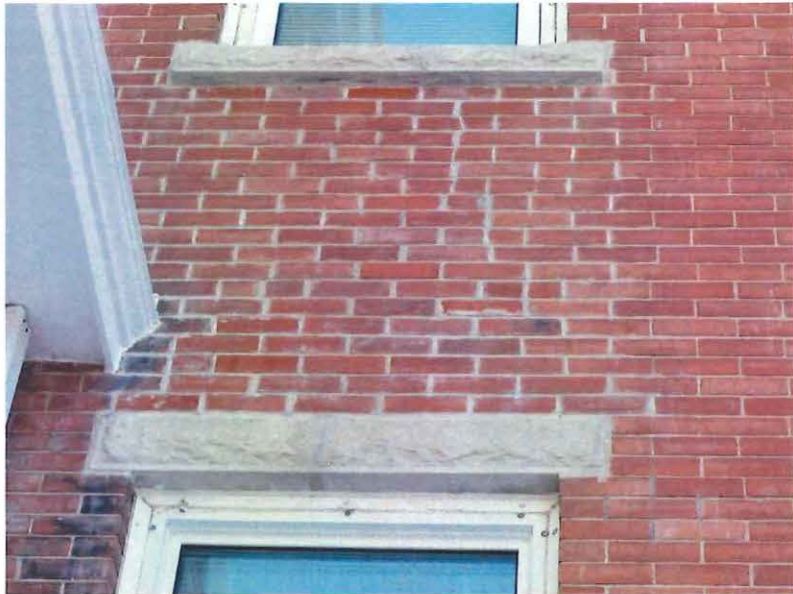
The east façade has had some masonry repairs done to it recently. Mainly associated with repair of broken limestone lintels and sills. There has also been some minor localized repointing. As work has been done at various times in the past on this area of the building and elsewhere, it is difficult to ascertain exactly which repairs were done with the stone repairs.

The method used to repair the stone lintels and sills at this end of the building entailed removal and replacement of the brick masonry above and below the affected windows. The resultant work has a significant impact on the historic masonry work on the building due to full removal of the original work. It has been replaced using a different treatment of the final mortar joint. The original mortar joints are tooled in a slightly “weathered” joint, whereas the reinstalled masonry has used a “coved” tooled joint. Further to this, the brick work was not cleaned off sufficiently after work was completed, leaving mortar around the edges of the bricks. The removal and replacement of the brick masonry has also left some of the bricks damaged. There was no effort to replace these broken bricks and they have been reinstalled into the wall.

Figure 23 – East façade – note brick joints in area of replaced wall above and below windows

The stone repairs that were completed on the east side of the building in 2017 were undertaken by removing portions of the brick masonry above and below the windows to remove the stones for repair and replacement. This impacts the appearance of the historic masonry on the wall and it is something we would like to avoid in conducting the repairs. According to the masonry contractor who did those repairs the stones are 8" in depth (two wythes of brick). See figure 20.

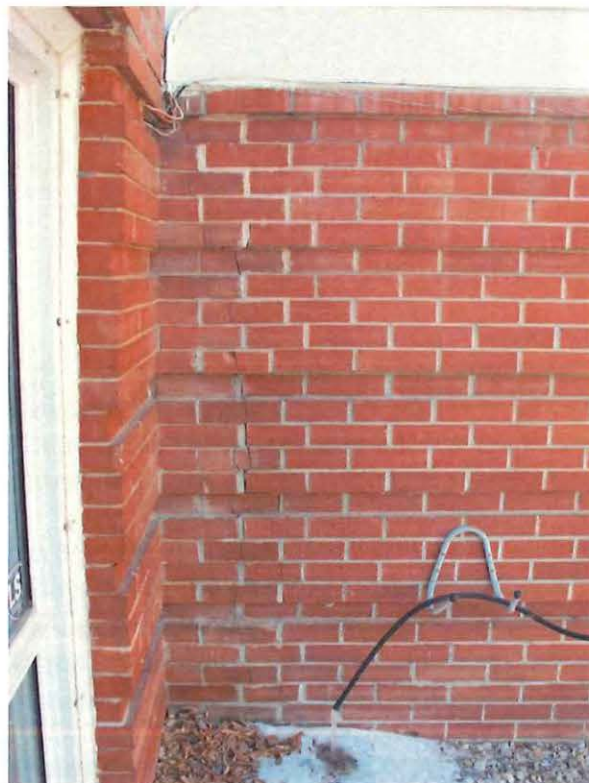
The porch on the East side of the building is experiencing some movement, as illustrated by the open crack and repointing work adjacent to it.

Figure 24 – Vertical crack on south side of porch on east side of building

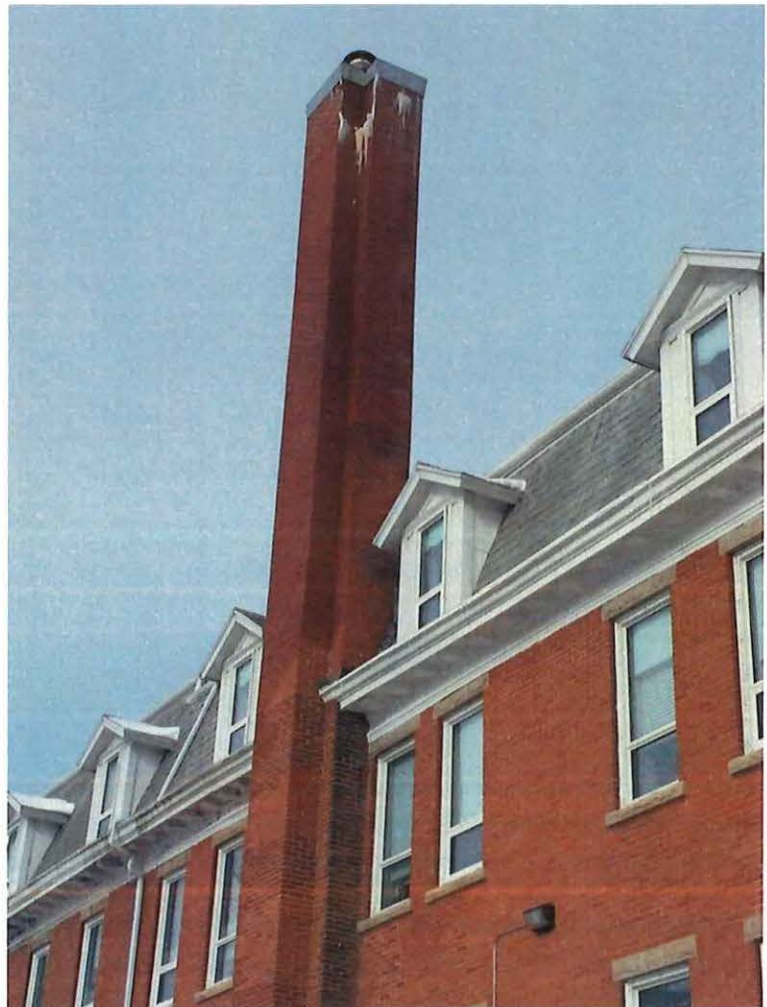
When the site was visited at various times during February and March it was noticed that there was considerable wetting of the bricks on the tall chimney at the south side of the building. This condition was reported to the building owner who contacted a mechanical company to do some investigation. It was found that the flexible metal liner of the chimney had deteriorated and recommendation was made to install a new metal flue into the chimney when weather permitted the shut down of the heating system of the building. We do not know how long this condition has existed. Saturation of the masonry during cold weather can cause damage to the bricks and mortar through repeated freeze/thaw cycles. It should be noted that there is some noticeable spalling of the face of the bricks on the chimney. Mortar in the wet areas is very friable on the surface and the joints are quite heavily weathered on parts, more noticeable on the south and west sides. The vertical mortar joints get progressively wider higher up on the chimney. We suspect that this is the result of everything expanding due to freezing and that the interior masonry of the chimney may also be in suspect condition. There is a noticeable bulging in part of the chimney and obvious vertical cracks through the bricks, that have been repaired at some time in the past.

Figure 25 a) – Chimney is wet from combustion gasses seeping through flue liner.

We are recommending removal of the upper part of the chimney, as it is overly high, rebuilding of the chimney from the eave line up to 1 metre above the upper roof level, and repointing of the remainder of the chimney. More investigation may be necessary. We propose similar brick detailing at the top of the rebuilt chimney to that on the existing chimney at the west end of the building. Reducing the height of the chimney will make future repair and maintenance more reasonable in effort in cost.

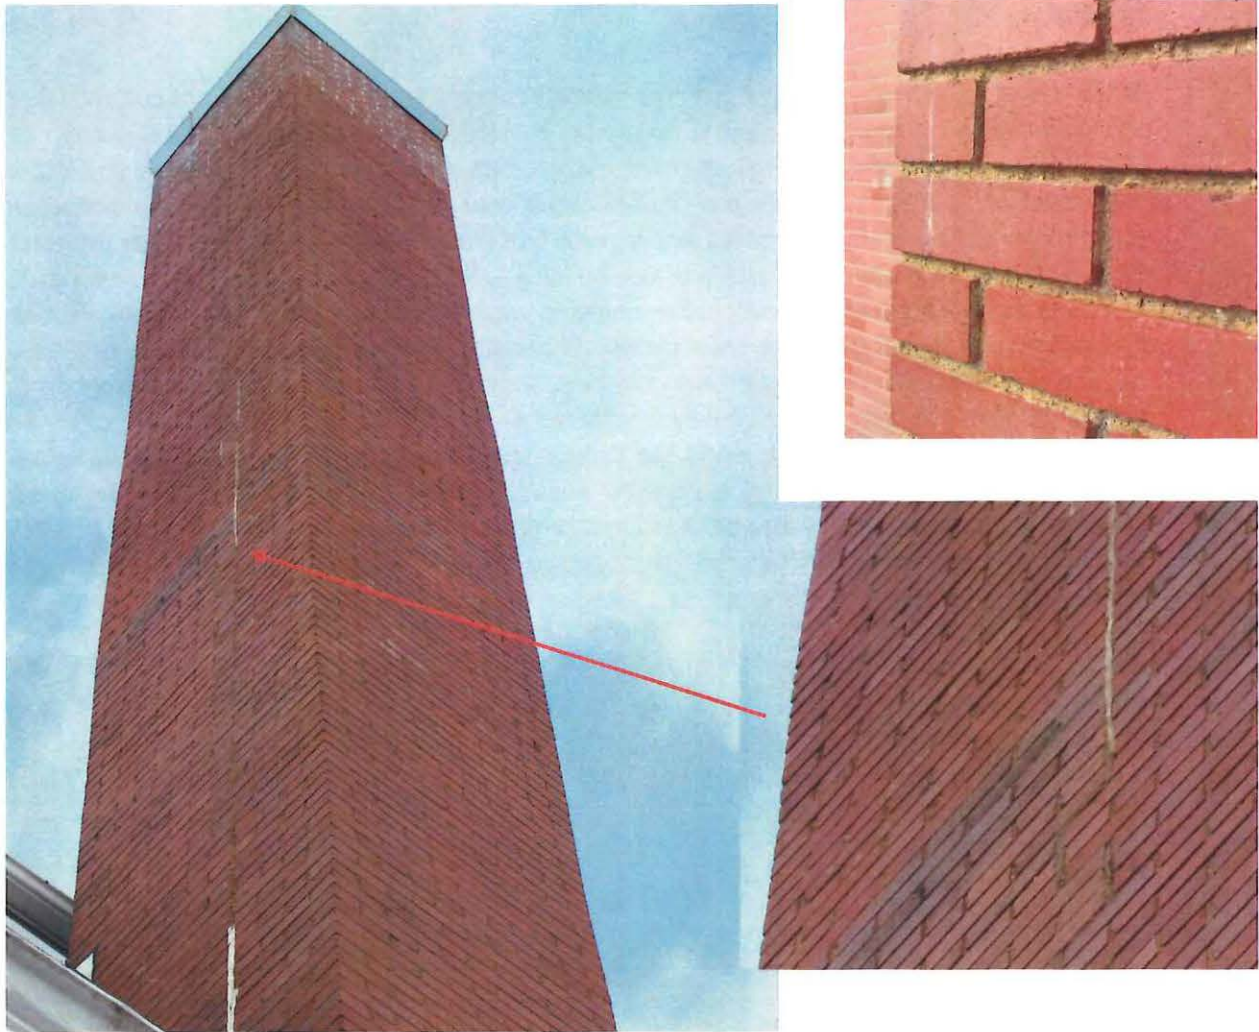
Figure 25 b) – (left) Bulging and vertical split through masonry

Figure 25 c) – (right top) weathered mortar joints starting about 12 feet above ground level

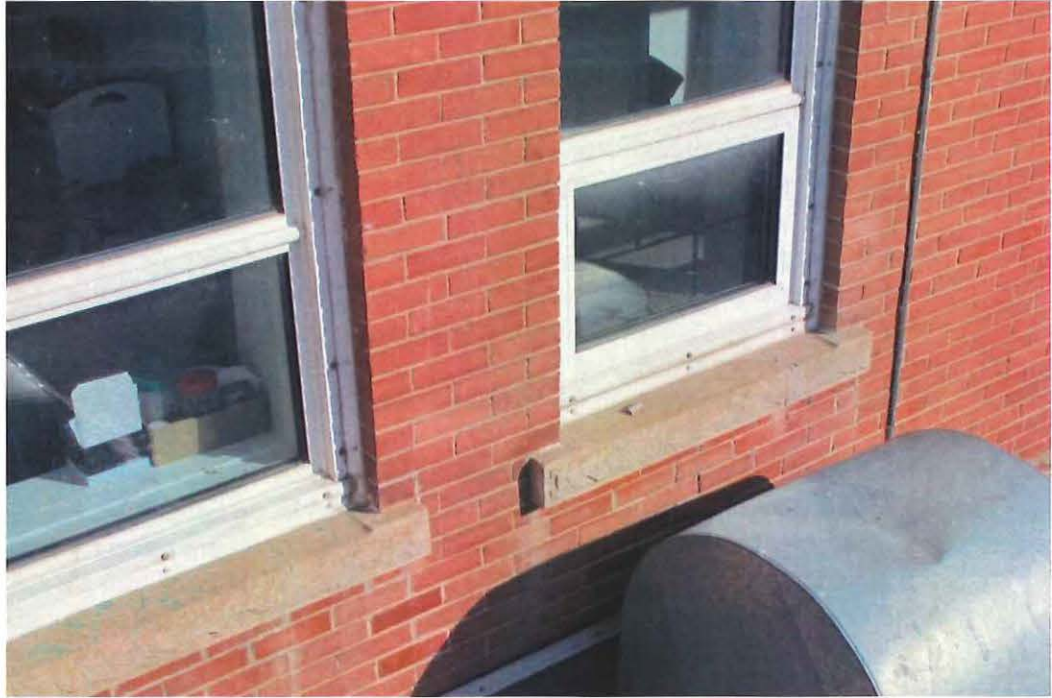
The sills are all lug style with slight slope of the top towards the exterior. A drip is noticeable in the stone sills. Many of the stone sills and lintels are cracked. A few have experienced severe breaks. These cracks allow moisture into the stone and wall which further advances the deterioration. Therefore it is important to seal these cracks to prevent water ingress.

Figure 26 – Example sills with evidence of previous repairs on South face of building

It is our recommendation that the stone repairs be done in-situ rather than removing them. For the lintels, this can be accomplished by crack fill repairs on lintels that are not showing any sign of displacement. On lintels where movement is noted or where the crack is more severe, drilling and pinning diagonally through the face of the stone will be done, using a proprietary anchoring mortar to embed stainless steel anchor pins. The face can be patched using a proprietary matching repair mortar. The cracks in the face can be injection filled. Loose stone material can be removed to a sufficient depth to allow for bonding of the repair mortar. Materials suggested are Jahn M80 anchor setting mortar and Jahn M70 limestone repair mortar.

For the stone sills that are cracked we recommend repairing in-situ. Similar methods can be used to fill narrow cracks as described for the lintels. That would employ injection crack fill and sufficient removal of any loose stone material around the crack to sufficient depth to allow for bonding of the repair mortar. Where there are large loose pieces of stone that have broken away, these may be removed, loose material cleaned away, and then set in place using a setting mortar and pinning in place or anchoring the material. The resultant crack can be repaired using proprietary repair mortar. Piecing in may be required where large pieces of stone are missing or where the break is at a corner or edge. Finding matching stone would be the greatest challenge for piecing in work. See Figure 27 for example of a severe crack in the sill where a large amount of stone material is missing.

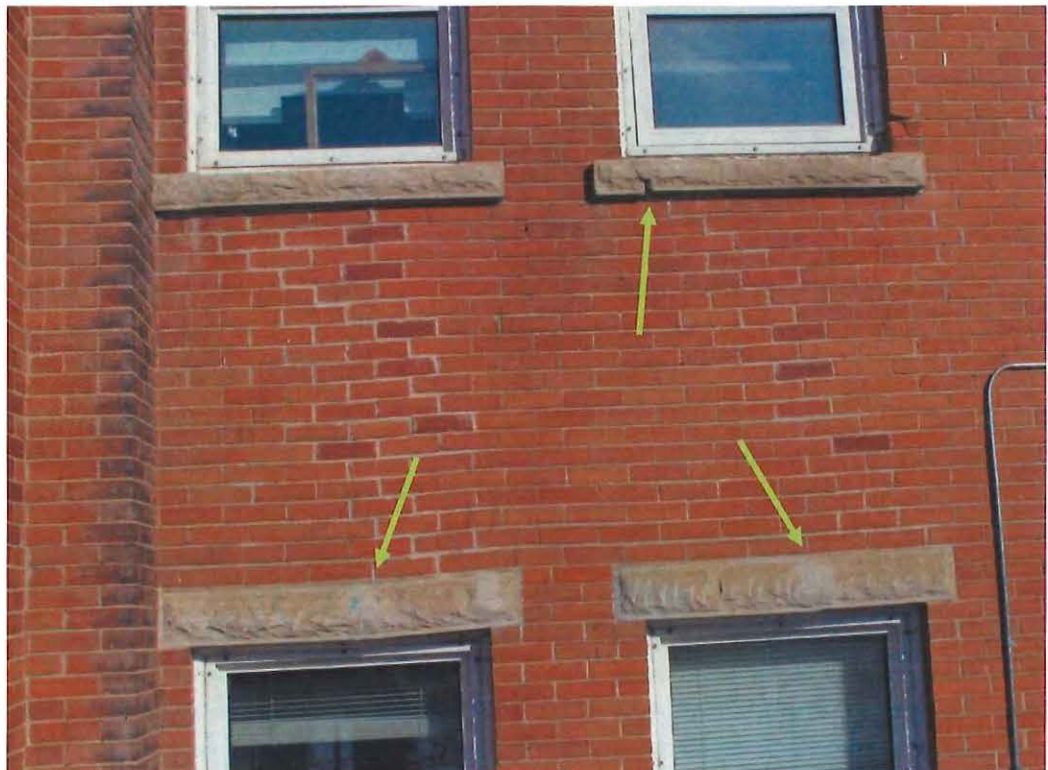
Figure 27 – Examples of cracked stone sills and lintels with evidence of previous repairs on South face beside chimney

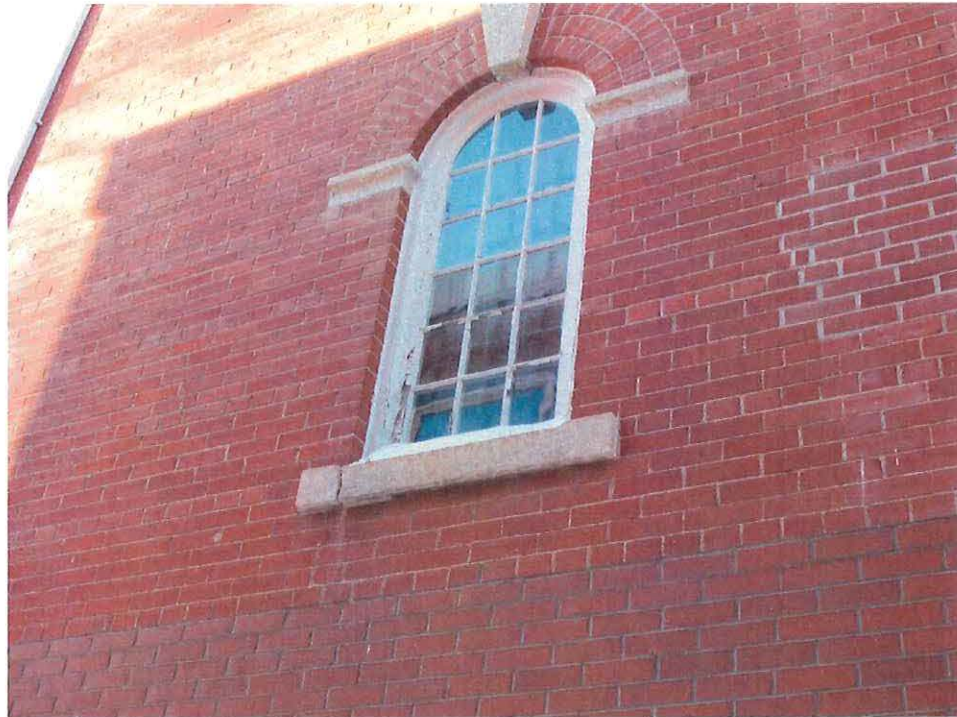
Figure 28 – South face of Chapel showing severely cracked Tyndall Stone sill

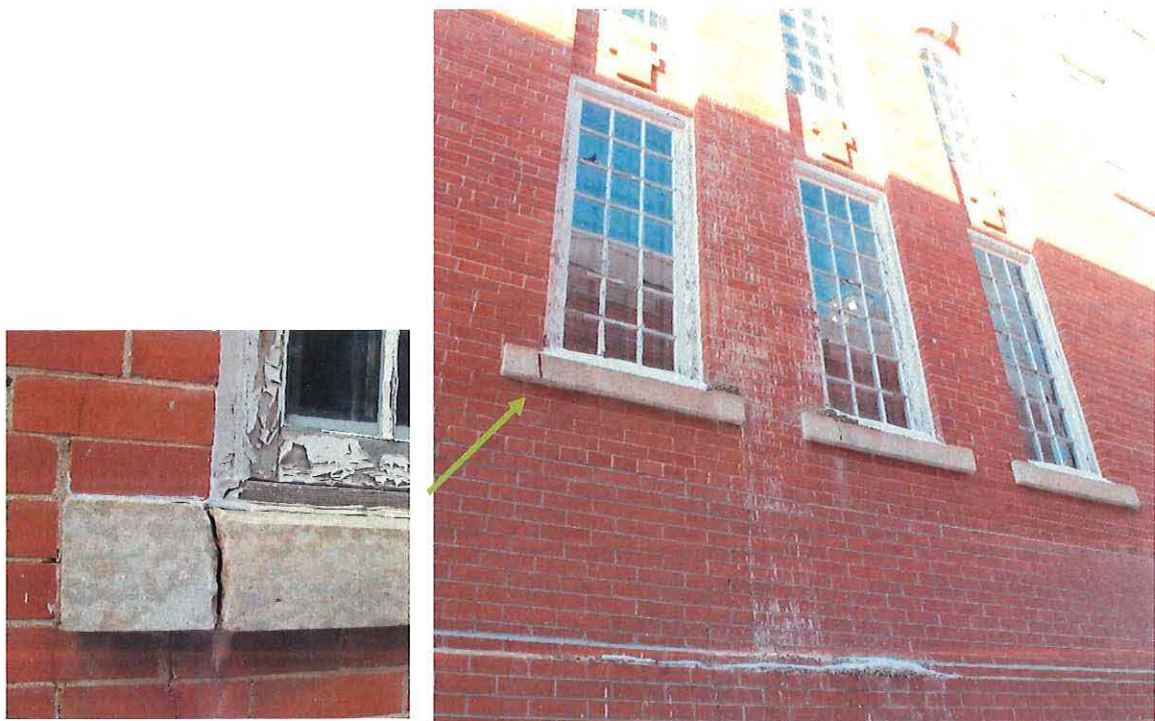
Figure 29 – South face of Chapel showing cracked Tyndall Stone sills on two windows

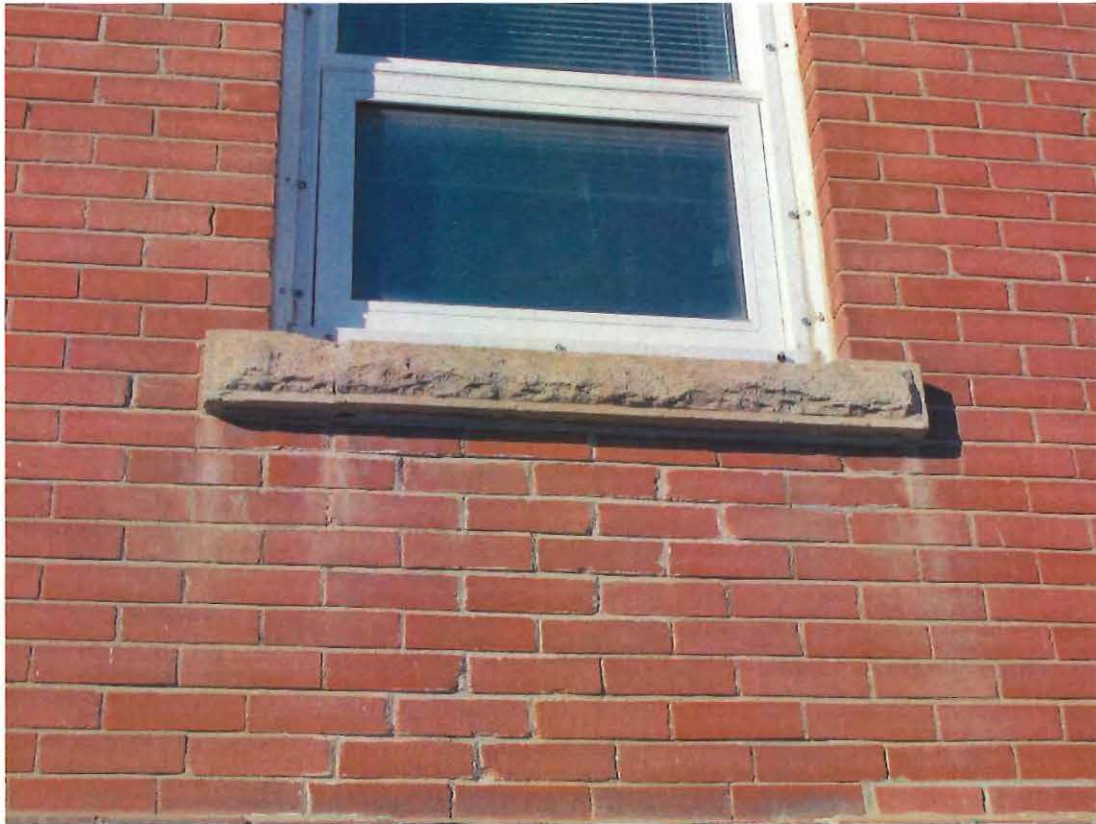
Figure 30 – Cracked limestone sill on South face of building

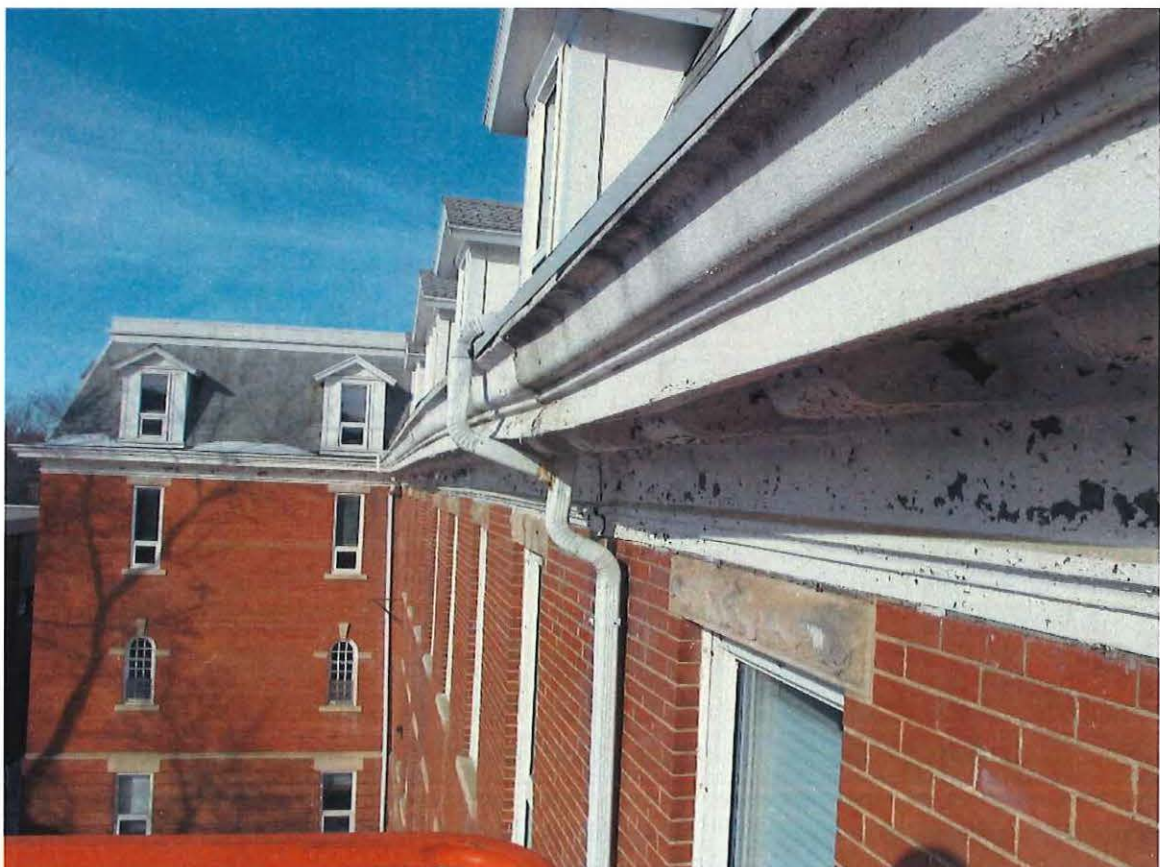
The cornice on the South face of the building appears to be in the worst condition. This is likely due to more direct sunlight melting snow and heat loss through the envelope causing ice damming conditions on the top surface of the cornice.

Figure 31 – profiled metal cornice on south face – distortion along length

1. Remove lead paint using proper hazmat methods and control dust
2. Clean and etch galvanized material that will remain
3. Where profiled metal is damaged beyond reasonable repair replace with matching profile

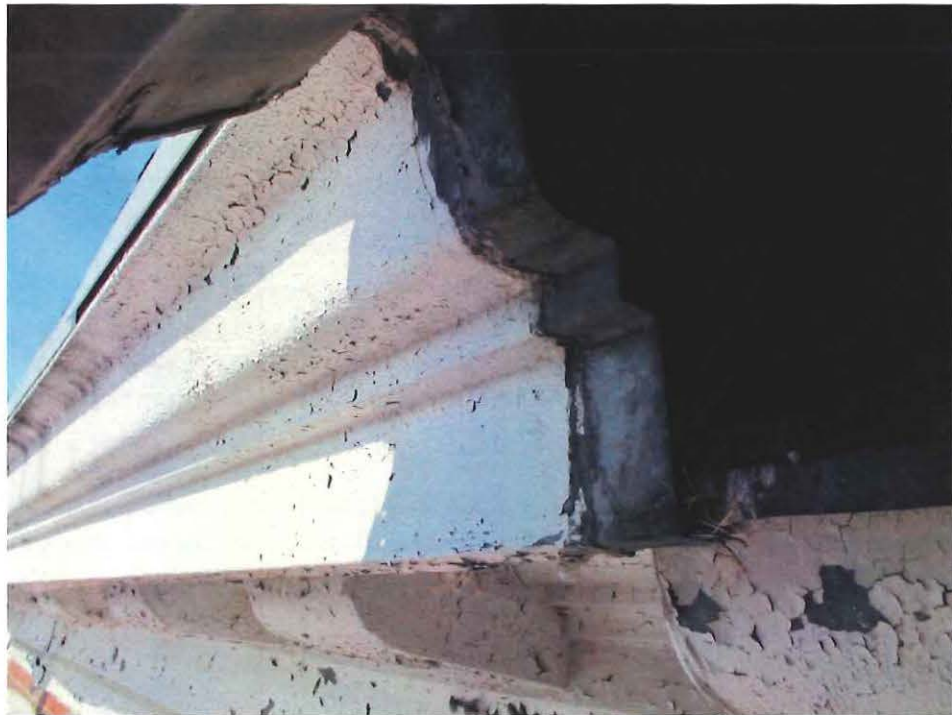
Figure 32 – profilled metal cornice on south face – showing profile at join

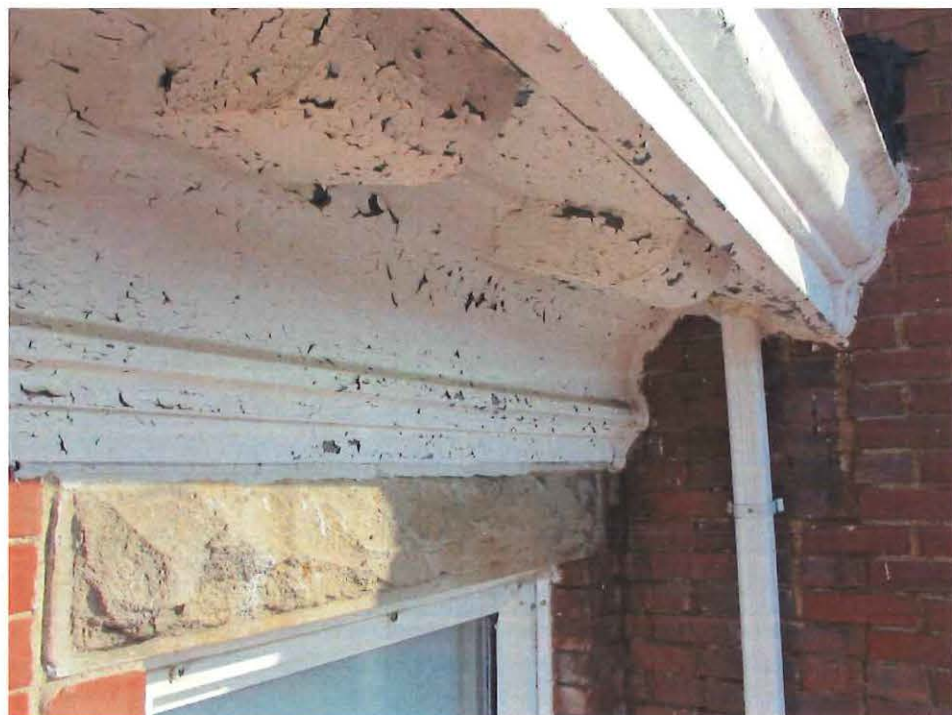
Figure 33 – profilled metal cornice on south face – noticeable deflection

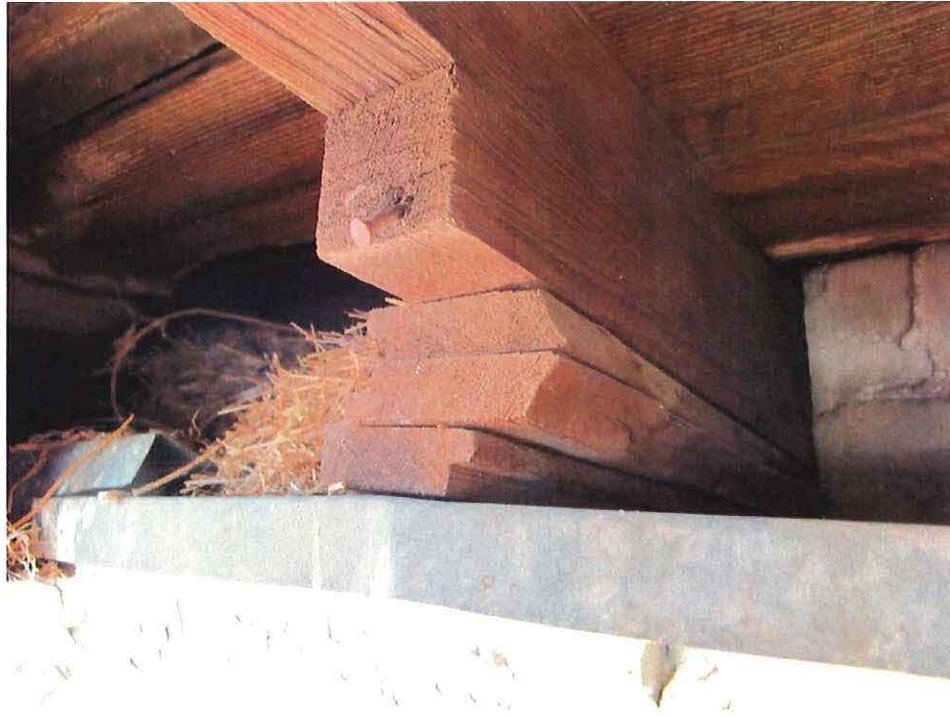
Figure 34 – showing wood framing and furring (note bird nest)

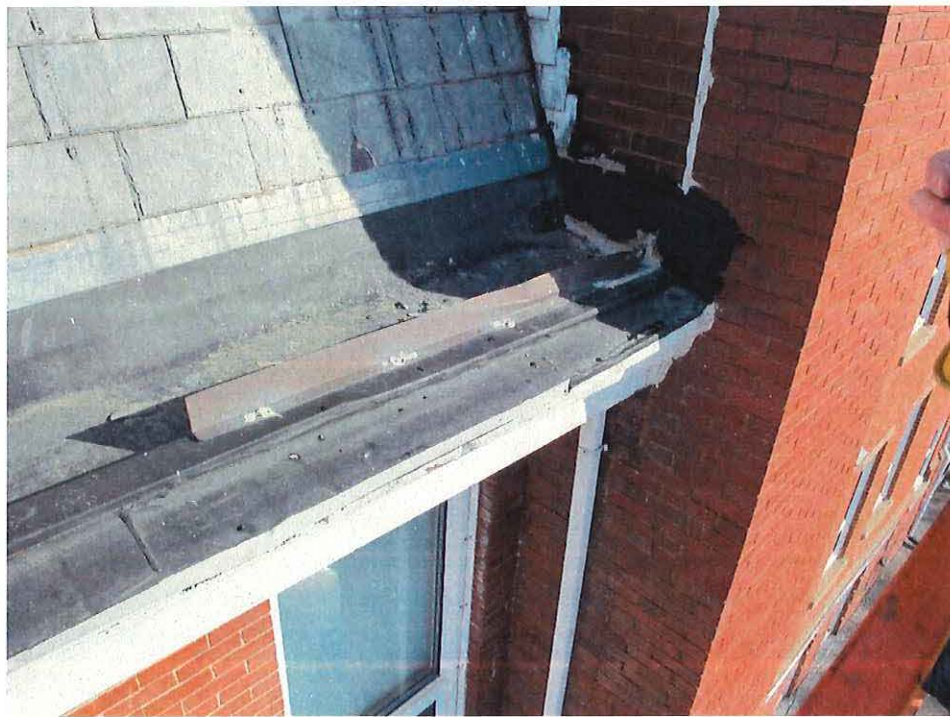
Figure 35 – top side of cornice with EPDM roofing (wet condition at chimney)

4. Remove EPDM roofing on top of cornice; replace rotten areas of wood deck (leave sufficient EPDM below metal flashing at the bottom of the slate roofing to allow tie in of roofing attempting to carry top edge of membrane underneath the existing metal flashing
