CATHEDRAL COURTS

Conservation Report
2018-04-05

The following Conservation Plan for the Cathedral Courts building, located at 3225 13th Avenue in the City of Regina has been prepared for Academy Housing by SEPW Architecture with the sub-consultant KGS for structural items.

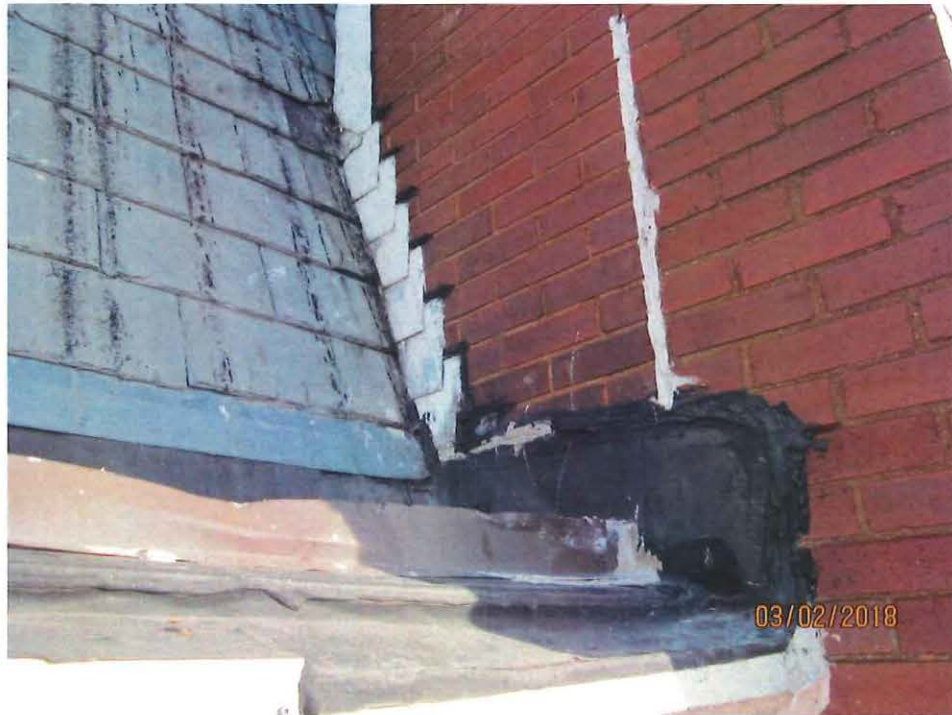
Figure 36 – top side of cornice with EPDM roofing and roof patch material at chimney

4. Remove EPDM roofing on top of cornice; replace rotten areas of wood deck (leave sufficient EPDM below metal flashing at the bottom of the slate roofing to allow tie in of roofing attempting to carry top edge of membrane underneath the existing metal flashing

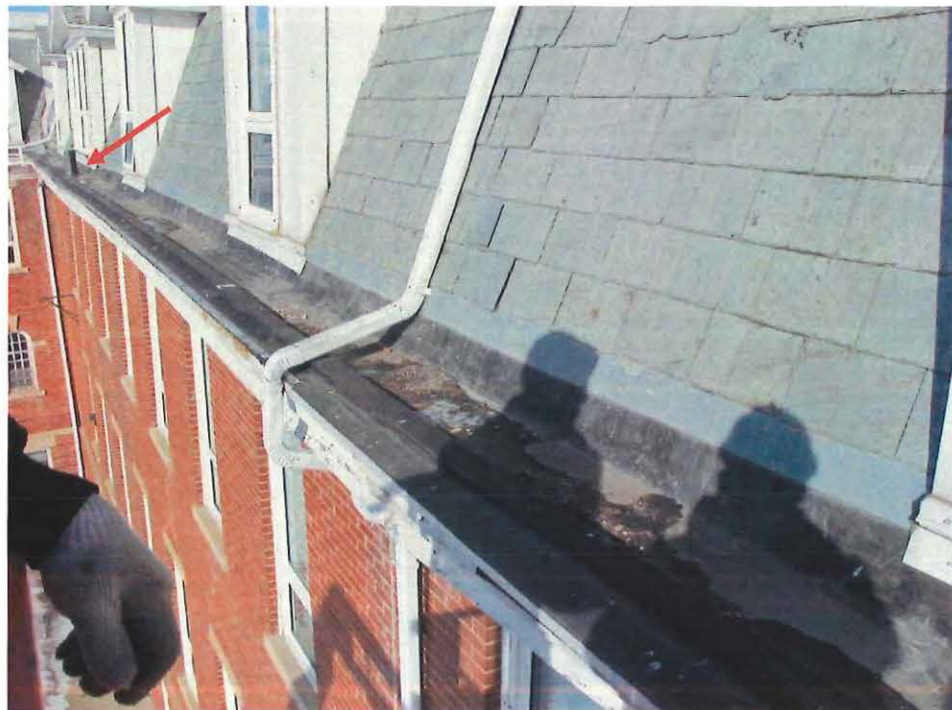
Figure 37 – top side of cornice with EPDM roofing – at least one roof drain in the cornice appear to have been closed off (red arrow).

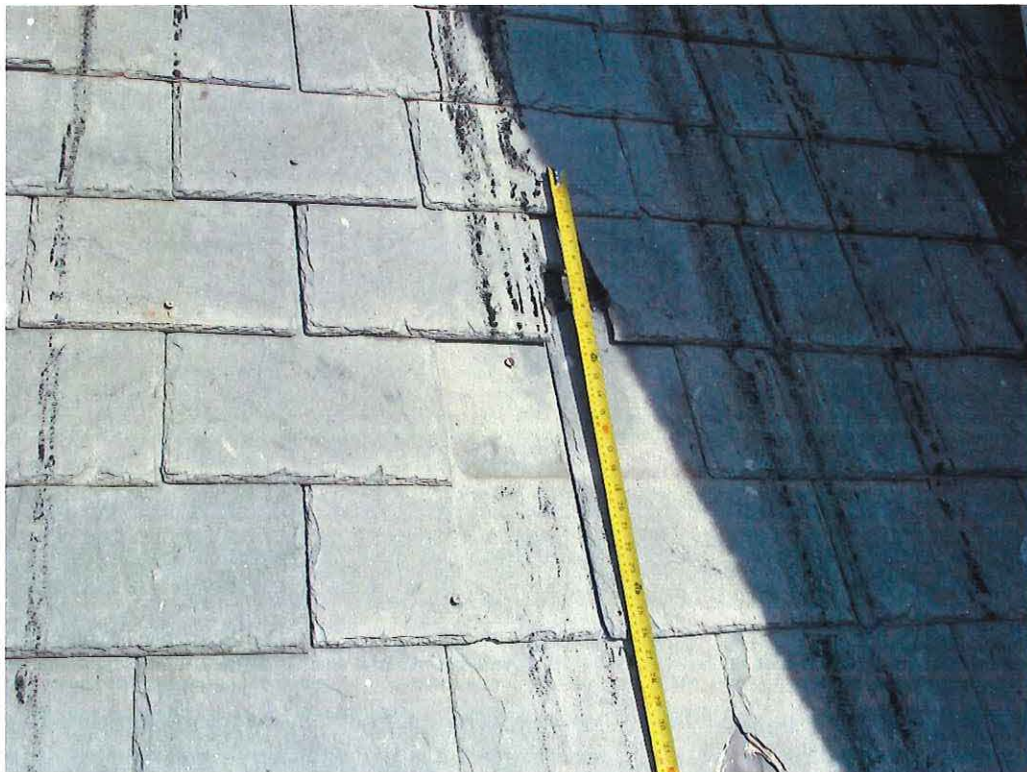
The Mansard roof on the entire building is clad with a green slate tile. The slate tile is likely original to the building. The condition of the slate varies around the building. In some areas observed on the South roof of the 1909 portion the slate is broken and missing and fastened in by using screws through the face of the tile. On areas around the building there is roofing tar that must have run onto the face of the slate during a re-roofing installation and never cleaned off.

Figure 38 – South façade - missing and broken slates and fasteners through face of slates (common around building)

Where the slate is missing it should be replaced. The flashing around the dormer roofs should be replaced (none is evident). Some joints have been caulked, perhaps to address moisture ingress at some point in time. There may be limited tradespersons who can do the slate repair work. Consideration should be given to replacing the areas of the slate roof with the most damage. The areas where screws have been installed through the face of the slates should be observed periodically to ensure that any damage can be addressed.

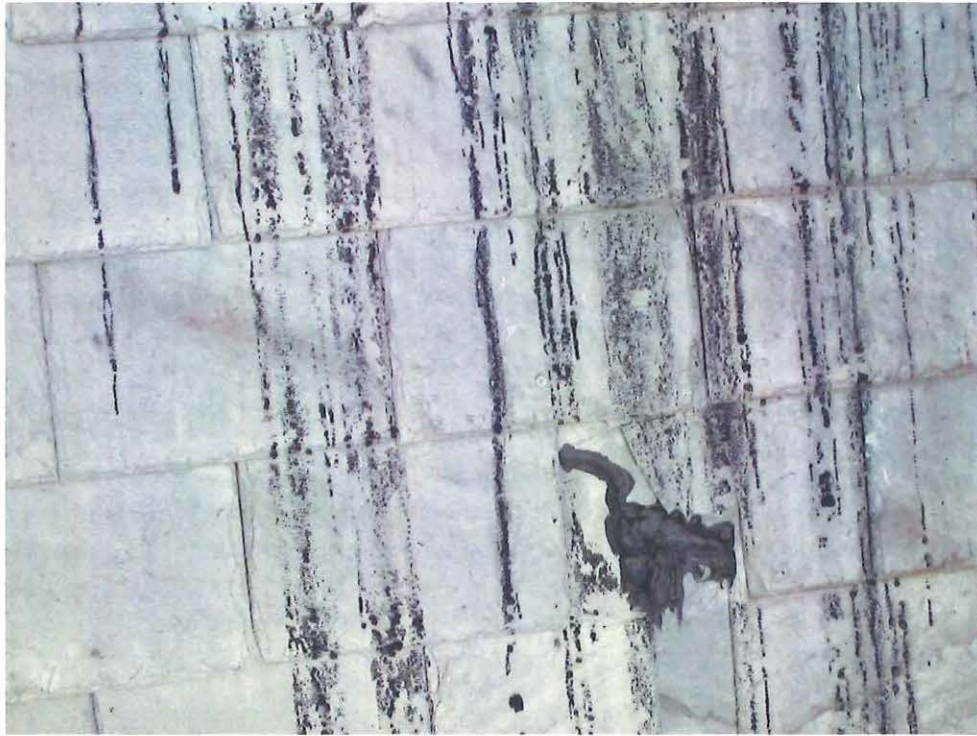
Figure 39 – South façade – asphalt or tar on slates (common around building)

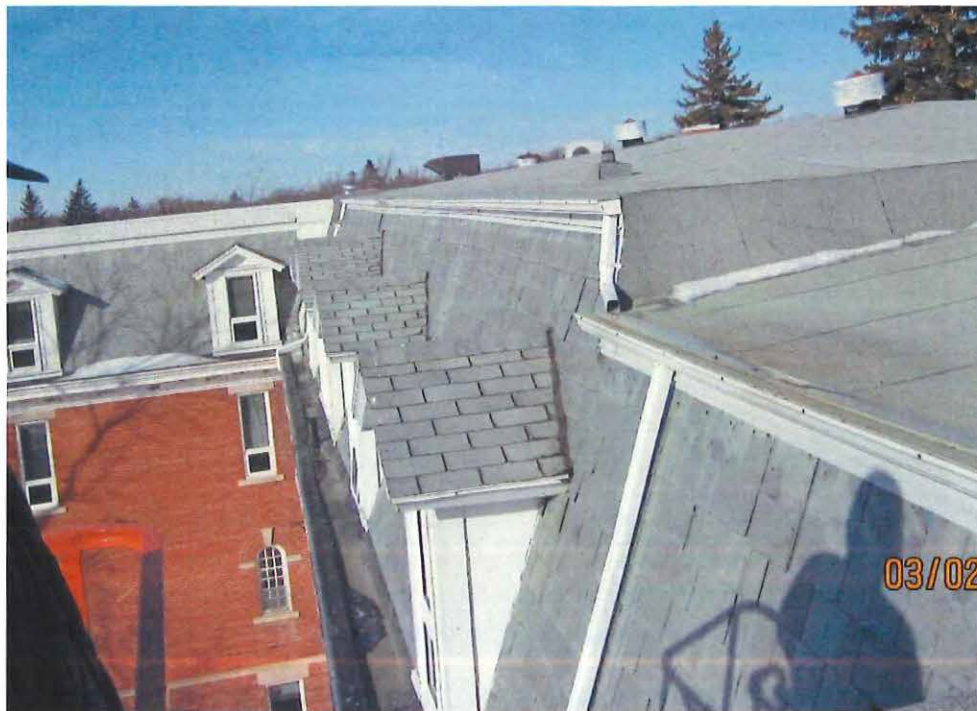
Figure 40 – South façade – roof caulk at dormers; missing top row of slates (note asphalt shingles on dormers and no metal flashing)

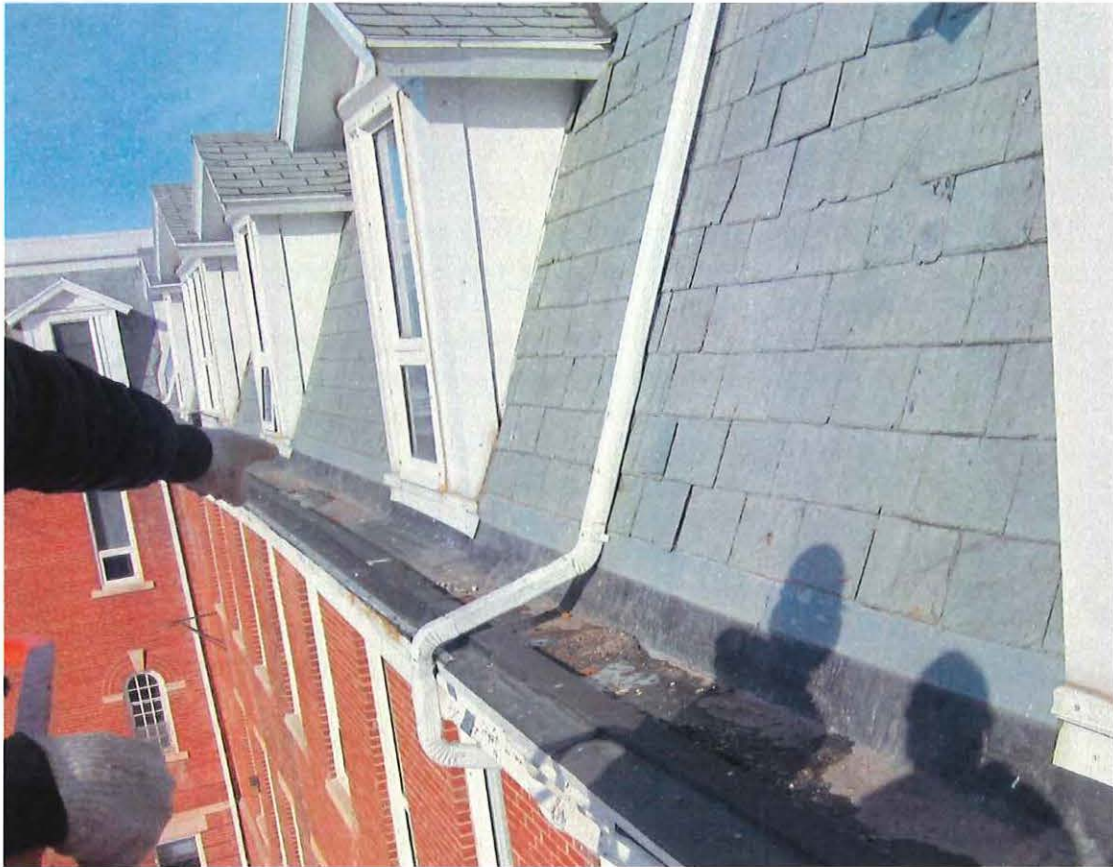
Figure 41 – South façade – plugged off roof drain location (below downspout). Also note broken, loose slates with face fastening.
