CATHEDRAL COURTS

Conservation Report
2018-04-05

The following Conservation Plan for the Cathedral Courts building, located at 3225 13th Avenue in the City of Regina has been prepared for Academy Housing by SEPW Architecture with the sub-consultant KGS for structural items.

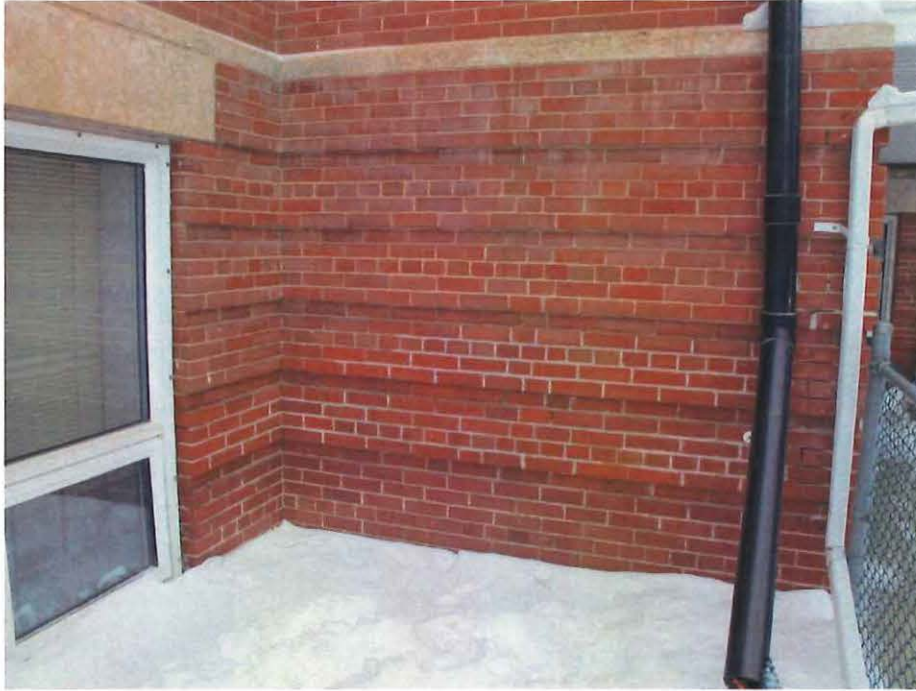
- Mortar in some areas was in fairly good condition
- Localized areas of missing horizontal and vertical joints
- Areas where up to 50% of the mortar requires repointing due to weathering

Figure 18 – Southwest corner of West façade – areas where more deterioration was noticed

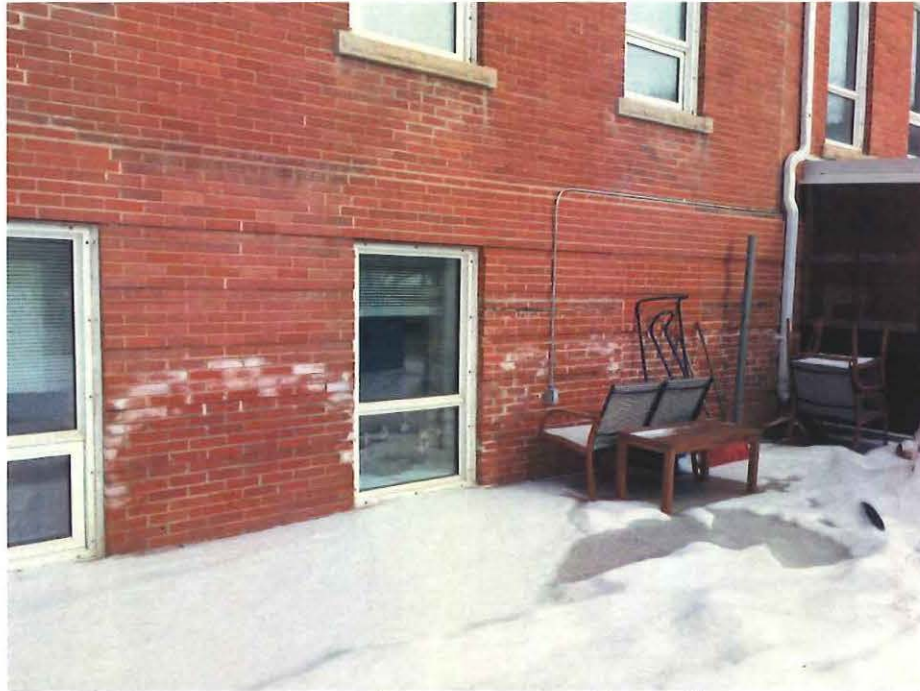
Hard surfacing and lack of positive grading along the south side of the building is contributing to wetting of the bricks through splashing of rain and melting snow, and wicking up of moisture into the brick masonry wall, evidenced by the staining pattern below windows on this façade.

Figure 20 – South façade where wicking up of moisture is evidenced by the efflorescence on the bricks

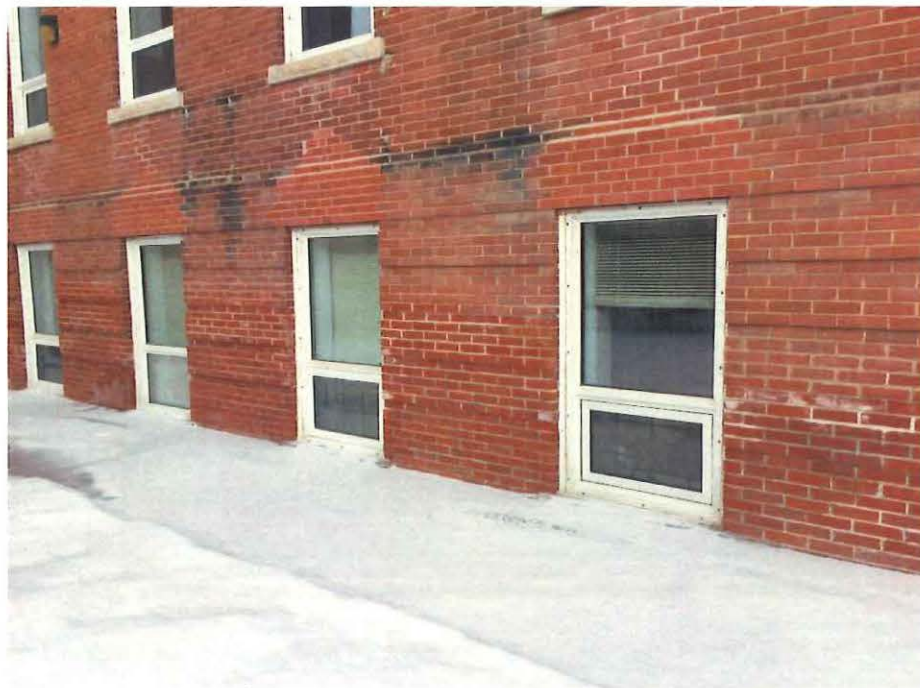
Figure 21 – South façade – note running bond above windows where original brick arches have been replaced

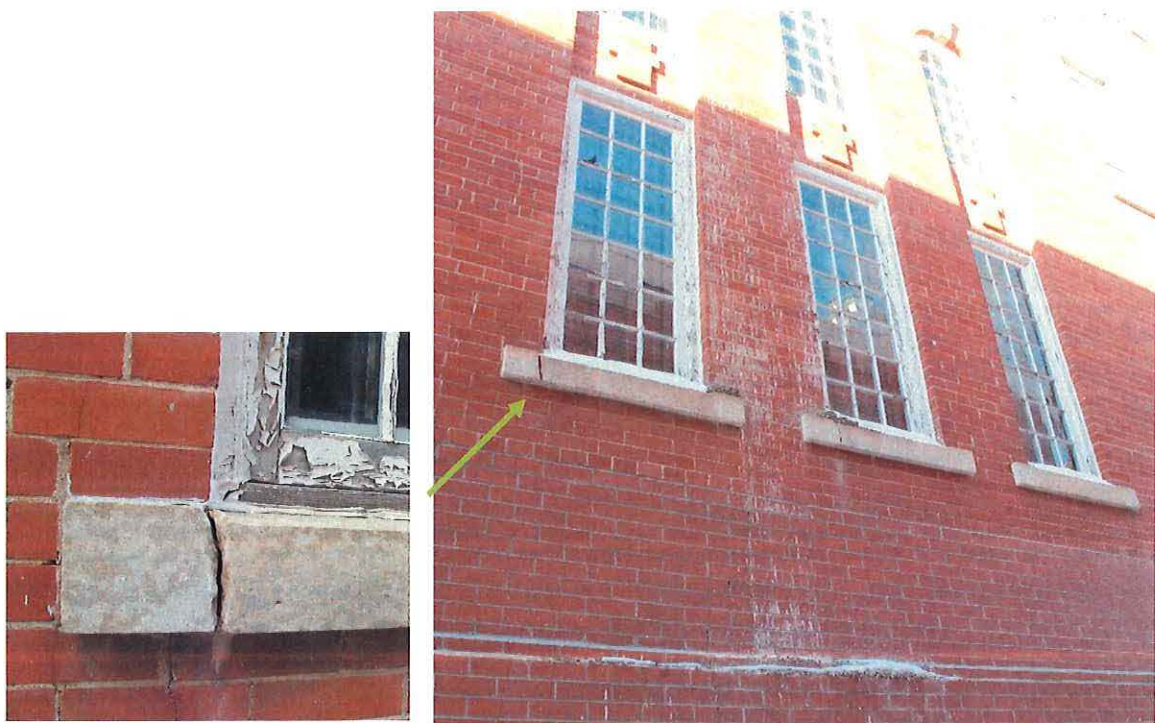
Figure 29 – South face of Chapel showing cracked Tyndall Stone sills on two windows

For the stone sills that are cracked we recommend repairing in-situ. Similar methods can be used to fill narrow cracks as described for the lintels. That would employ injection crack fill and sufficient removal of any loose stone material around the crack to sufficient depth to allow for bonding of the repair mortar. Where there are large loose pieces of stone that have broken away, these may be removed, loose material cleaned away, and then set in place using a setting mortar and pinning in place or anchoring the material. The resultant crack can be repaired using proprietary repair mortar. Piecing in may be required where large pieces of stone are missing or where the break is at a corner or edge. Finding matching stone would be the greatest challenge for piecing in work. See Figure 27 for example of a severe crack in the sill where a large amount of stone material is missing.

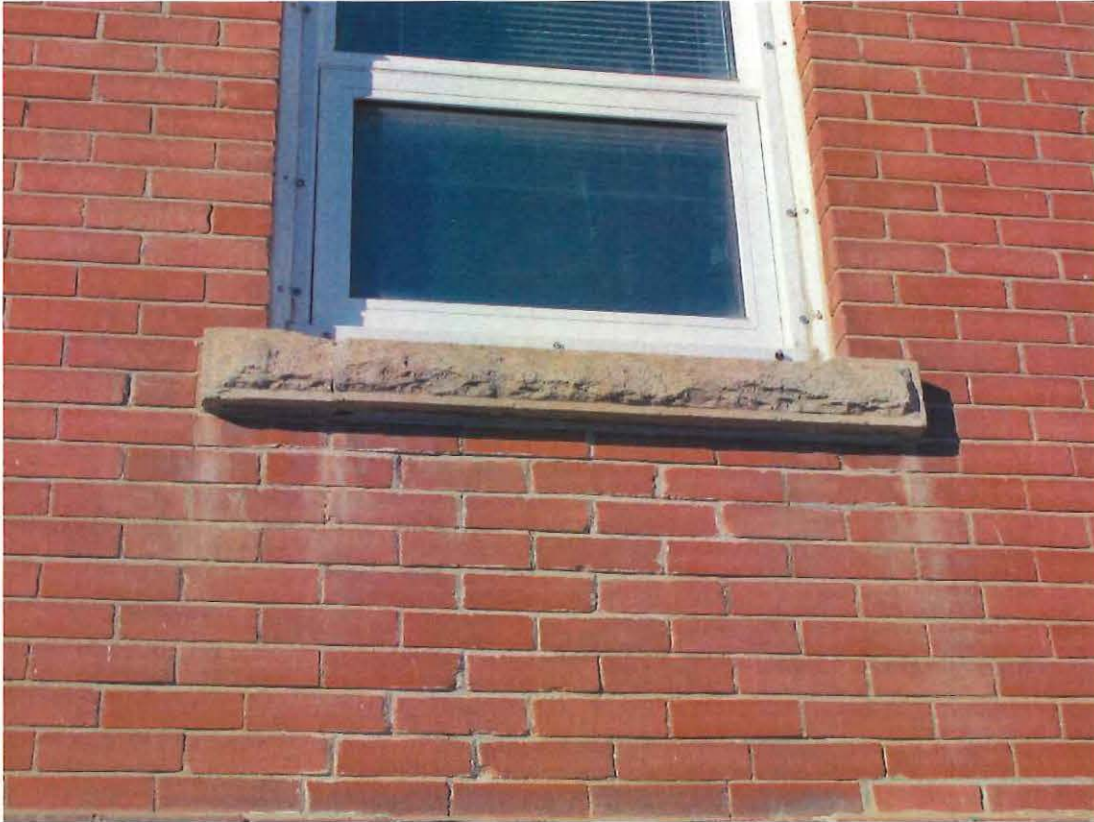
Figure 30 – Cracked limestone sill on South face of building

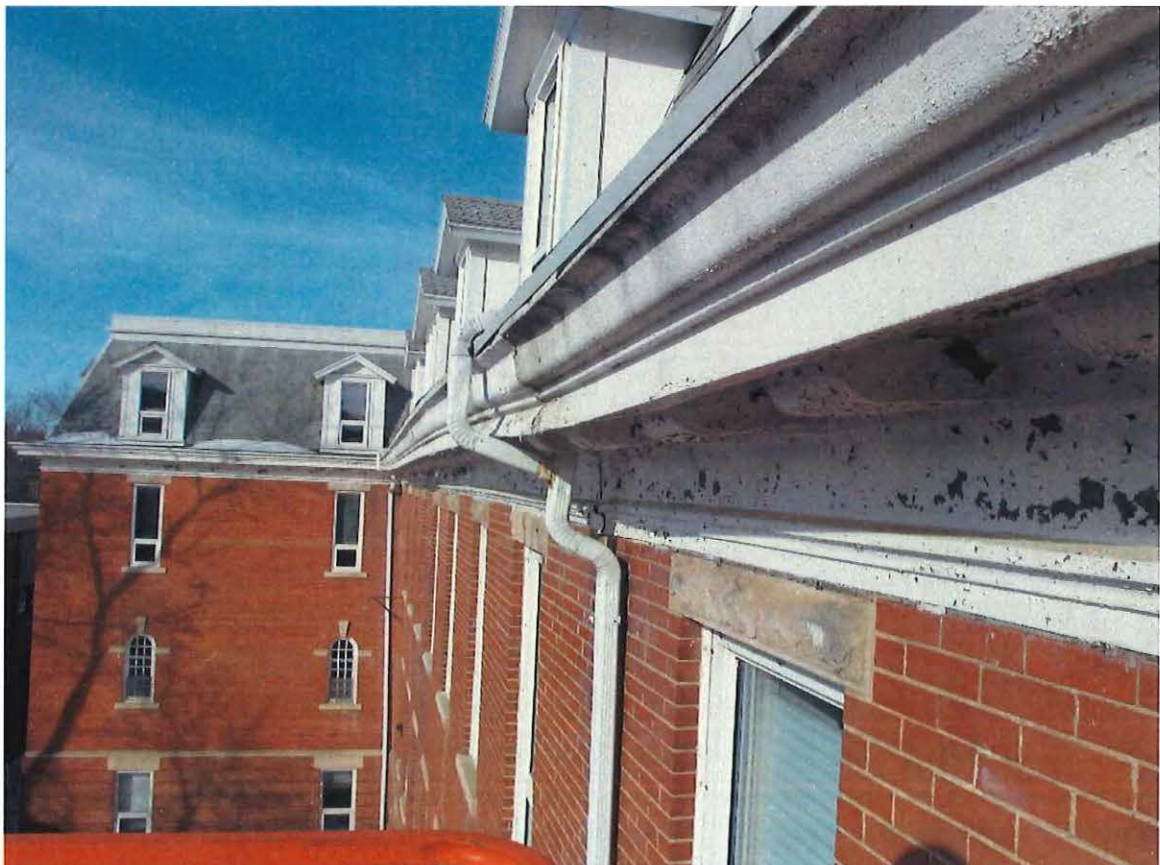
The cornice on the South face of the building appears to be in the worst condition. This is likely due to more direct sunlight melting snow and heat loss through the envelope causing ice damming conditions on the top surface of the cornice.

Figure 31 – profiled metal cornice on south face – distortion along length

1. Remove lead paint using proper hazmat methods and control dust
2. Clean and etch galvanized material that will remain
3. Where profiled metal is damaged beyond reasonable repair replace with matching profile

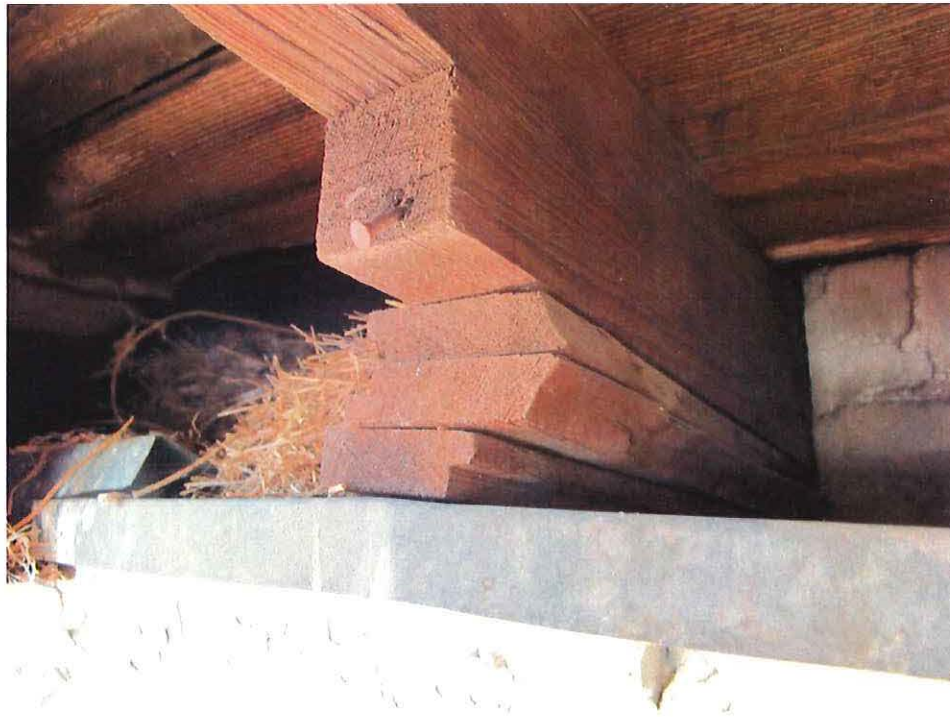
Figure 34 – showing wood framing and furring (note bird nest)
