## CONSERVATION PLAN

### ST. MATTHEW ANGLICAN CHURCH PROPERTY - REGINA

Original: July 2017 Amended: August 2019  
Author: Mae Boa, St. Matthew Anglican Church  
With the assistance of J.C. Kenyon Engineering Inc.  
Owner: The Diocese of Qu'Appelle

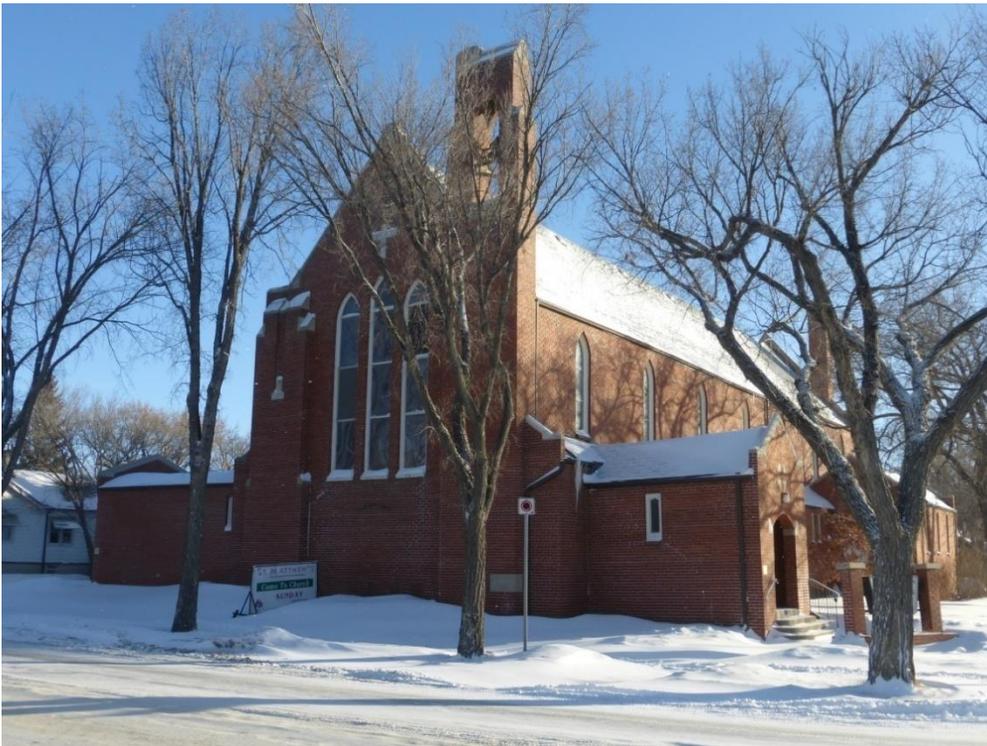
Photo 1: Bell Tower

From a heritage perspective, the bell tower on the west side of the church building is the most distinctive exterior element of the property. It extends 70 feet from the ground level. (The bell tower is referenced in both the 2007 and 2014 J.C. Kenyon Engineering reports .)

The picture of the bell tower (photo 1) in the February 2014 J.C. Kenyon Engineering report shows the cathedral style of architecture. It has an unique feature with the West Window of Three Gothic panels with glass window inserts as it sits on the corner of Winnipeg Street - a very busy thoroughfare of the neighborhood.

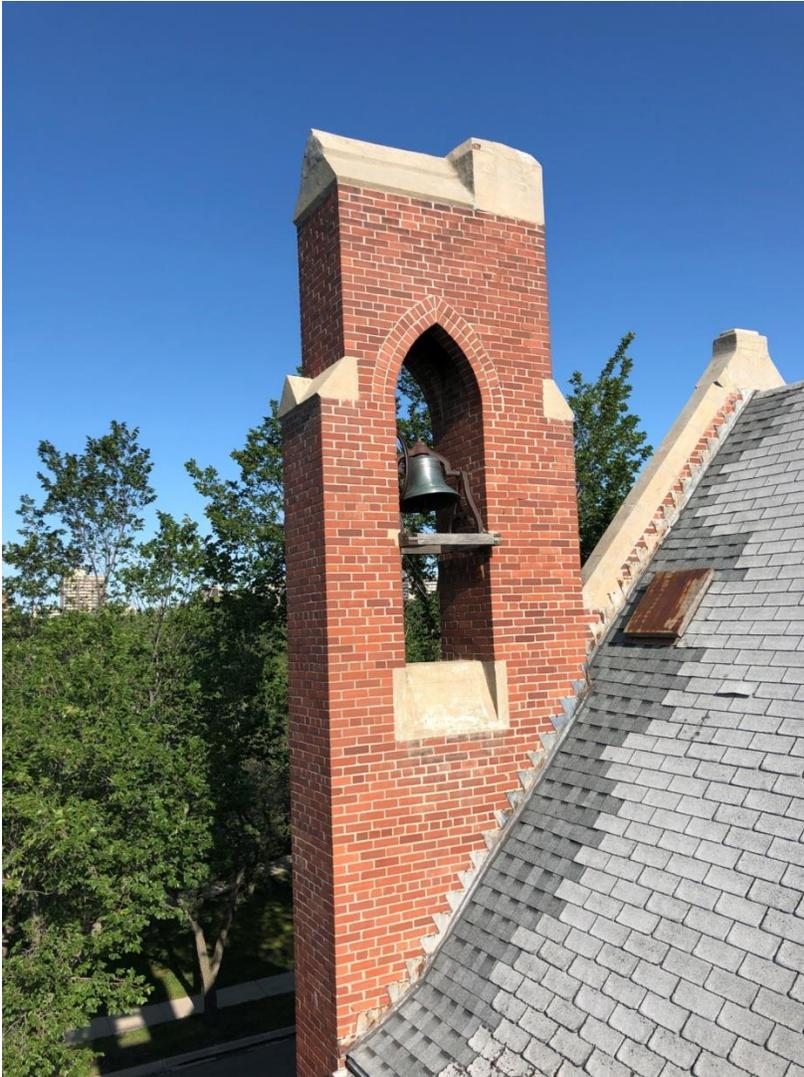
Photo 8 of that same report, shows the bell tower tilt toward the west and photo 13 compares the change between 2007 and 2014. From the ground it was not possible to determine if the bell tower is cracked and if so, to what extent. The bell itself is in good repair; however, the wooden framing does need replacement.

Photo 2: View of Bell Tower and Bell - Photo A

The J.C. Kenyon Inspection Report dated August 1, 2019 recommends that the wood support frame be treated to protect the wood from further deterioration, and that the east framing member be secured with metal brackets on the inside corners. The pulleys are to be replaced so the bell tower may be returned to full service.

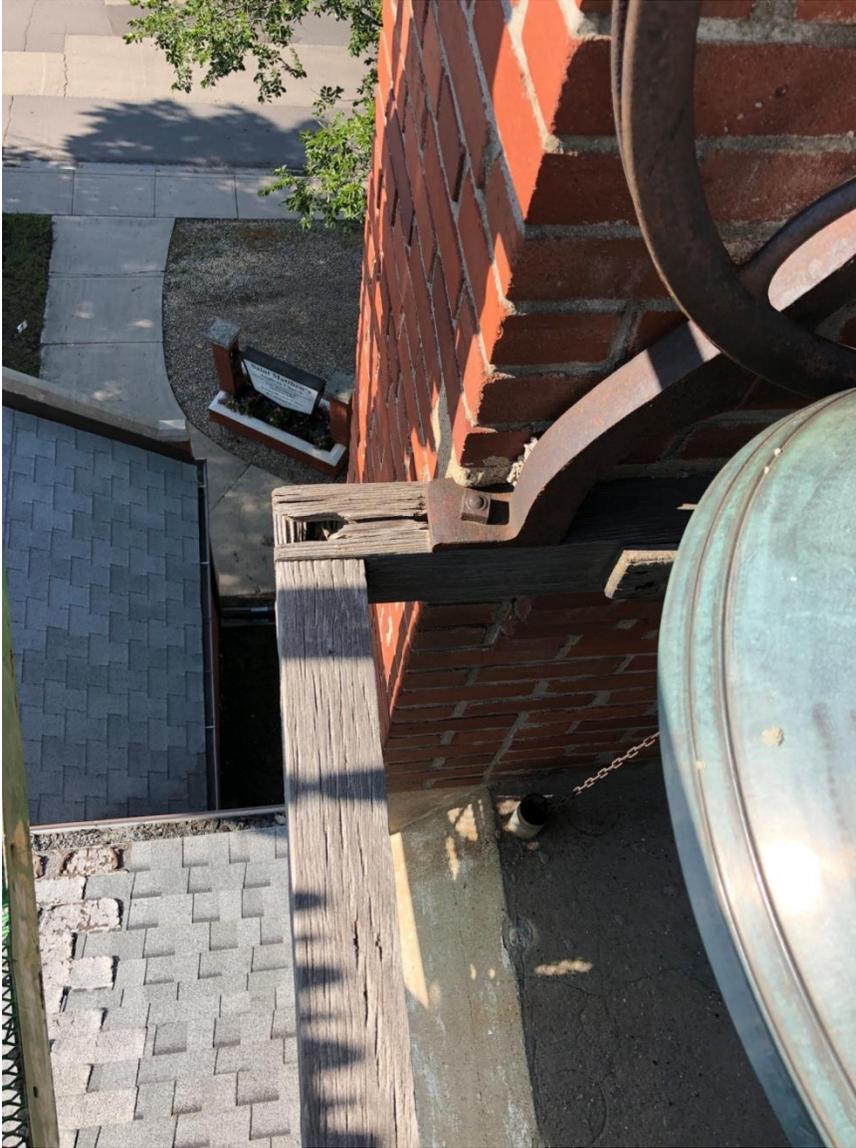
Photo 3: View of the Loose and Deteriorated Wood Member on East Side

- the wood support be treated to protect the wood from further deterioration
- the east framing member be secured with metal brackets on the inside corners, and,
- the pulleys be replaced so that the bell may be fully operational

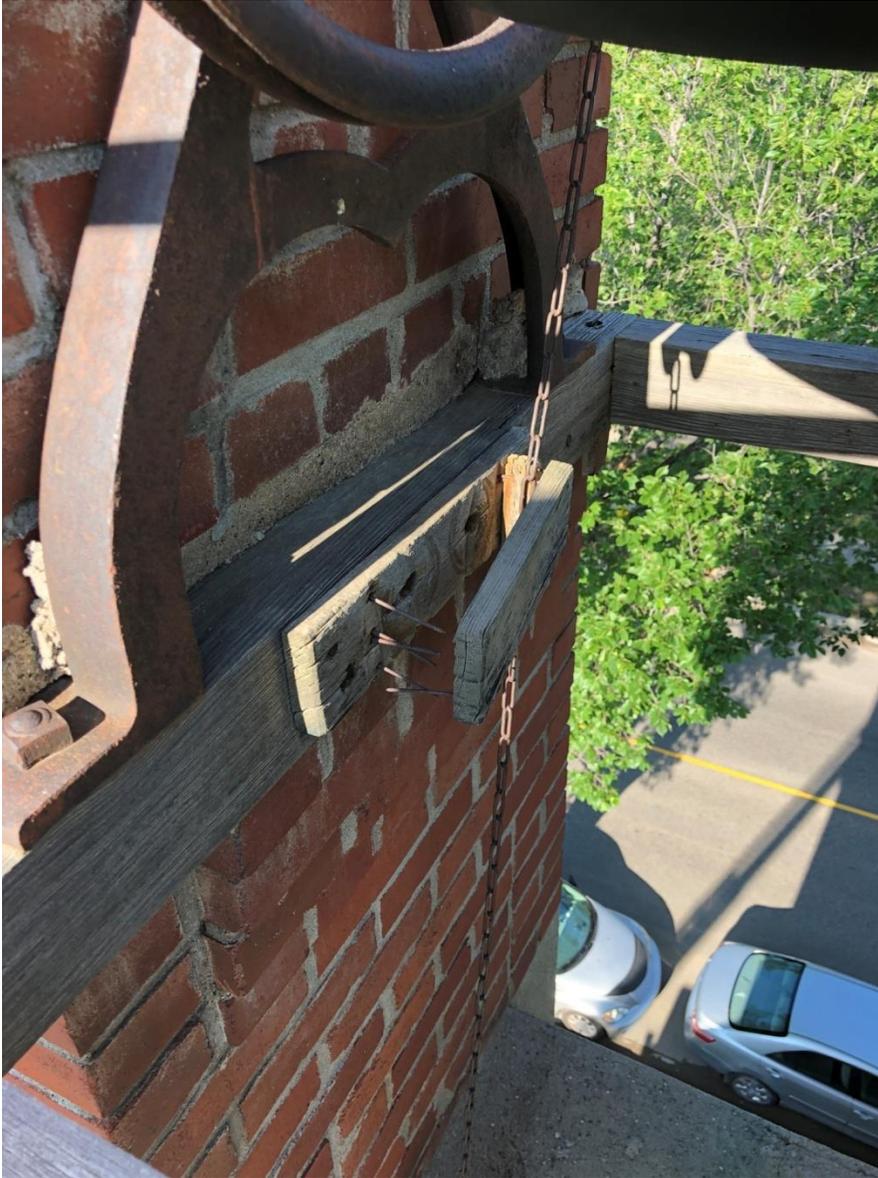
Photo 4: Location of the missing Pulley

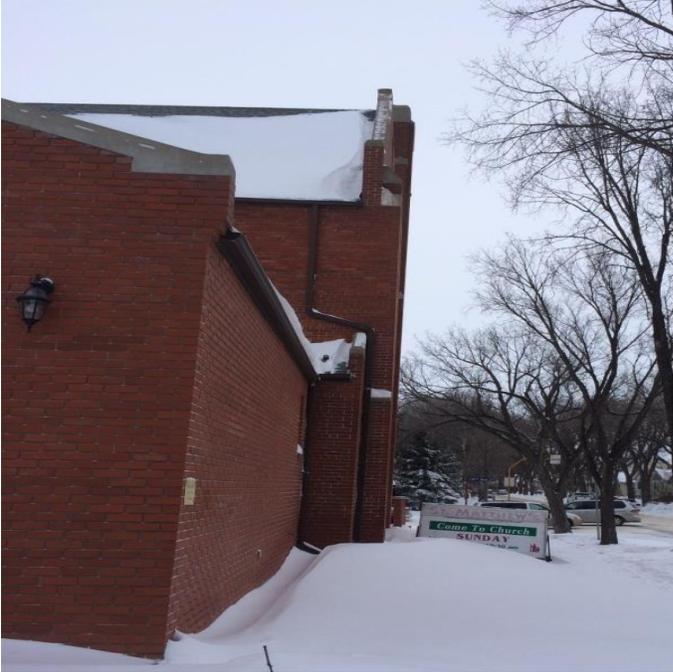
Photo 5: Bell Tower tilts toward the west

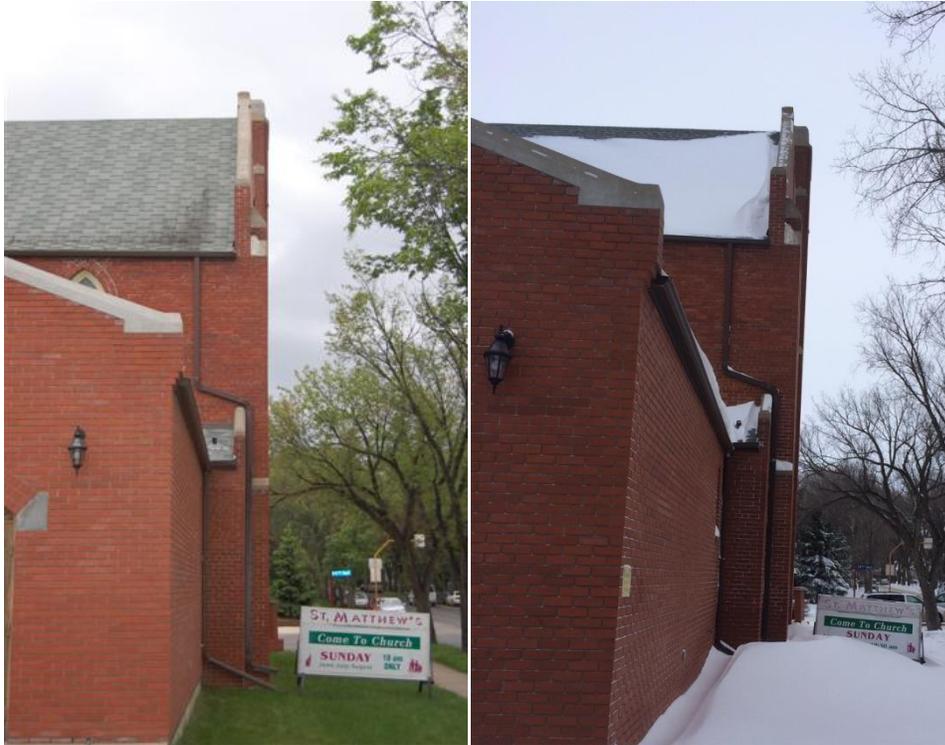
Photo 13: Comparison of Bell Tower between 2007 (left) and 2014 (right)

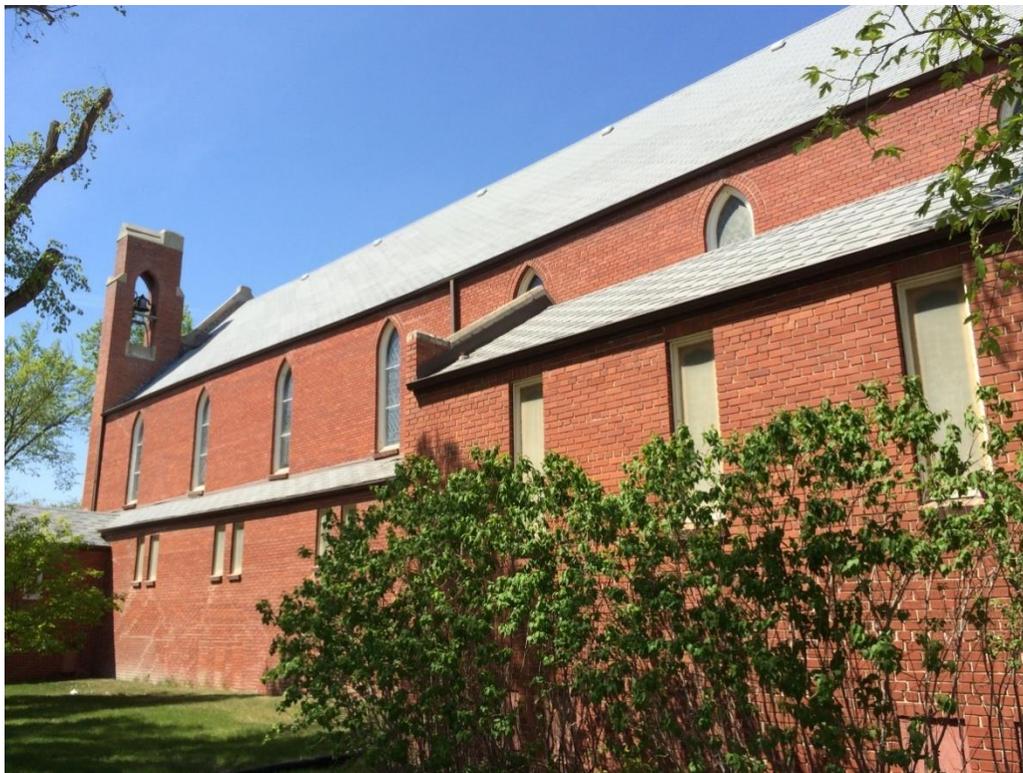
Photo 13: Chimney tower

The chimney tower at the east side of the church building is referenced in the February 2014 J.C. Kenyon report and noted "as tilting more towards the west since the 2007 Kenyon report" (see photo 14 comparison). Further the report states that "from the ground it was not possible to determine if the tower is cracked" and/or to what extent. The chimney extends 65 feet from the ground level.

More investigation is required to determine the extent of the movement and benchmark survey work is being undertaken to identify and monitor movement.

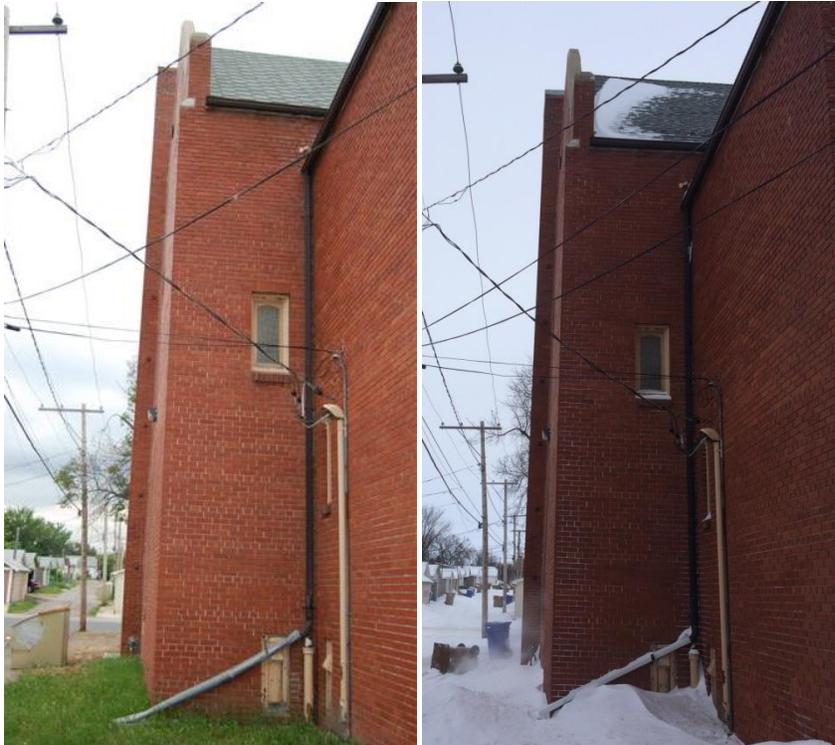
Photo 14: Comparison of chimney between 2007 (left) and 2014 (right)

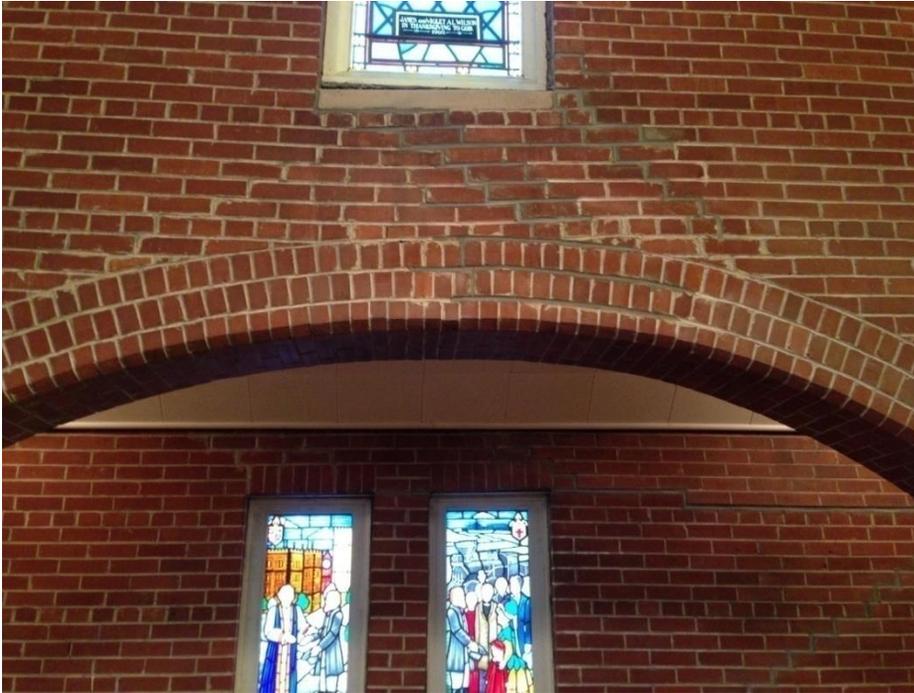
During a walk through inspection in May 2017 more brick movement was noted by J.C. Kenyon Engineering under two of the arches from the west on the south side under two of the stained glass windows. It was noted that the bottom course of brick was no longer in compression and that the mortar joints had become loose (reference February 14, 2014 J.C. Kenyon report and photos #4 and #11).

Photo 15: Gap observed beneath stained glass window

J.C. Kenyon Engineering worked with the heritage stone mason Charlie Pirie on a temporary solution which consisted of wooden support arches built with 2 by 6 lumber beneath the two brick arches. Centre four studs are double-studs. The arch was made of 3/4 inch fir plywood that is cut to shape. There are four plies of plywood in the arches which is closed off to traffic for safety of users. This temporary solution was completed within a week of the discovery.

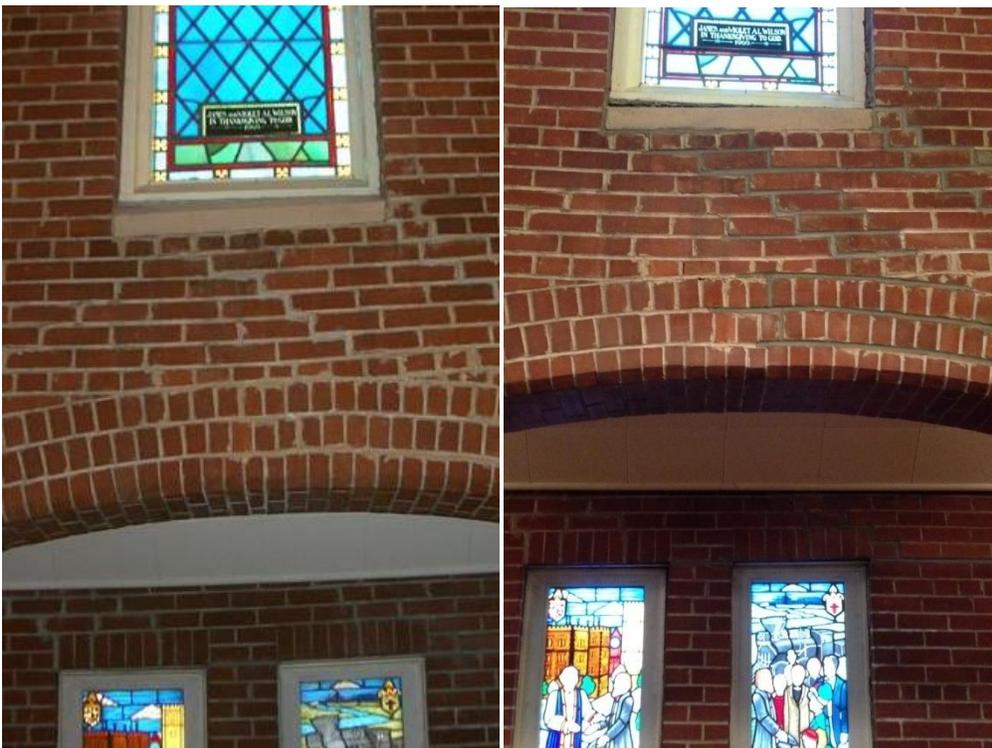
Photo 16: Comparison between 2007 (left) and 2014 (right)

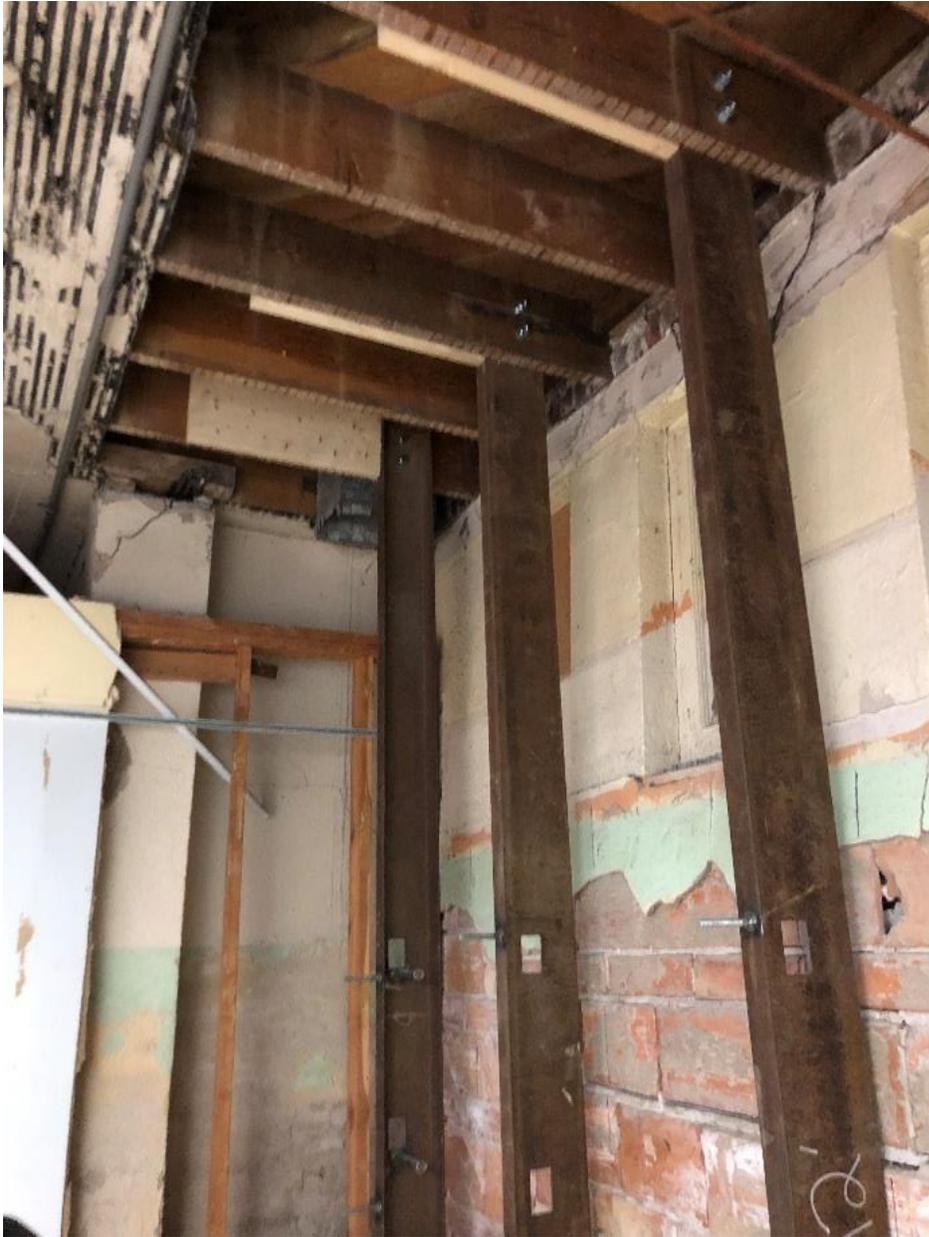
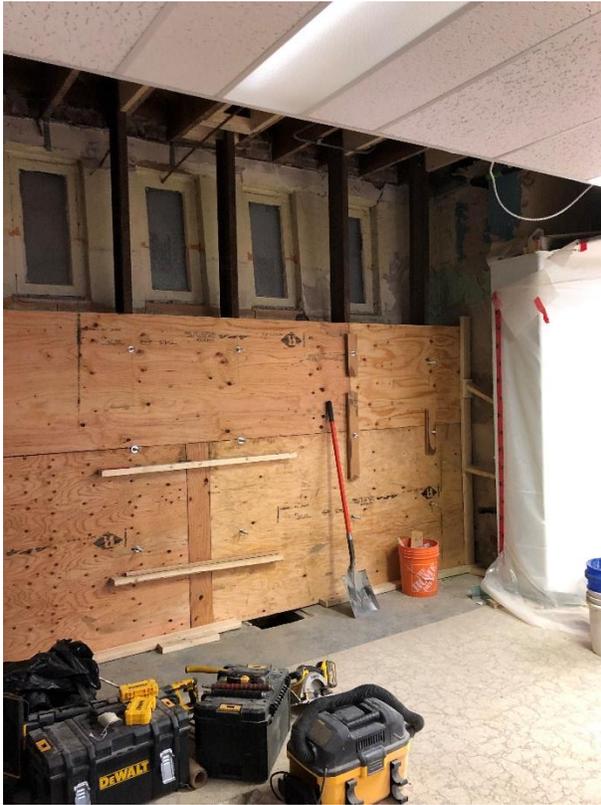
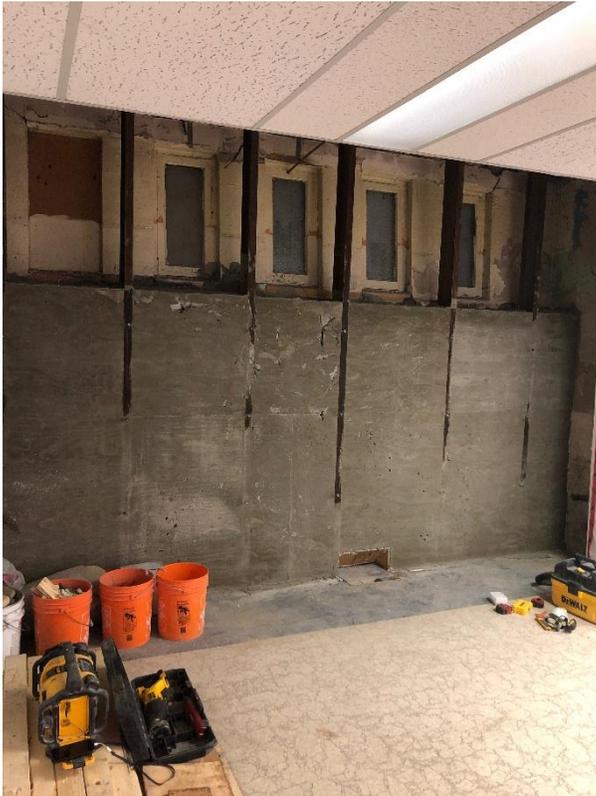
In the early to mid-1970's, the west end of the church furnace area was excavated to the footings to determine the building materials used for the walls. At that time, the inside south wall received an eight inch application of spray crete over the clay tile from the kitchen pass through east window to the furnace room on the west. The furnace room still has the clay tile below ground and brick above ground. Some stabilization channeling work was done in 2018.

Photo 17: Channeling work completed in November 2018

In November 2018 J.C Kenyon completed their third engineering assessment. The priority was the stabilization and repair of the lower hall west wall. The wall was reinforced on the inside face. This included demolition of the ceiling and parts of the floor slab adjacent to the wall, installation of steel channels and reconstruction of the interior wall. To provide further stabilization a three inch concrete slab was poured over the existing slab in the adjacent south storage area.

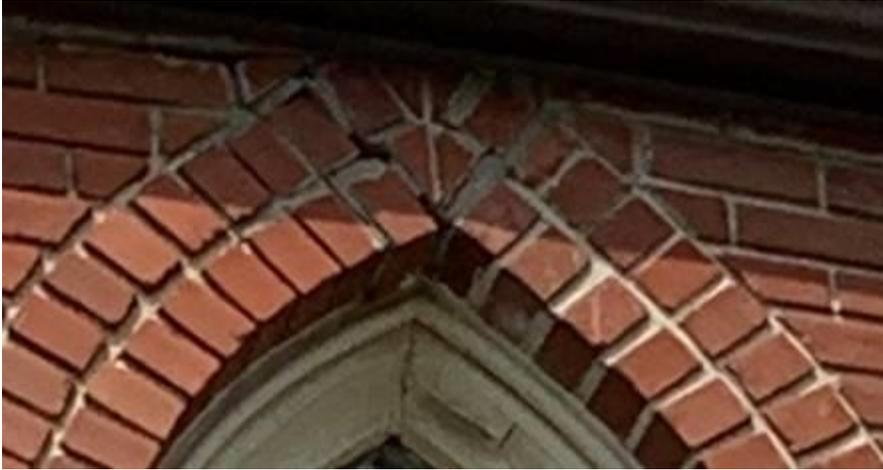
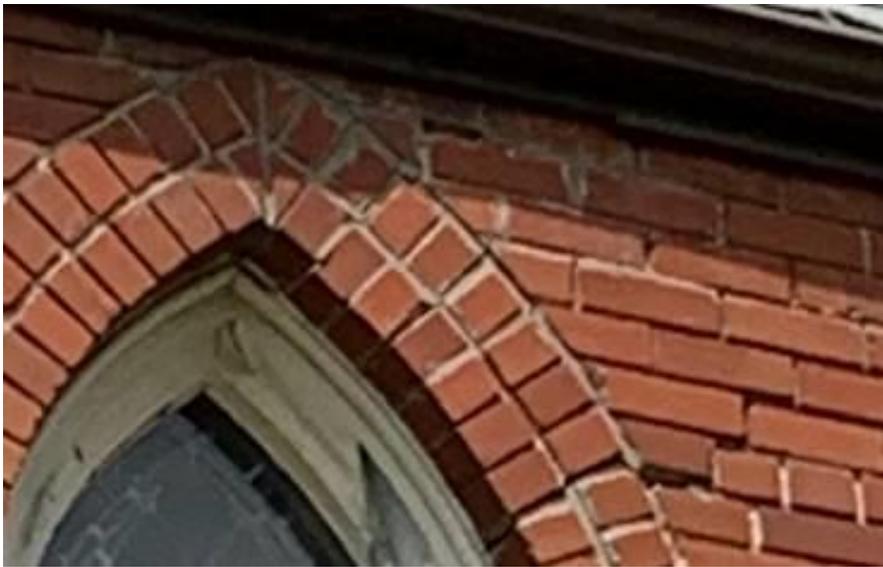
In July 2019 the exterior brick arches on the south side of the church were repaired by BrXton Masonry Inc. in conjunction with J.C. Kenyon Engineering. The bricks were no longer in compression and the mortar joints had become loose. Pictures of the condition of the exterior archway and brick before work was completed are shown below.

Photo 18: Exterior brick arches on the south side (14th Avenue)

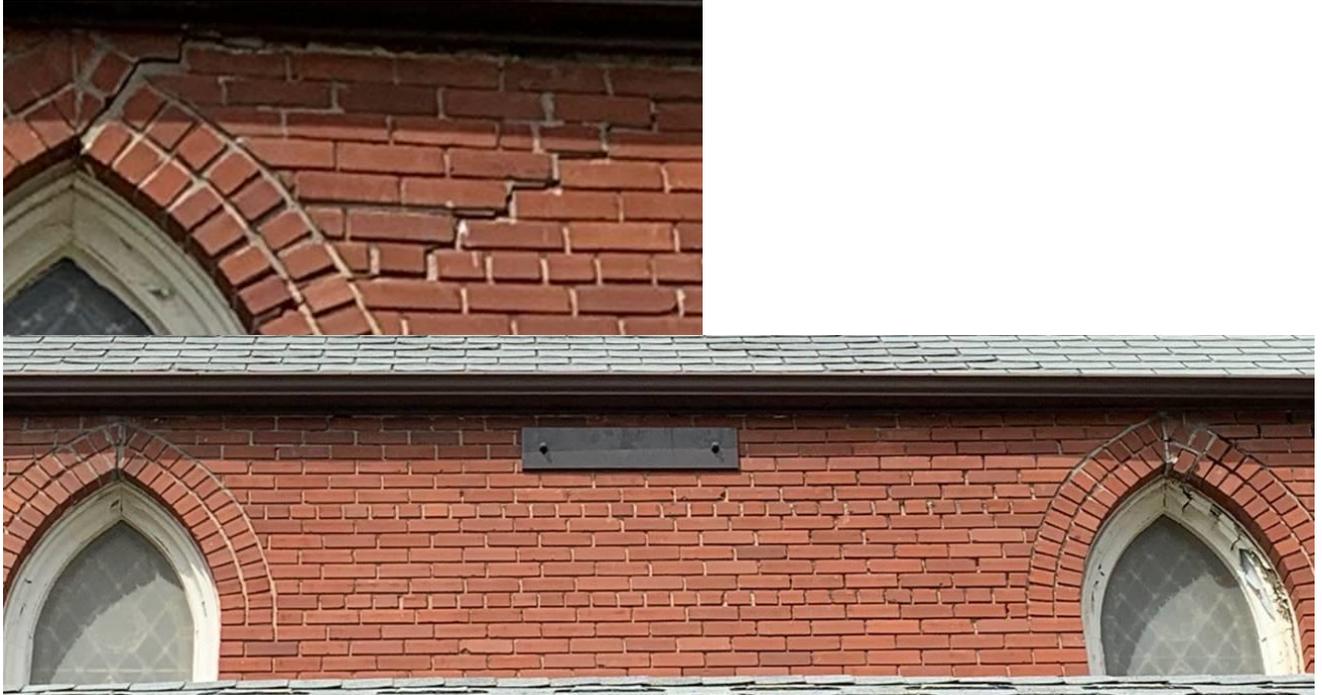
Photo 19: South side exterior Brick Arches

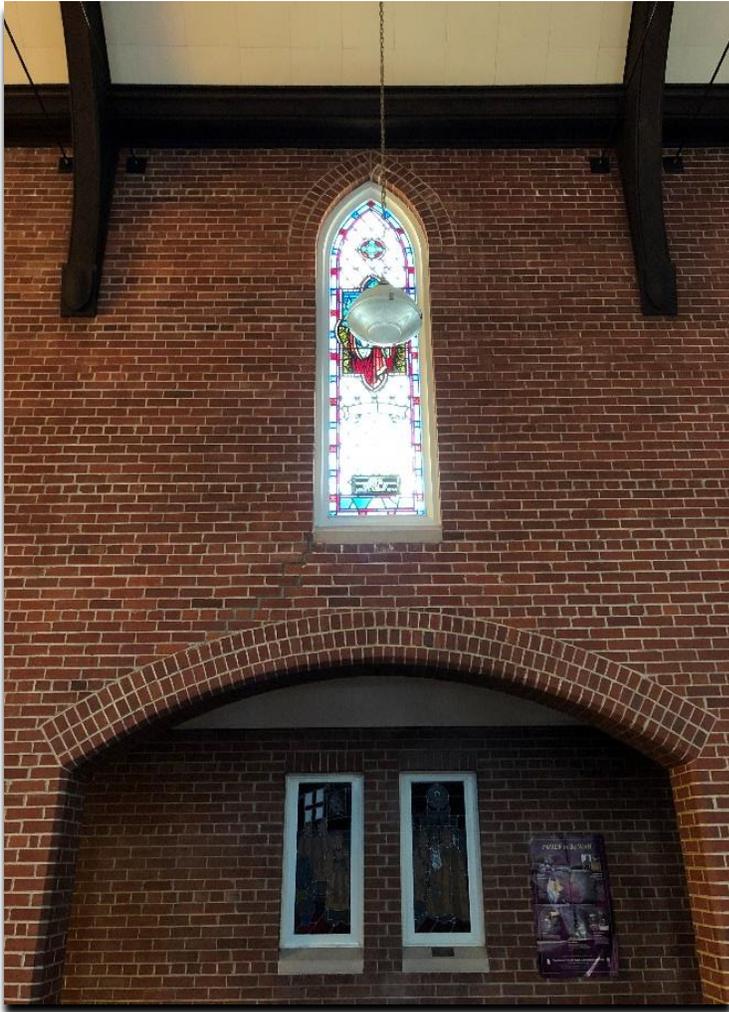
The City Heritage Grant request is for reconstruction work to be done in late fall 2019 on the interior third brick archway on the north side of the building which forms part of the load-bearing walls. The brick is no longer in compression and loosening mortar is compromising the safety and stability of the building.

Photo 20: Restoration work to be completed in 2019

- Removal and reconstruction of the third masonry archway on the north side of the building to the extent detailed on the structural drawings.
- Existing brick shall be salvaged and reused; any additional bricks required are to match.
- If required, new bricks shall be installed on the north face of the wall near the top.
- Masonry is to be designed and constructed to [CSA S304-14](#). (Engineering standard)
- The mortar will be compatible with the historic appearance of the building. The contractor will prepare a mock-up for approval by the Consultant.
- Repair exterior vertical crack in the brick wall.
- Any existing mortar that is not compatible in texture or color will be removed and replaced.
- Shoring of the existing wall to allow for removal of the masonry arch supports.
- Partial removal of the existing masonry arches as detailed on the drawings and in the Conservation Plan.

- Hoarding and shoring to ensure the existing structure is stable during construction.
- Reclaiming the displaced masonry unit by way of gently removing the masonry units from the wall and cleaning the masonry units of all existing mortar.
- Storage of reclaimed masonry unit in a dry and secure location.
- Salvaging and reusing the existing brick where possible and using new matched brick.
- If reuse is not possible, then new brick to be located at the top of the wall.
- Replacement and supply of mortar that matches the existing mortar in texture, colour, strength and aggregate gradation.
- Reconstruction of the arch to match the original profile to the fullest extent possible given the existing building conditions.
- Repointing an exterior vertical crack in the masonry wall.

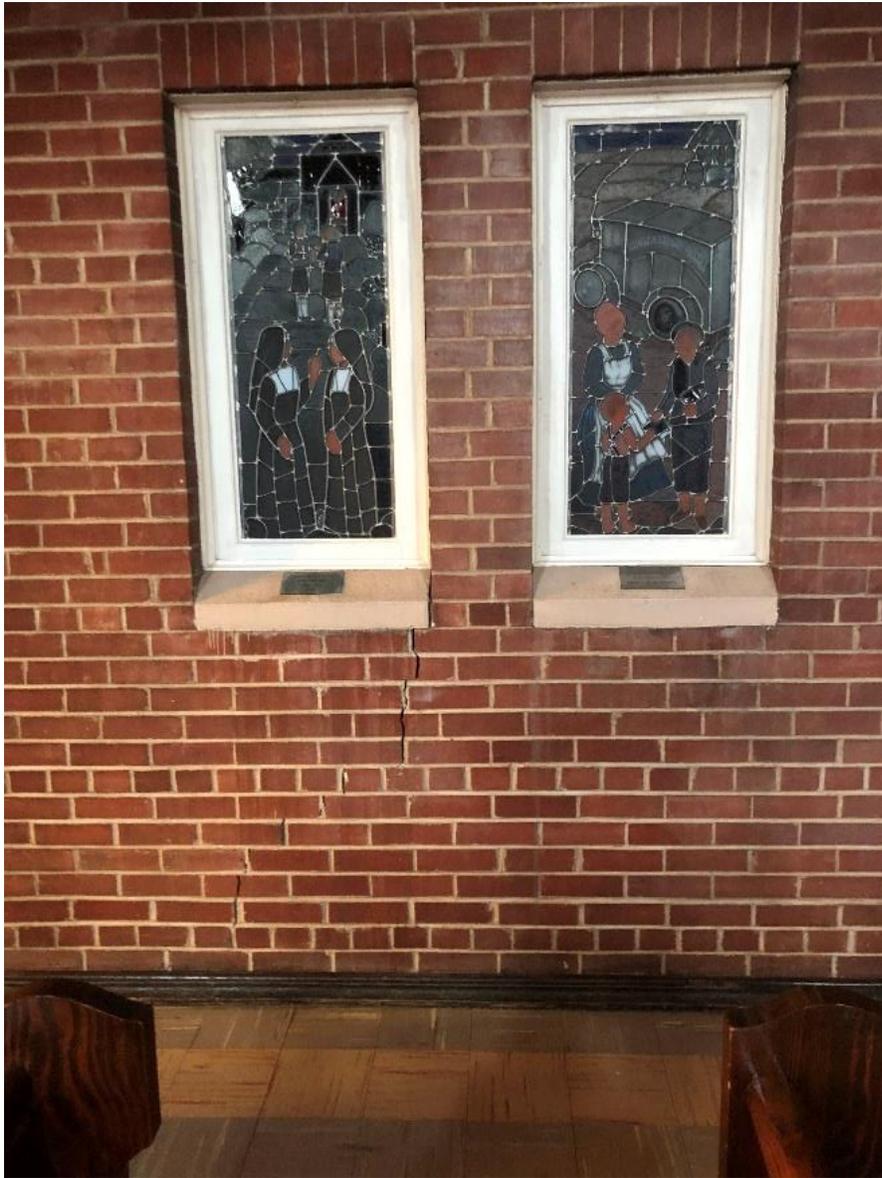
Photo 21: Restoration to be completed in 2019

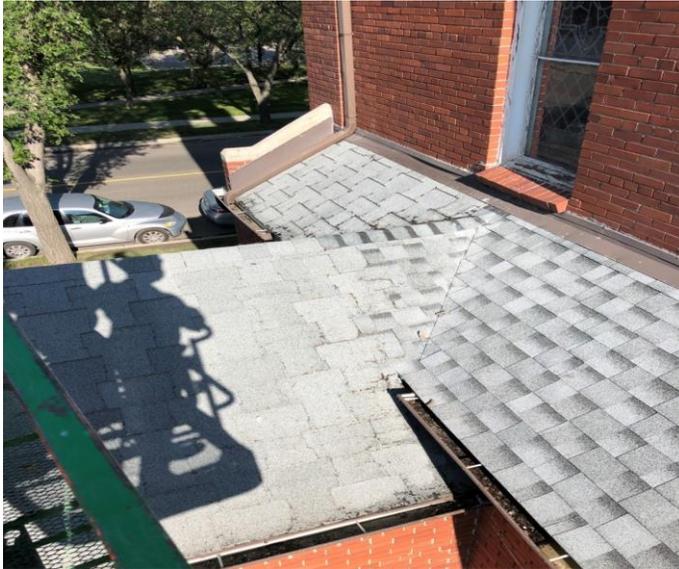
Photo 22: From the August 1 Inspection Report - View of the Shingles on the South West Side (Winnipeg Street)

The roofing replacement is to ensure adequate protection from water and moisture penetration of the heritage church envelope.

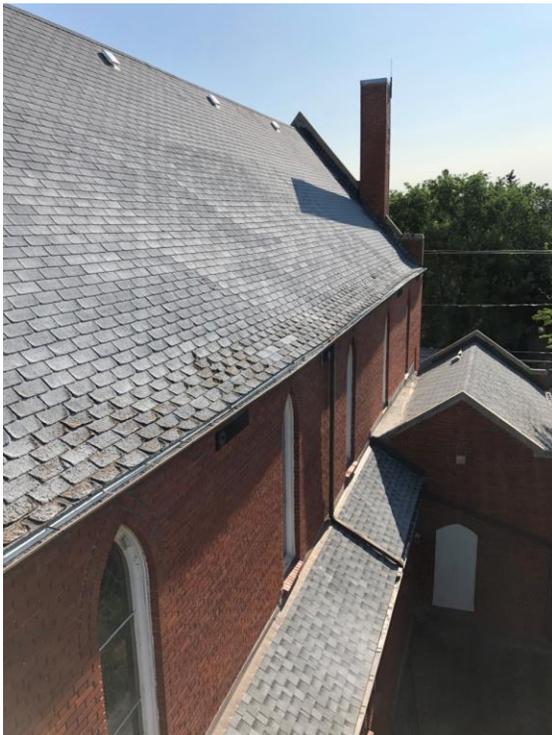
Photo 22: August 1, 2019 Inspection Report - View of the Weathered Shingles along the South Side of the Upper Roof.

The roofing replacement is to ensure adequate protection from water and moisture penetration of the heritage church envelope. This includes the lower roof panels on both the north and south and the top edge of the south side of the church.
