Dear Members,
City of Regina Planning Commission,
RE: 3160 Albert Street

February 18, 2021

Regarding: File #: 2019 - 1822
Report Type: Engineer's Report
Structural Assessment & Building Envelope Assessment
Municipality: City of Regina, SK.
Civic Address: 3160 Albert St.

**Property Located At:
3160 Albert Street Regina, SK**

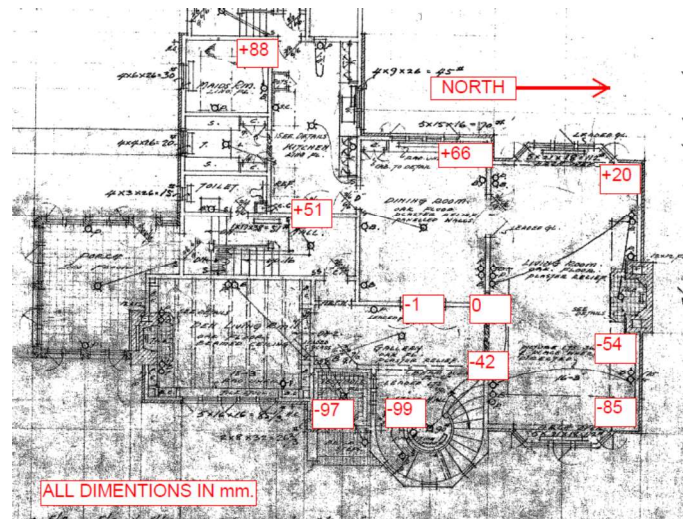
Figure 1: Main Floor Elevations

The survey of the main floor indicated that the centre of the building is high compared to the perimeter foundation walls and that the foundation walls have not moved uniformly. The highest point in the floor is over a load bearing concrete wall. The survey indicates that there has been significant differential movement of the foundations over many years.

To properly stabilize the foundation of this building, the footing foundations must be replaced with piles that extend deep into the soil. The existing footings must be isolated from the clay and all building loads must be transferred to the new piles. This system of underpinning allows re-leveling of the building structure and also protects the foundation from vertical movement. This system has been used on residential, institutional and government buildings in Regina including the Saskatchewan Legislative Building and the University of Regina's College Avenue Campus and Darke Hall. Underpinning a building is a significant undertaking and includes the following steps:

1. Removal of the basement floor slab
2. Excavation around the perimeter of the building and below the footings
3. Installation of piles and releveling of the building
4. Installation of piles to support the new basement floor slab
5. Installation of a new basement floor slab
6. Installation of waterproofing, drainage and backfill around the exterior of the foundation wall

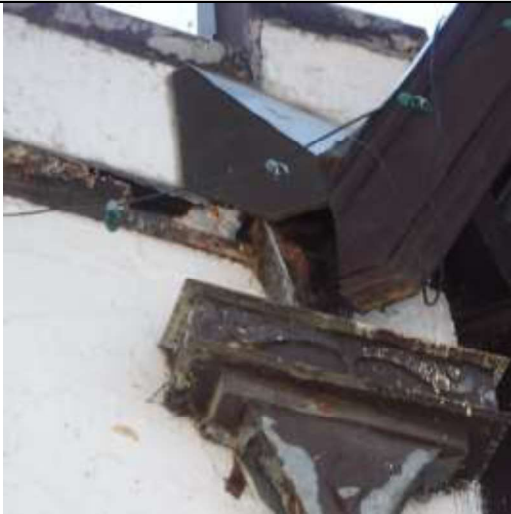
Rusted/damaged/leaking flashings, gutters, downspouts

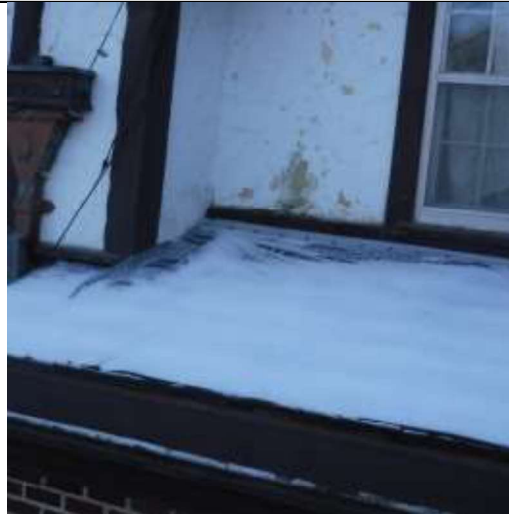
#104- evidence of past damming/moisture transfer at back lower roof and interior damage in dining room area. Recommend roofer to address repair to prevent further damage.

Suspected leaking flashing at back lower roof-interior damage

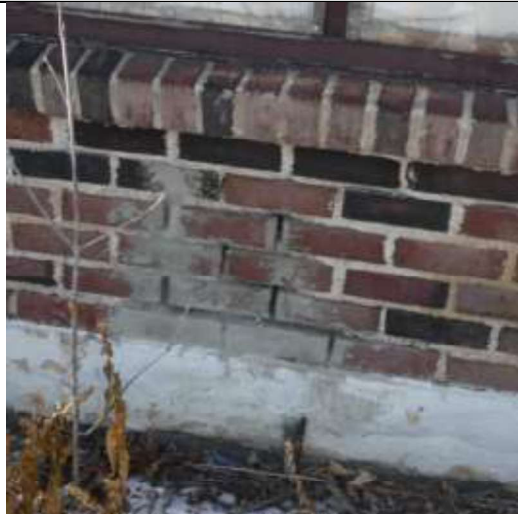
Cracking in brick and stucco

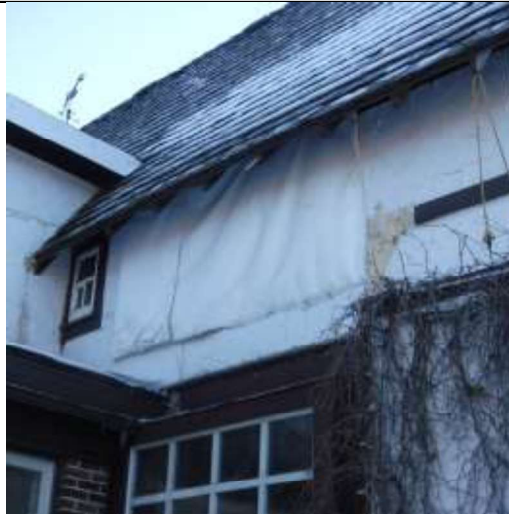
Water proofing installed over stucco at back due to suspected moisture transfer

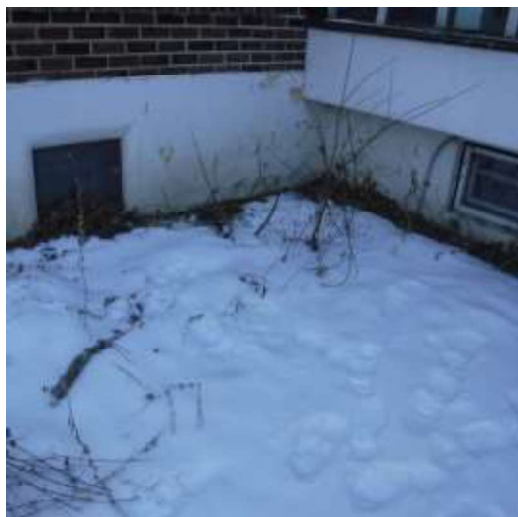
Poor drainage away from the fountain in several areas

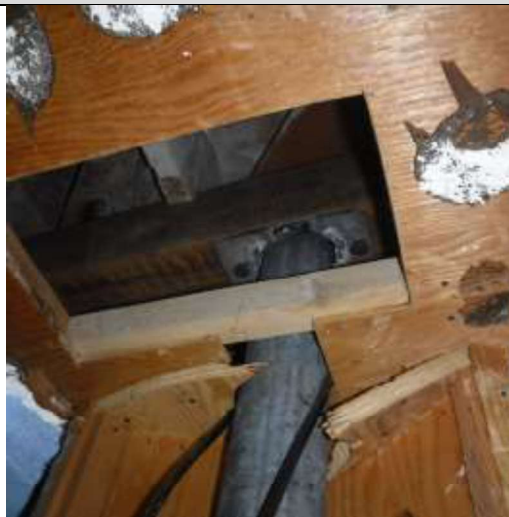
#303-304- home slopes from back to front due to settlement and sinking in the footings at front (approx. 51/4"-6) non-adjustable support columns installed under main beams and solid concrete structural walls that are not adjustable noted in basement. Significant cracking in walls on main and 2nd floor, doors nit fitting in their pockets and significant deflection in front basement steps structure due to non-adjustable columns, structural walls and settlement at front of building. Recommend contractor to address all areas to prevent further damage and for level structure.

Main beam-non-adjustable columns

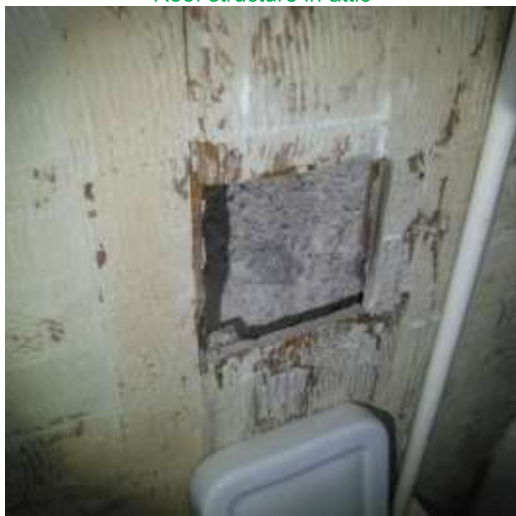
Concrete non-adjustable structural walls

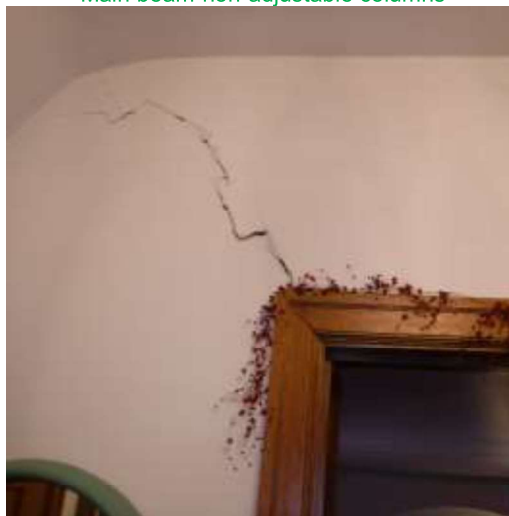
Cracking in walls/ceilings from pressure and settlement

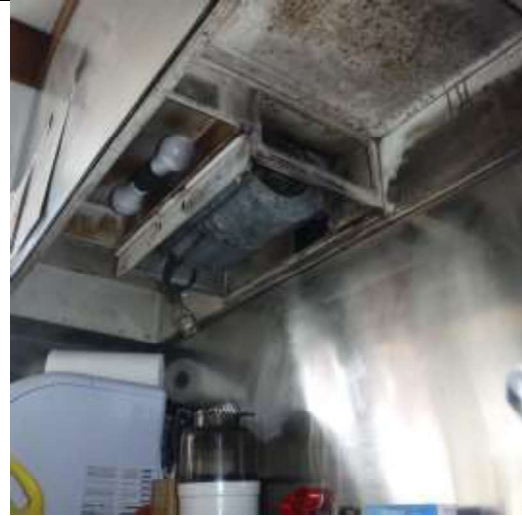
#416- inoperative kitchen exhaust fan, master bathroom fan is venting into attic, no fan installed in main bathroom. Recommend repair and all fans vent to the exterior.

Inoperative kitchen exhaust fan

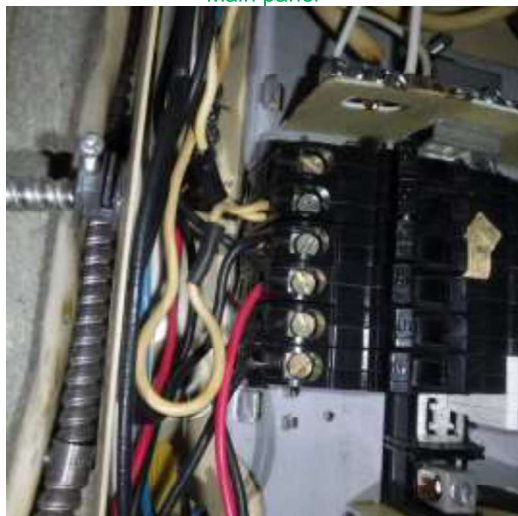
Double tapped breakers in sub panel

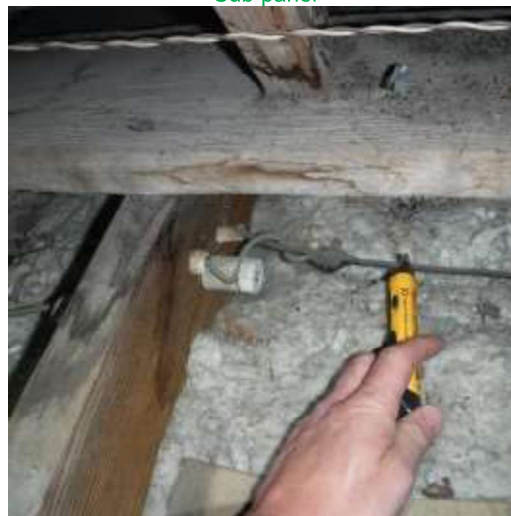
#503- only 1-50amp breaker and 1-30 amp breaker noted in panel and several sub-panels being fed from main panel. Some Knob and tube wiring still in service seen in attic and all plugs tested in the home are not grounded. Recommend electrician to address all areas for adequate installation, operation and safety.

Knob and tub wiring in service in attic

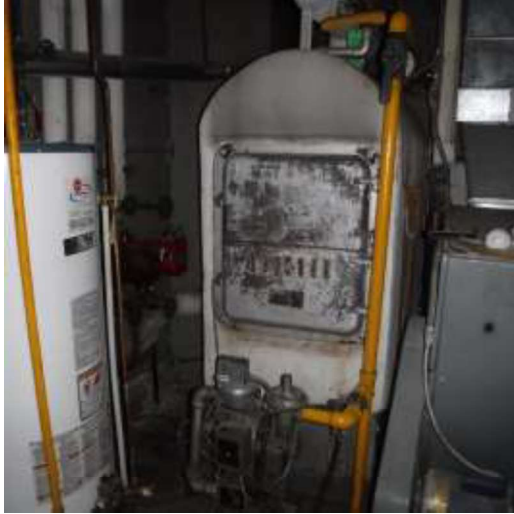
| # | SOP | ✓ | COMPONENTS: DESCRIPTION & COMMENTS |
|--|---|---|--|
| #603- boiler is past its expected life expectancy, asbestos wrapped pipes for boiler, boiler was previously oil burning and oil leak at old line coming out of basement slab (no evidence of oil tank seen on site), forced air dust servicing garage (making gas proofing compromised) one missing circulation pump, circulation pump on one zone appears undersized and basement boiler heat radiators appear inoperative. Recommend additional mechanical inspection for operation and safety and asbestos removal to be addressed by professional. | | | |

Boiler

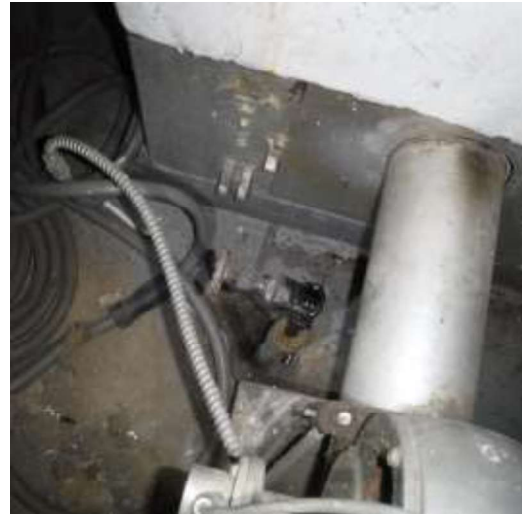
Leaking oil line near boiler

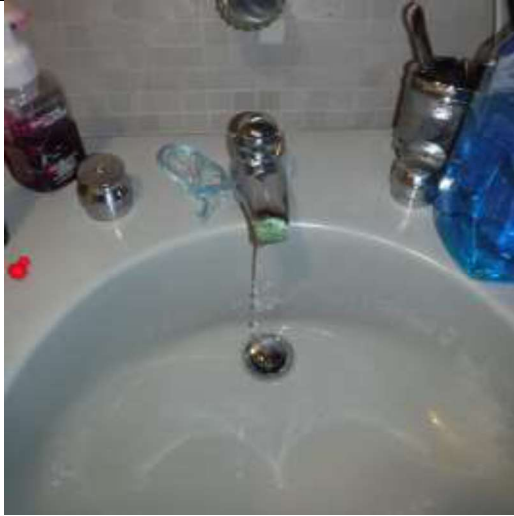
#717- faucet in main bathroom vanity runs full time, devices/faucets/tub surrounds and showers are very old and will require repair/replacement in the near future.

Leaking faucet in main bathroom

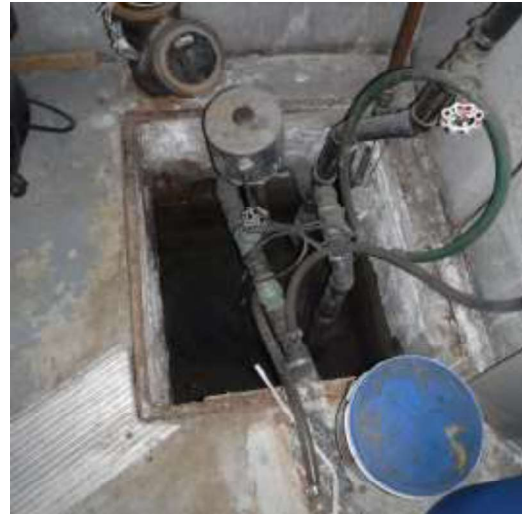
Sump put-pump inoperative

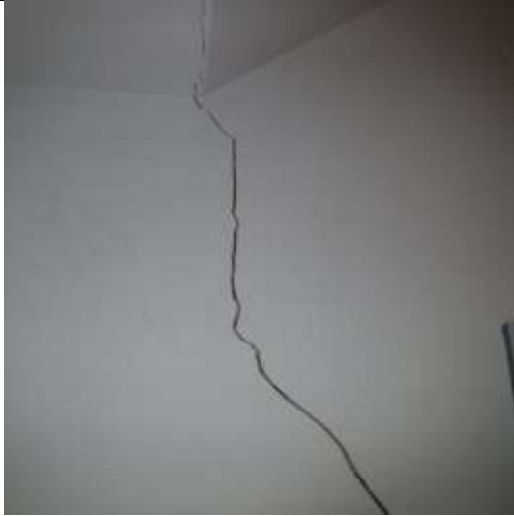
Large cracking in main floor stairwell

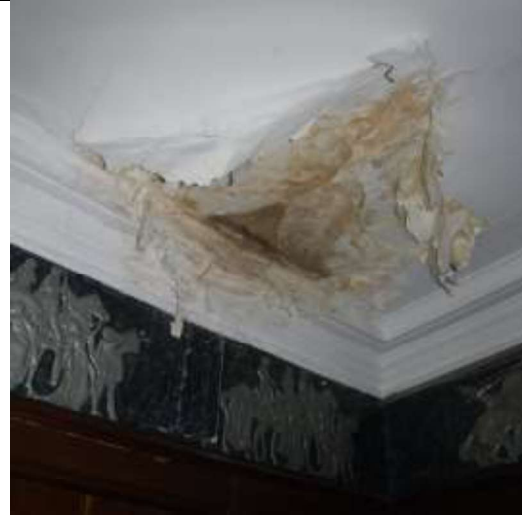
Damage to main floor ceilings

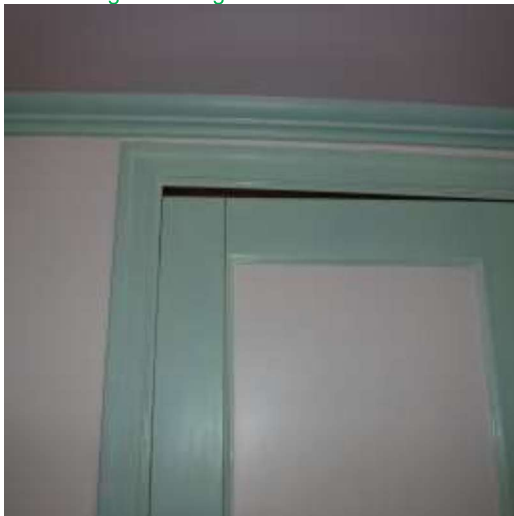
Doors no fitting due to pressure/settlement

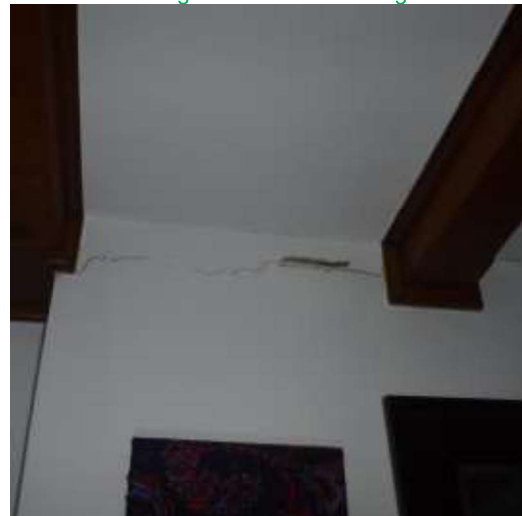
Cracking in main floor walls

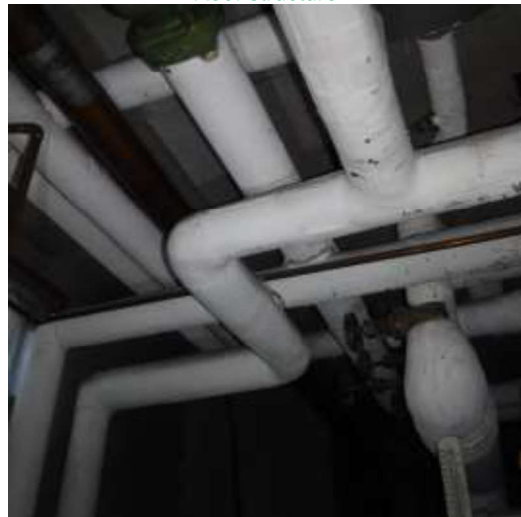
Suspected asbestos wrapped boiler lines

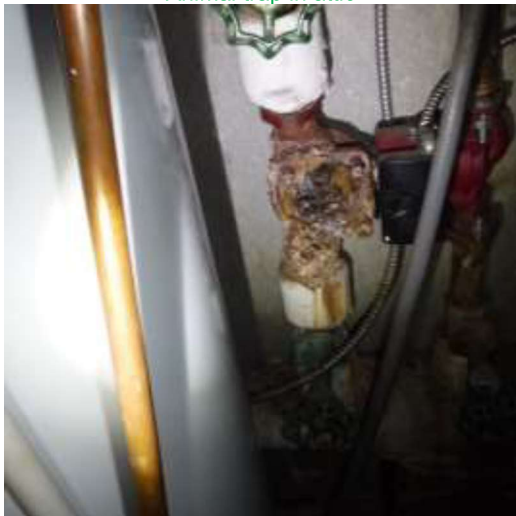
Missing circulation pump-rust-deterioration
