JC KENYON ENGINEERING INC.
STRUCTURAL ENGINEERING CONSULTANTS

May 24, 2019

File: 067-19

Re: Structural Inspection Report
1863 Cornwall Street
Regina, Saskatchewan

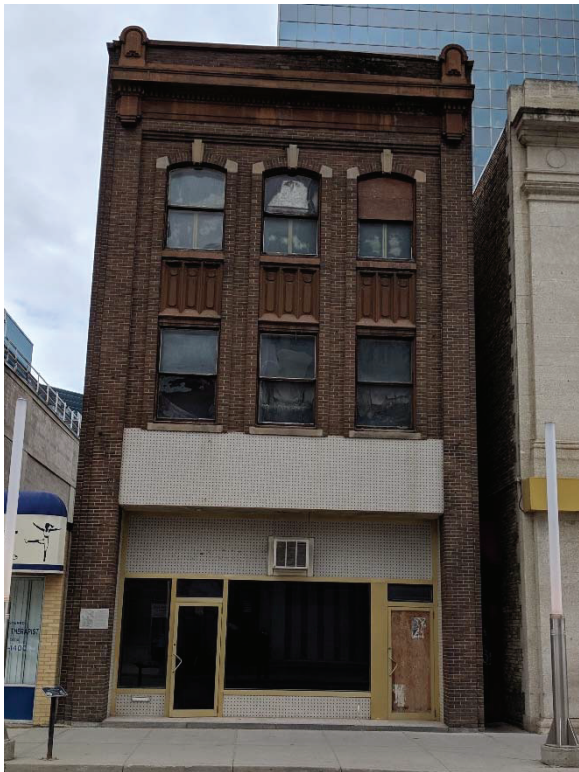
1863 Cornwall Street is a three-story masonry structure that was originally built for the Roman Catholic Episcopal Corporation of Regina in the early 1900s, Photo 1. The roof of the building is comprised of wood decking overlaying wood joists. The joists span the width of the building and bear on 17-inch thick exterior brick walls on the north and south sides of the building. The second and third floors have wood decking overlaying wood joists. The first floor is comprised of chipboard floor sheathing overlaying wood decking and wood joists. The basement floor is comprised of wood planks overlaying wood sleeper joists bearing directly on grade. The building foundation consists of 17-inch-thick concrete walls supported by concrete footings.

Photo 1: West elevation of 1863 Cornwall Street

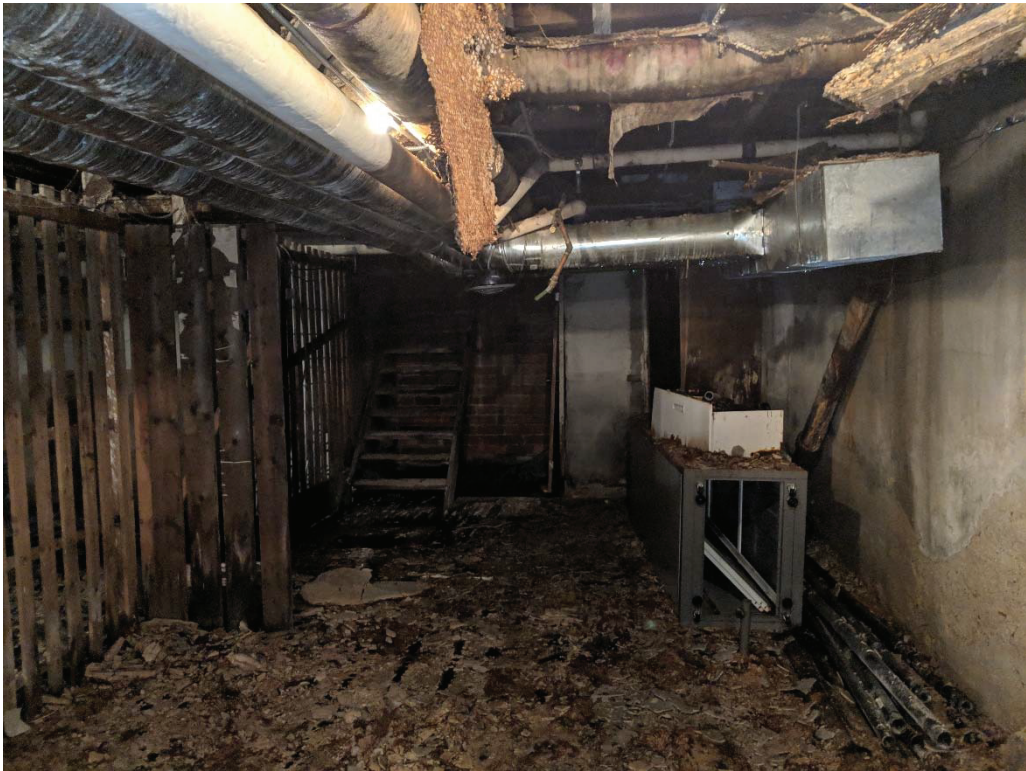
1. The ceilings were constructed with plaster on metal lath that was attached to the underside of the floor/roof joists.
2. A large amount of the plaster ceiling on each level had fallen to the floor below, Photos 2 to 5.

Photo 2: Basement fallen ceiling

Based on our observations, we believe that the building has undergone years of sustained water damage. The water infiltration appears to be primarily from a leaking and deteriorated roofing system; however, it may also be a result of leaking/broken pipes on each level. The water has caused the mesh in the plaster ceiling to corrode and fall, the ceiling tile grids to break and fall due to rust and falling plaster, the wood floor boards and joists to rot, the chipboard sheathing on the main floor to swell and deteriorate, and black mold to possibly form on surfaces in the building. With the amount of damage sustained by the building, including the rot and water staining displayed on the wood floor decking and wood joists, the building is unsafe for occupancy. Without stopping further water infiltration and allowing the building to dry, the building will continue to deteriorate. To stop further water infiltration the building will require a new roof, the damaged finishes will need to be removed with the fallen plaster cleaned up, and heating and ventilation needs to be provided to dry out the building.

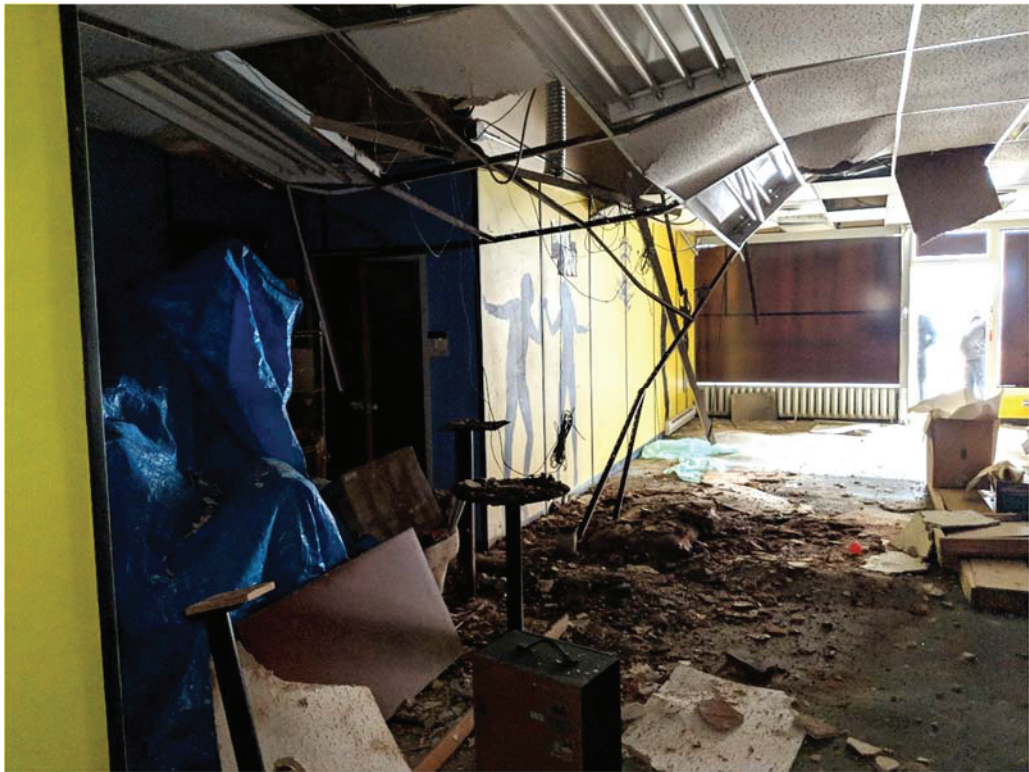
Photo 3: Main floor fallen ceiling

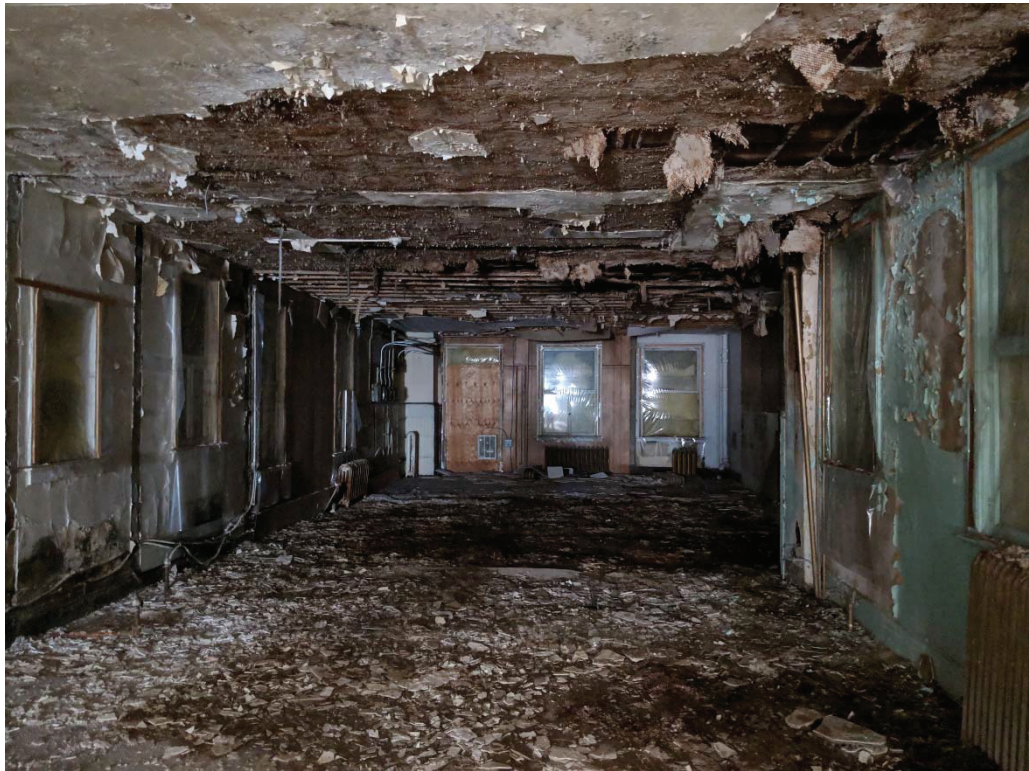
Photo 4: Second floor fallen ceiling

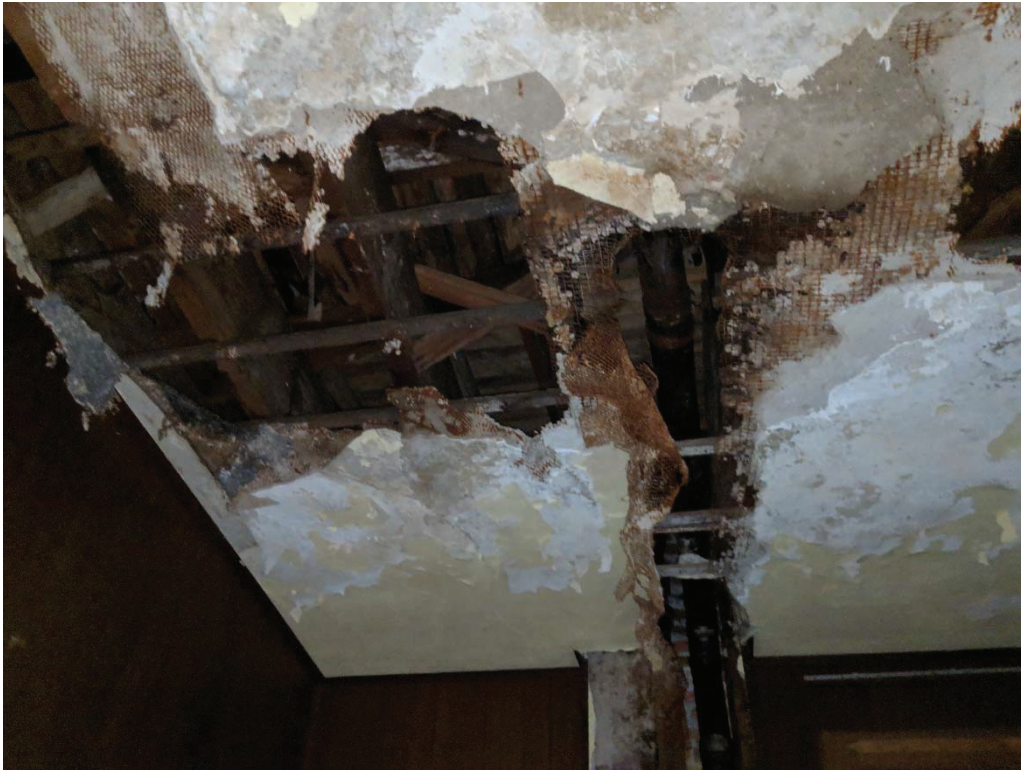
3. The steel mesh in the plaster ceiling that remained on the ceiling was corroded, Photo 5.
4. The main floor ceiling tile support channels on the main floor were corroded and broken in several locations, Photo 6.

Photo 5: Third floor roof and steel mesh corrosion

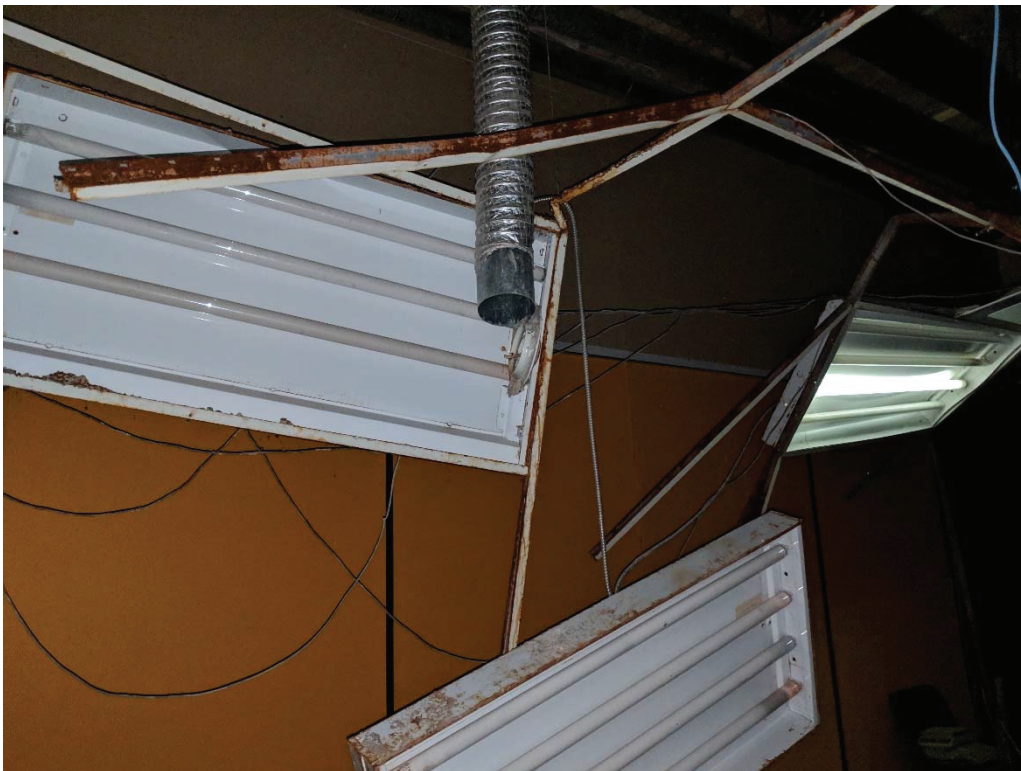
5. Light fixtures on the main floor were hanging from the ceiling tile support grid, Photo 6. Power was being supplied to the lights; one light bulb was on and two other light bulbs were glowing orange but were not functioning properly.

Photo 6: Main floor broken suspended ceiling support and glowing fluorescent lights

The lights on the main floor hanging by live wires and remaining powered in an unoccupied building are a fire hazard. It was recommended at the time of inspection to shut off power to the lights until they may be properly supported and there is no risk of water infiltration into the fixture.

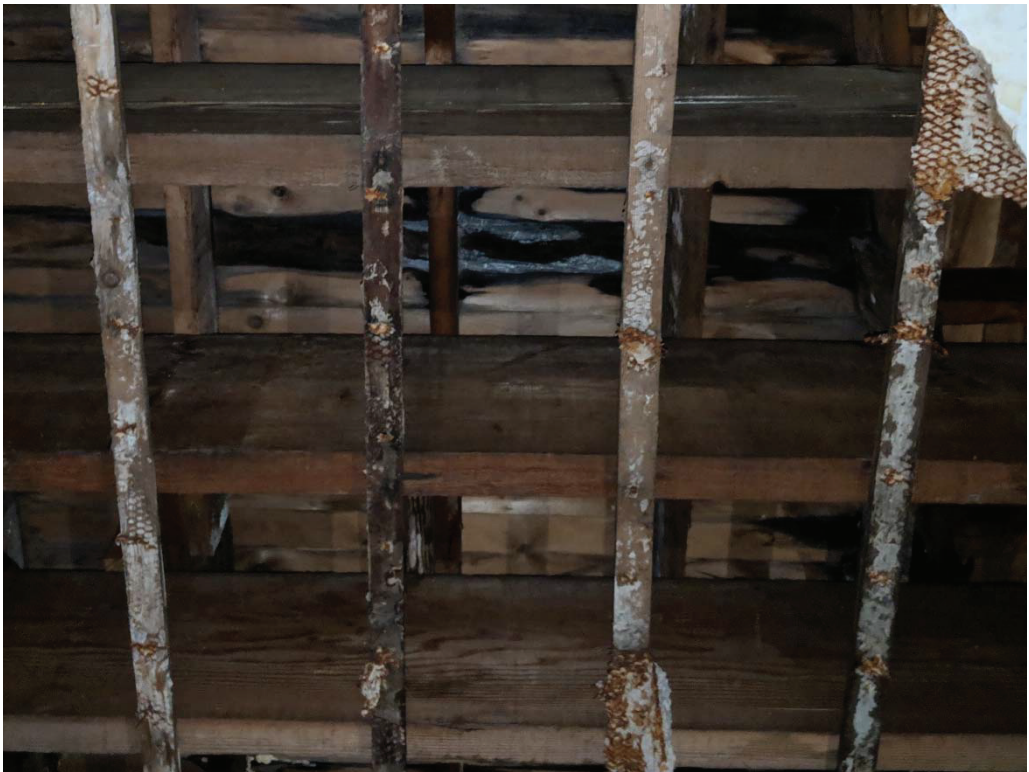
6. The wood decking and floor joists appeared to be damp and displayed a significant amount of staining throughout the building. The wood decking and floor joists appeared to be rotten in several locations on each level, Photos 7 to 9.

Photo 7: Rotting wood roof decking

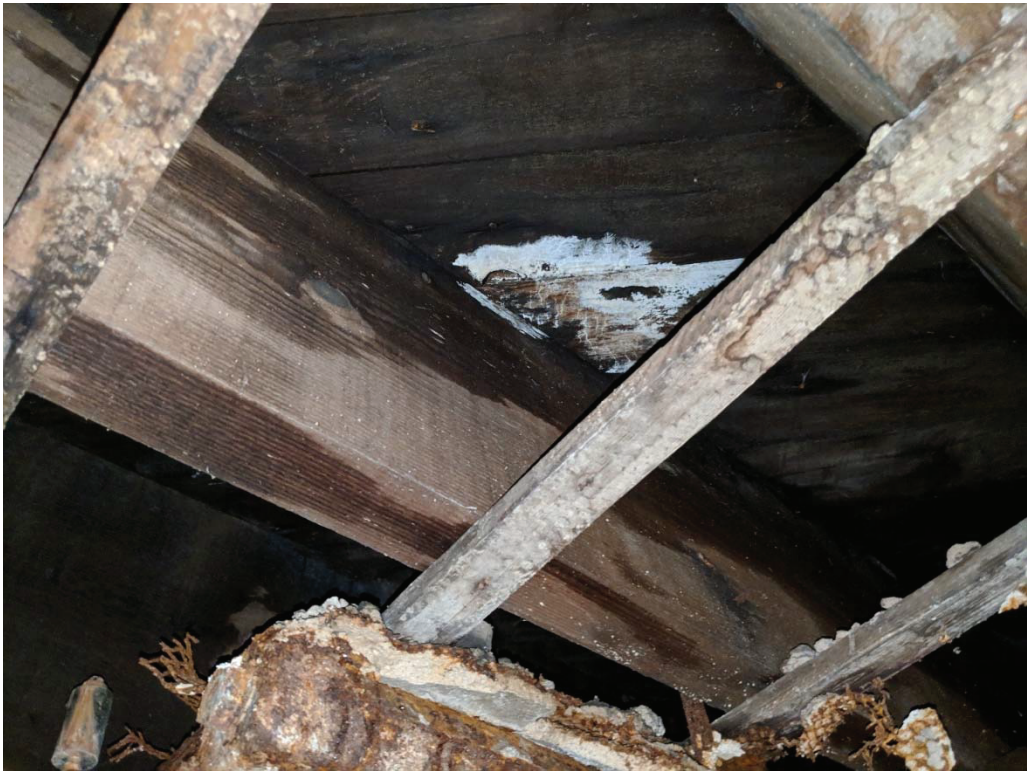
Photo 8: Rotting main floor wood decking and floor joist

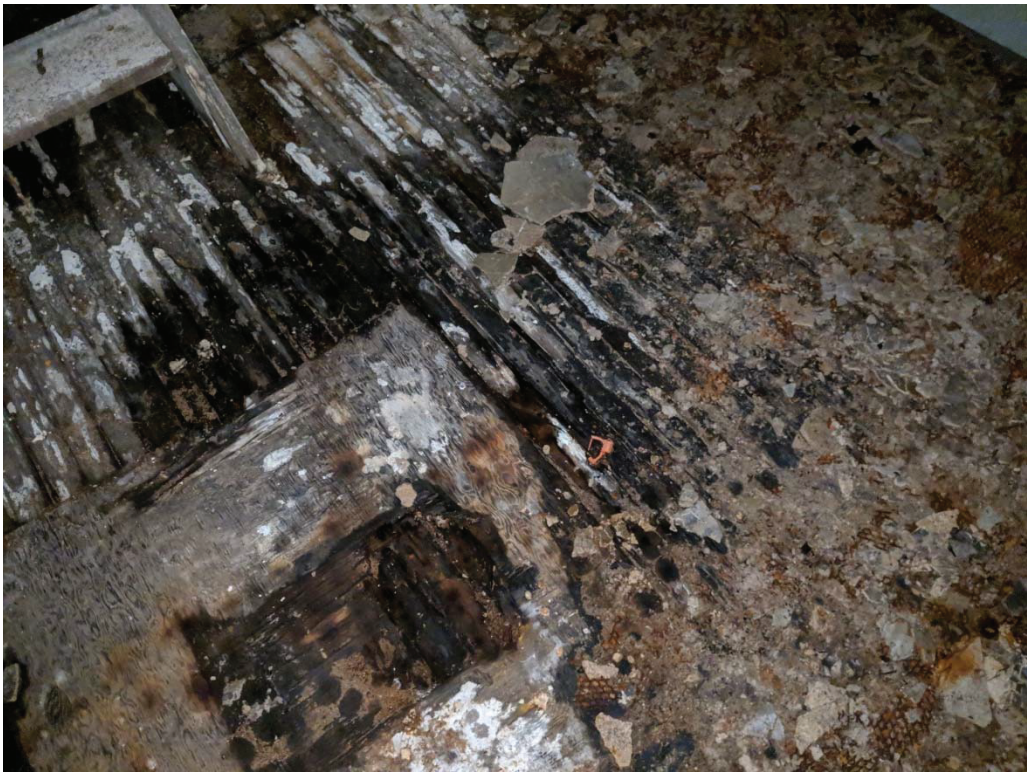
Photo 9: Rotting basement floor planks

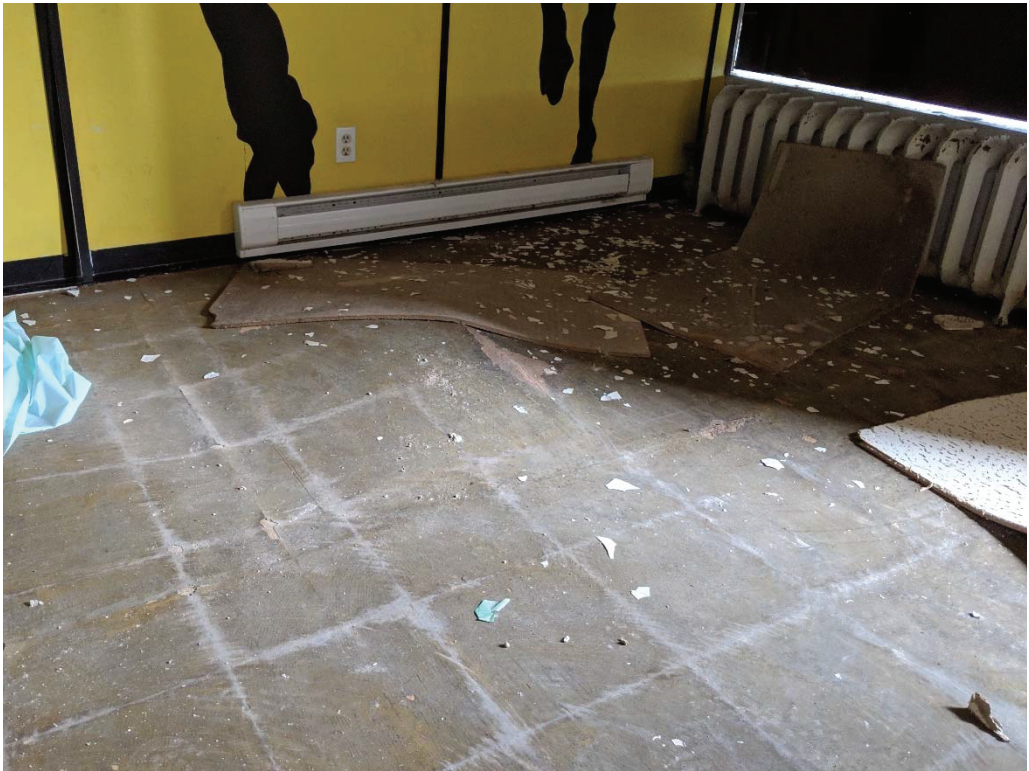
7. The floor sheathing on the main floor had swollen in certain locations creating large humps in the floor up to 4 inches high, Photo 10. The sheathing below these humps was deteriorated and wet, Photo 11.

Photo 10: Humps in flooring on main level

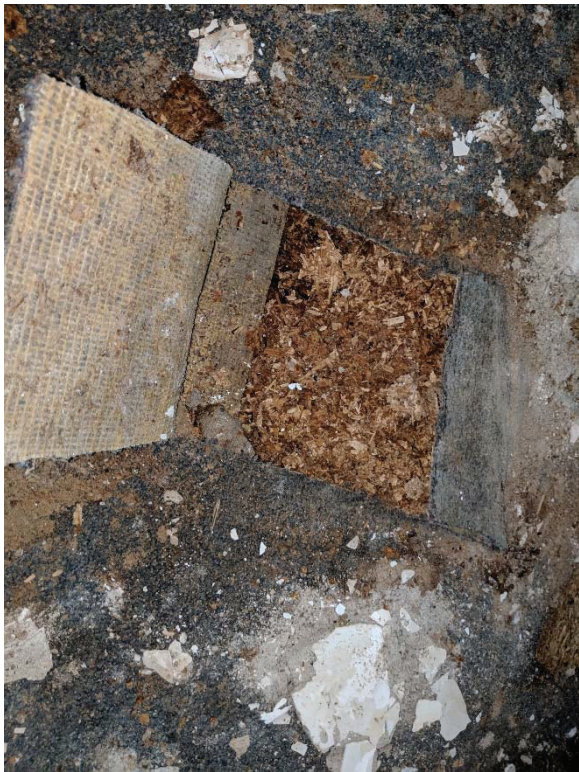
Photo 11: Wet and deteriorated chipboard sheathing on main floor

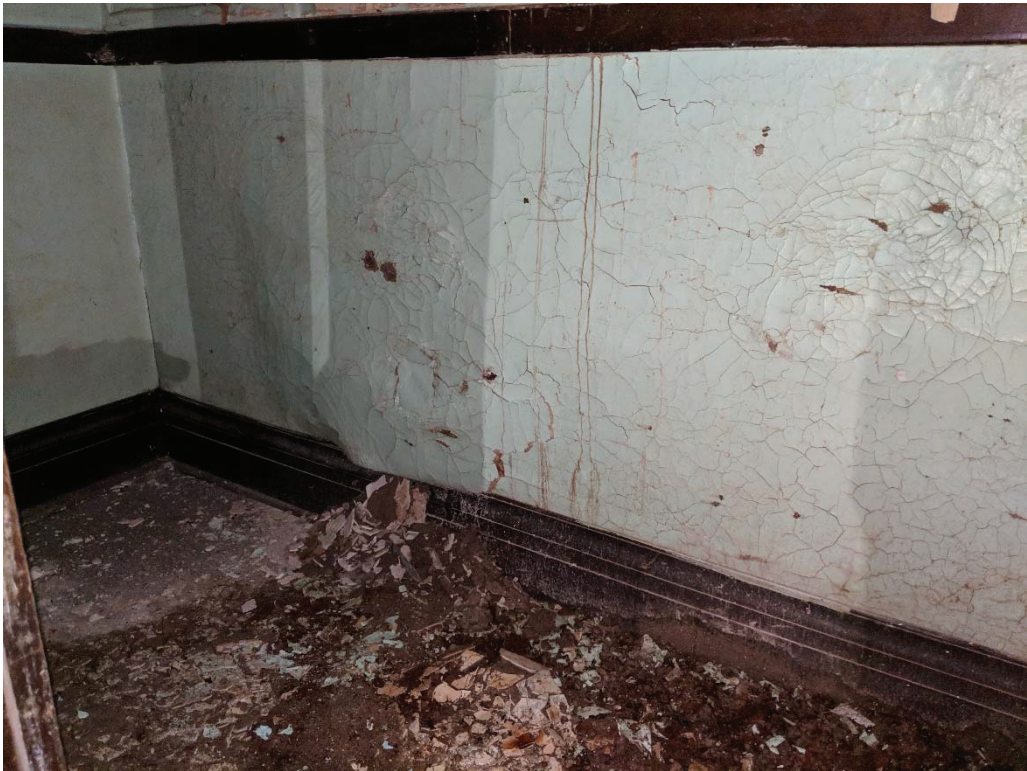
8. The plaster walls were cracked and deteriorated throughout the building, Photo 12.
9. The wallpaper on the second floor appeared to be covered with black mold, Photo 13.

Photo 12: Cracked and deteriorated plaster walls

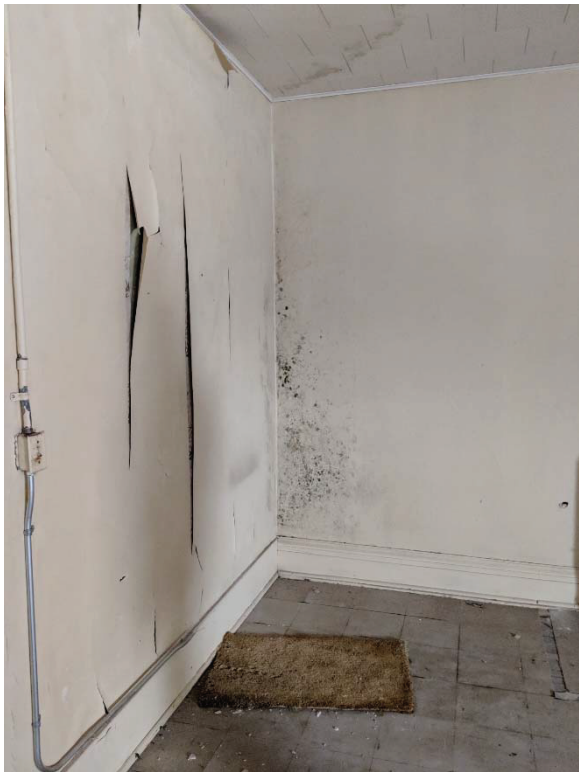
Photo 13: Potential black mold on second floor wall paper

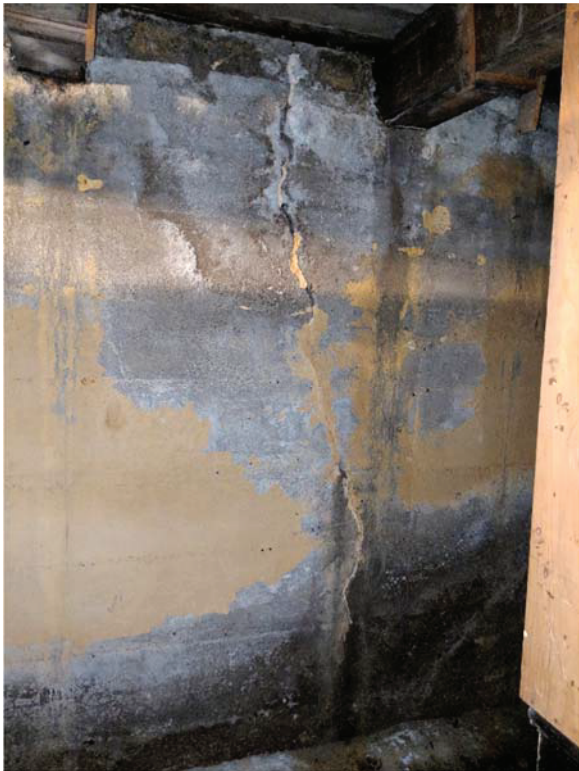
10. The west foundation wall contained a couple vertical cracks with some efflorescence, Photo 14.
11. The roofing asphalt and felt was deteriorated and peeling, Photo 15. Moss and plants were growing in-between layers of roofing material.

The cracks in the foundation walls are likely due to differential settlement of the building. This is a common occurrence for buildings constructed on footings in Regina due to the highly expansive native clay soil. These cracks are another source of water infiltration. At this time, they have little bearing on the performance of the foundation wall, but over time could cause issues.

Photo 14: Crack in west foundation wall with efflorescence

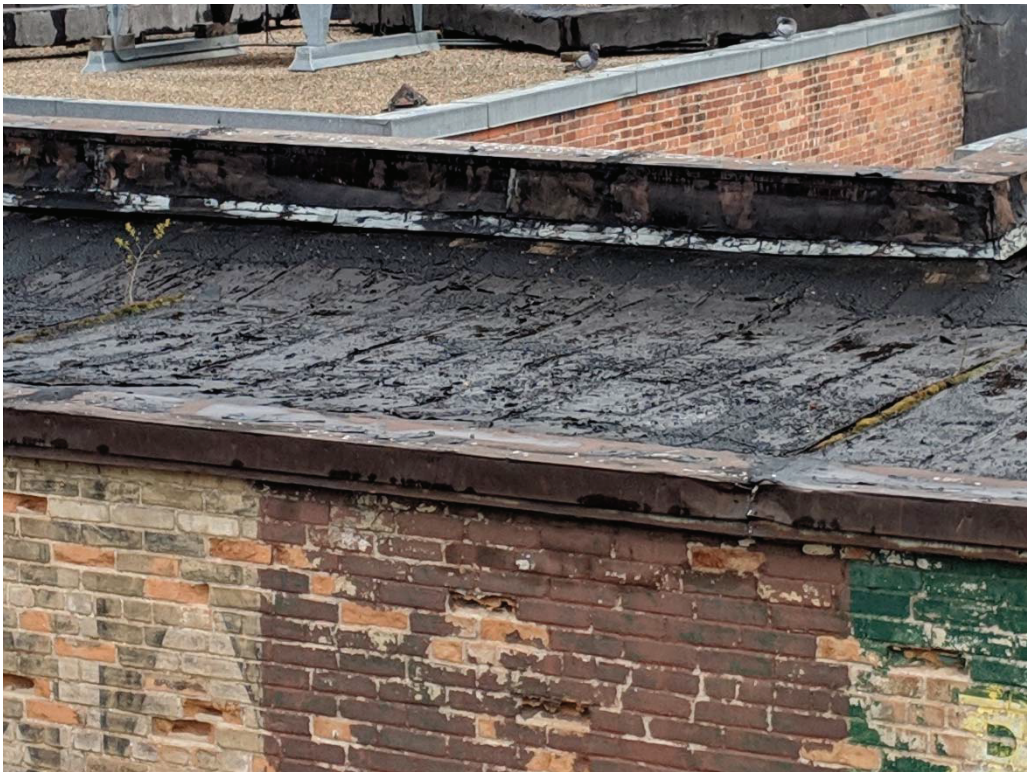
Photo 15: Deteriorated roofing and plant material growing on roof

In its current state, this building is not habitable and will deteriorate rapidly. To stop further deterioration, the building will require a new roof, cleaning of the wet and damaged finishes, and heating and ventilation to be installed. The estimated cost for this scope of work is \$200,000. If no remedial work is completed, the building will continue to deteriorate, and annual inspections will be required until these issues are solved.

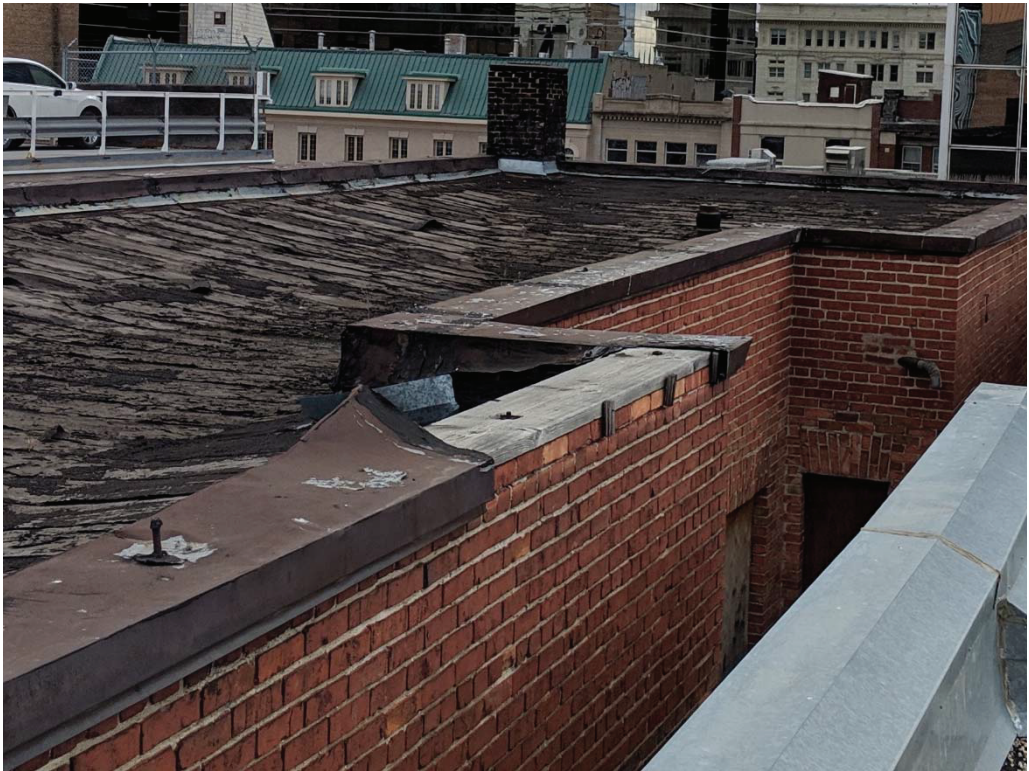
12. The parapet cap flashing was damaged over the entire roof and was missing in one location, Photo 16.
13. The west brick parapet was bowed outward above the cornice, Photo 17. The parapet flashing above this location was damaged, Photo 18.

Photo 16: Missing parapet cap flashing

The bowed parapet wall along the west side of the building is a result of water infiltration through the damaged cap flashing and freeze-thaw action. This parapet poses a risk to pedestrians below and should be repaired and repointed. All parapet cap flashing should be replaced to reduce water infiltration and damage to the masonry.

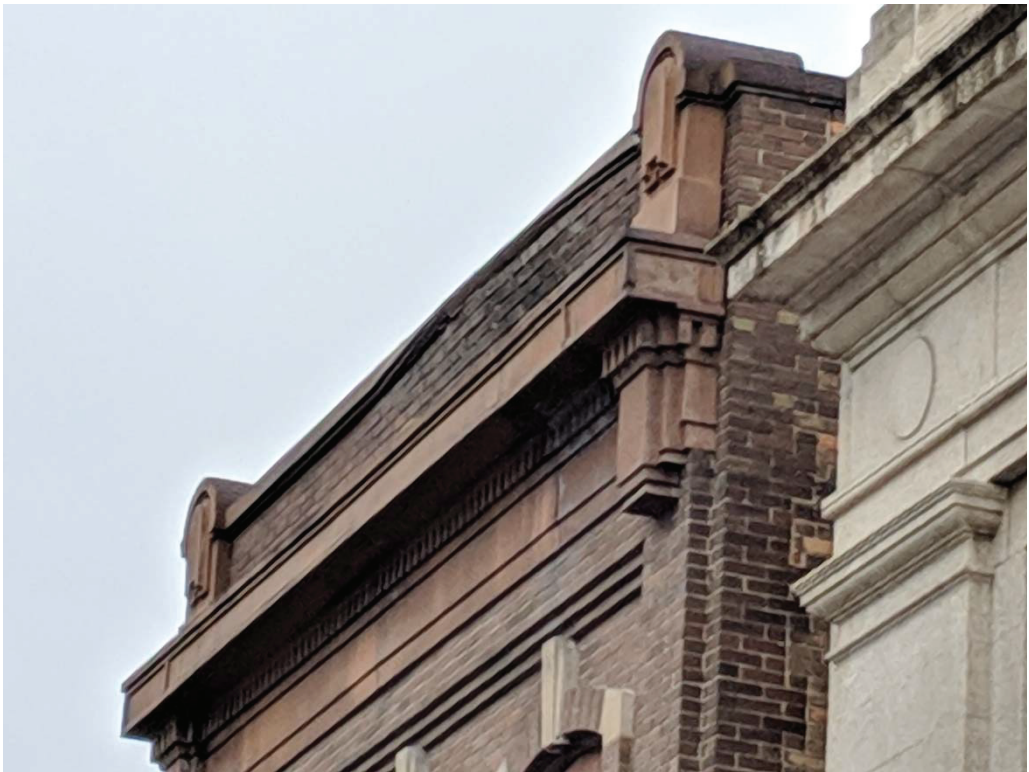
Photo 17: West parapet bowed outward

The condition of the parapet and cornice are a hazard and need to be repaired as soon as possible. We recommend that a mason is hired to repair these areas, as well as check the brick faces on the north and east exterior walls for delamination, and repointing of all deteriorated mortar joints, cracks, and holes around the building. The estimated cost for the masonry repairs is \$25,000.

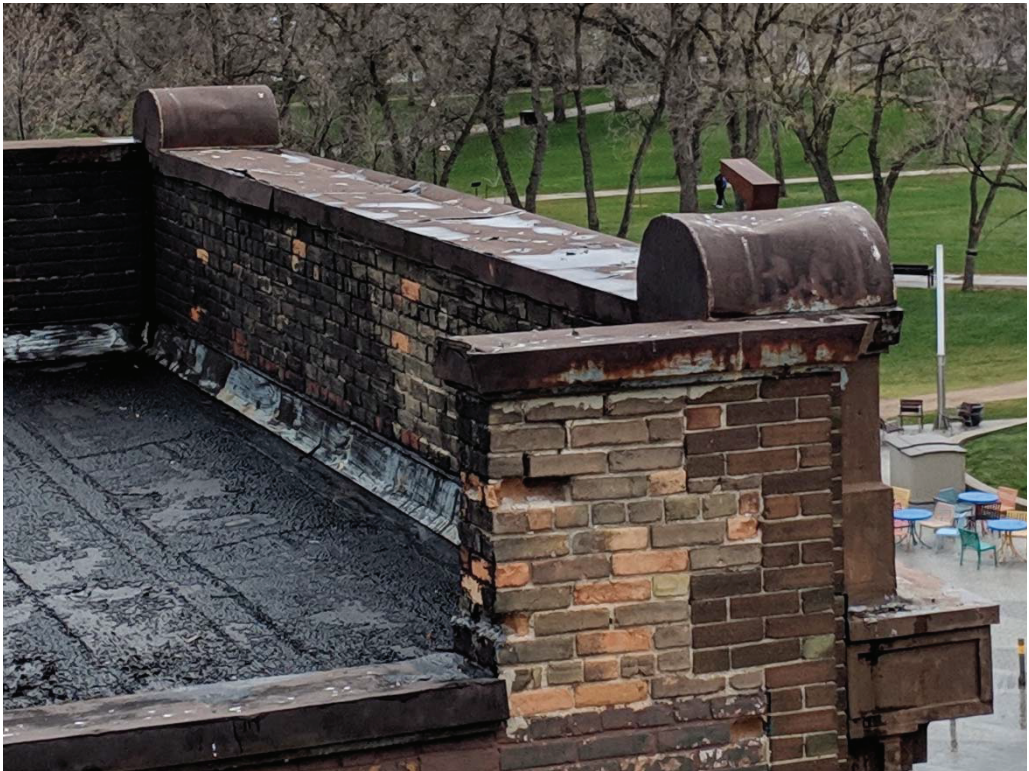
Photo 18: Damaged cap flashing over west parapet

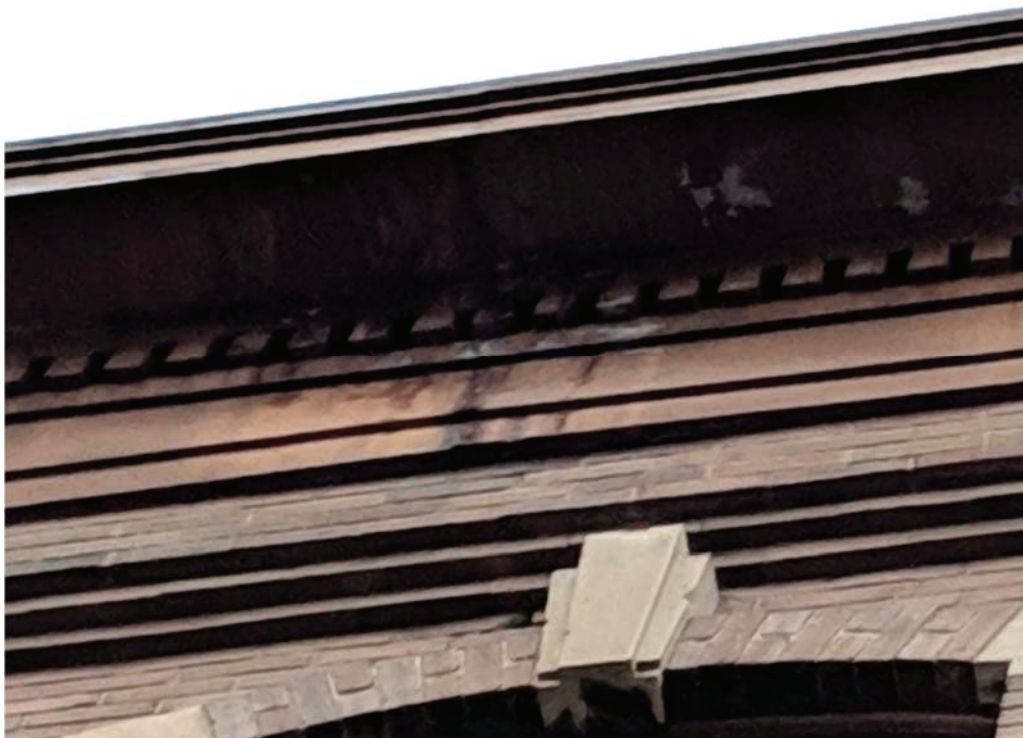
14. The front cornice displayed signs of corrosion with peeling paint, Photo 19. The side of the cornice appeared to be deteriorated, Photo 20.
15. The exterior brick had deteriorated mortar at the chimney, Photo 21.

The corrosion on the west cornice is due to deterioration of the flashing and its joints. Holes and deteriorated joints in the cornice flashing could allow for rot in the wood supports of the cornice and pose a risk to pedestrians. The cornice flashing should be repaired and sealed to ensure the integrity

Photo 19: Corrosion and peeling on underside of cornice

of the cornice and prevent further deterioration.

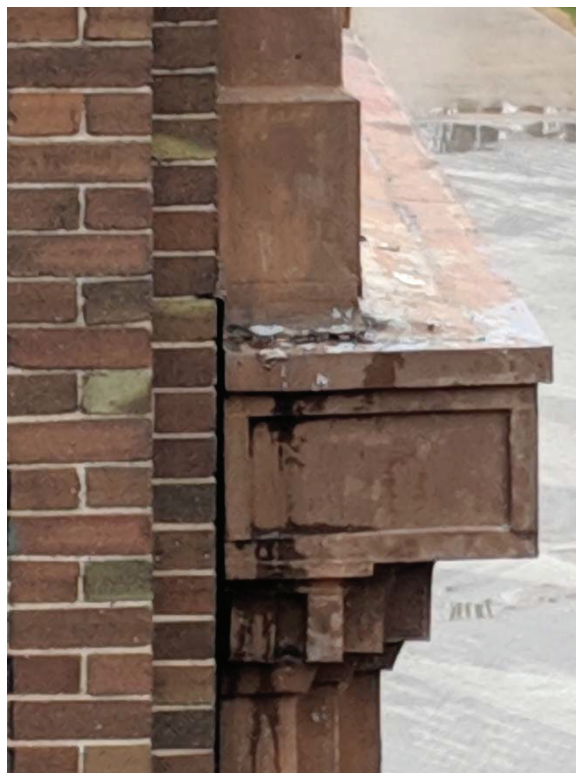
Photo 20: Deteriorated top edge of cornice

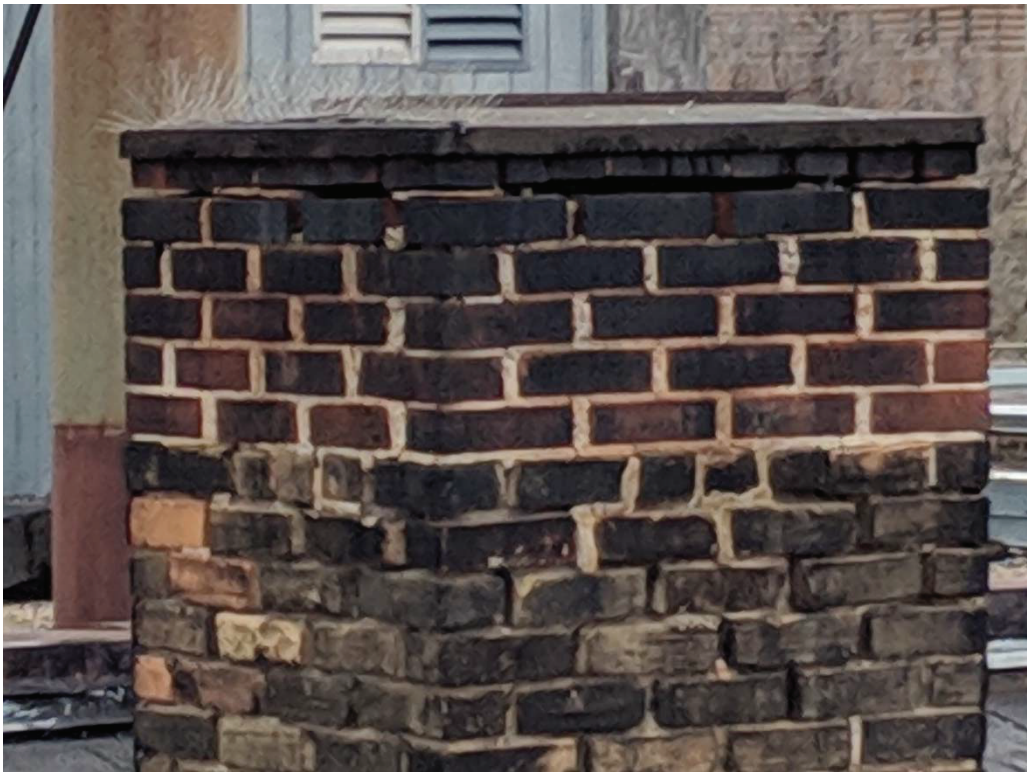
The weathered mortar joints around the chimney are normal due to environmental exposure but require repointing. The various cracks and holes around the building should be repointed as well to prevent further water infiltration and freeze-thaw damage.

Photo 21: Deteriorated mortar on chimney

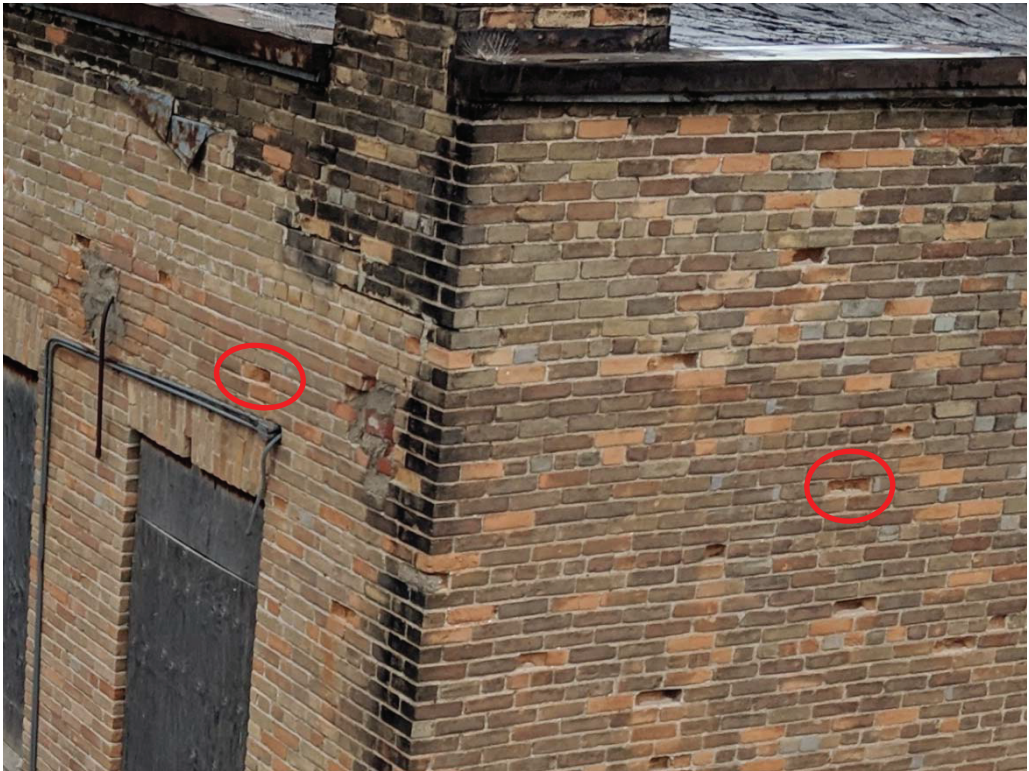
16. The exterior brick on the north and south faces of the building has spalled off in many locations, Photo 22.
17. The brick on the east and west sides of the tile mosaic between the first and second floor in the front of the building had a vertical crack, Photo 23. The mosaic tile at this location was also cracked.

The spalled brick along the north and east sides of the building is a result of freeze-thaw damage due to moisture saturation. The spalling of the exterior brick will be an ongoing issue if the building is to remain unheated. The spalled brick on the east side of the building is a risk to parked cars and pedestrians and should be examined by a mason. Any loose brick fragments should be removed. The brick along the north side of the building should also be examined by a mason to prevent damage to the roof of the adjacent building.

Photo 22: Spalled brick on north and east faces of building (Circled in red)

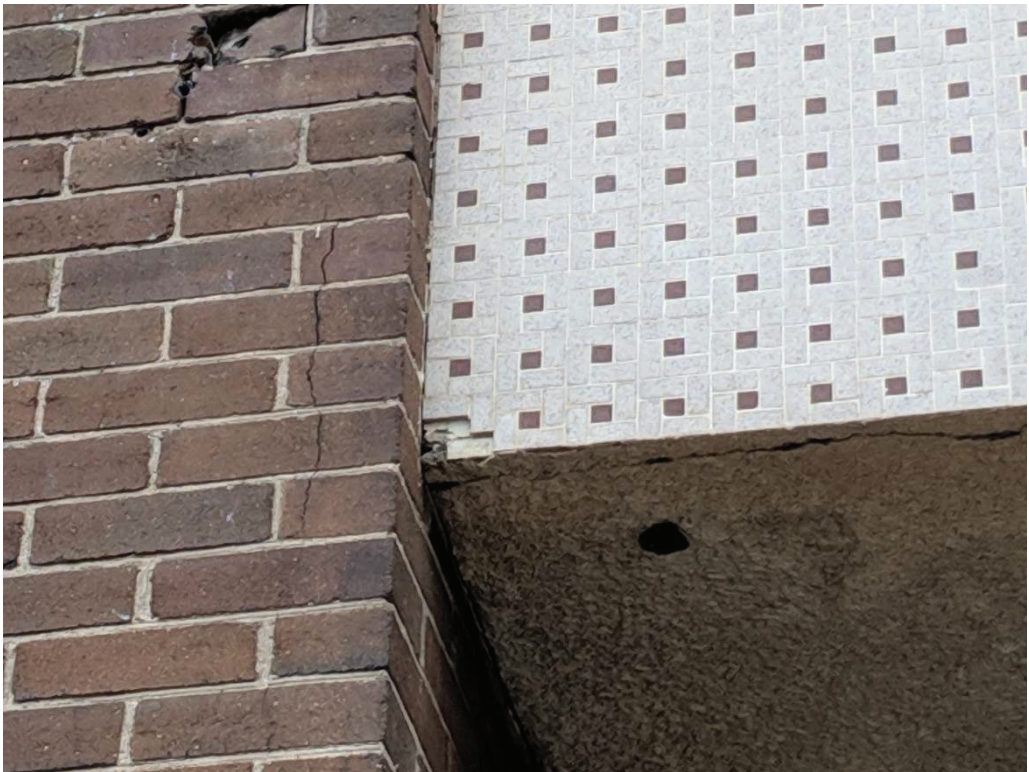
Photo 23: Cracked Brick and exterior tile

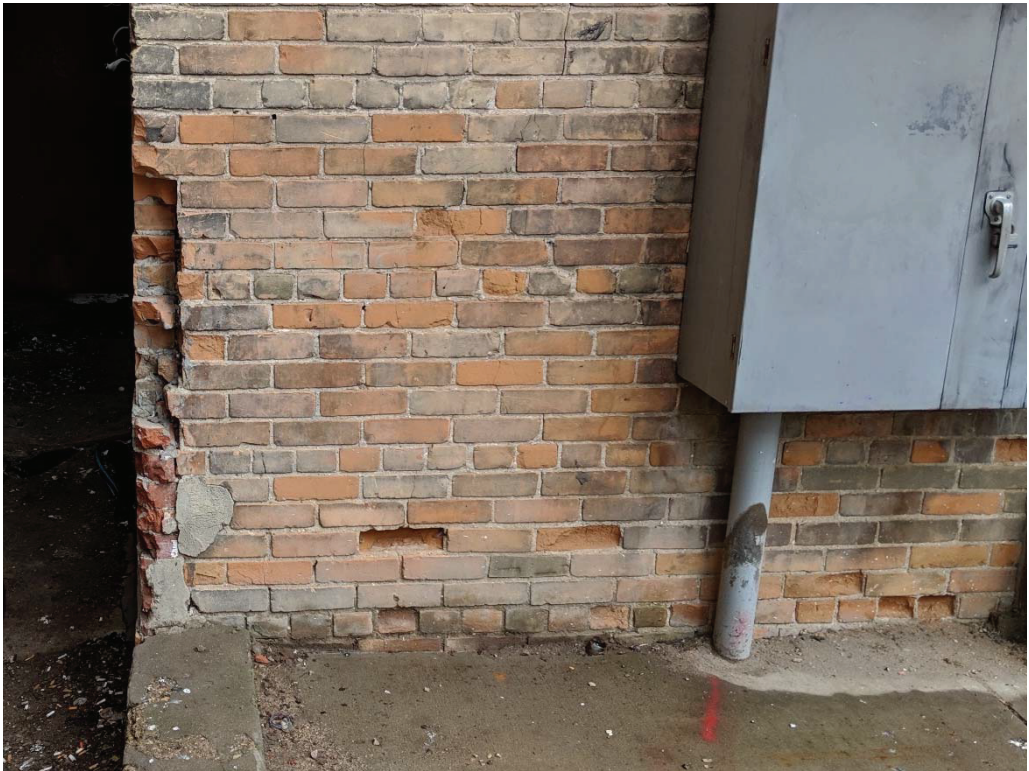
18. A few partial-depth holes were located in the exterior brick walls around the building, Photo 24.

Photo 24: Spalled brick and hole in southeast corner of building
