LEADER BUILDING

1853 HAMILTON STREET, REGINA, SK

CONSERVATION PLAN

MAY 2021

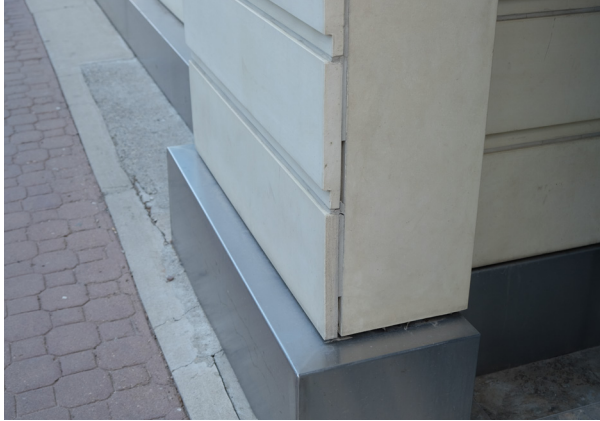
Additionally, the arched front entrances have been altered to have a flat top. The partially restored storefront is presumably constructed with terra cotta cladding. This area is in poor to fair condition, with several instances of mortar deterioration (figures 5.3.1 & 5.3.3).

The terra cotta appears to be in fair condition, with a few units cracking and some mortar joints requiring repointing (figures 5.3.1, 5.3.2 & 5.2.5). Currently, the exterior bricks are painted white. The brick façade appears to be in overall poor condition, with several instances of step cracking and mortar deterioration. Additionally, The brick walls appear to stagger vertically in areas of the south and east façades. The brick masonry should be inspected in further detail, as the current paint on the façade could potentially be obscuring some of its condition. Special consideration should be given to the implementation of weepholes in addition to vertical and horizontal control joints for compartmentalization to control water and air movement within the wall system.

Figure 5.3.1 Mortar missing in numerous masonry unit joints

- Review brick masonry condition and repoint the brick façades
- Repairs to the terra cotta façade should only utilize materials specifically designed for terra cotta repairs. It is important that any material with greater compressive strength than terra cotta not be used for repairs.

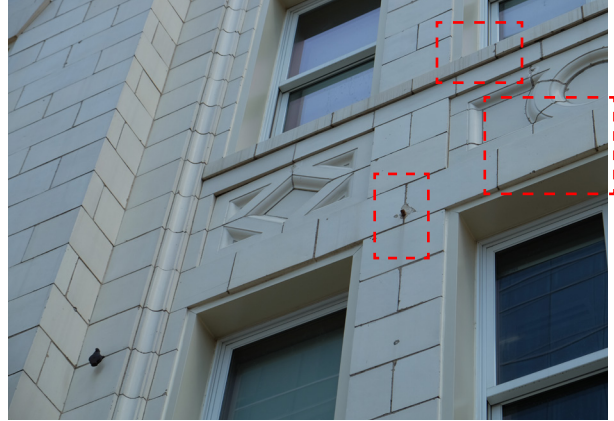
Figure 5.3.2 West terra cotta façade; outlining spalled and chipped terra cotta units.

- Should there be any terra cotta blocks that are irreparable, a replicated terra cotta block with the same cream coloured glazing, identical molding and profile should be used to replace the existing block. Terra cotta repairs should be undertaken by skilled masons with knowledge of terra cotta conservation.

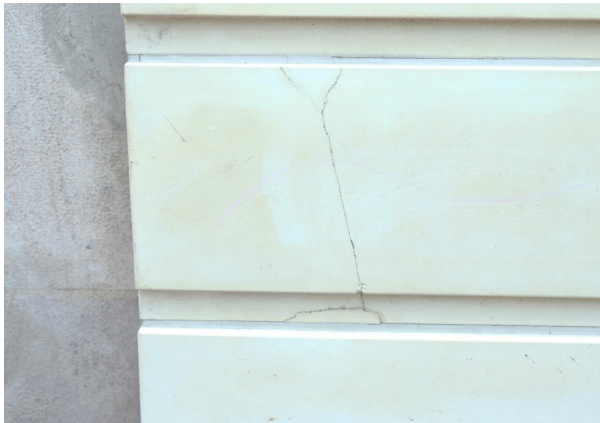
Figure 5.3.3 Cracked masonry unit to be repaired or replaced.

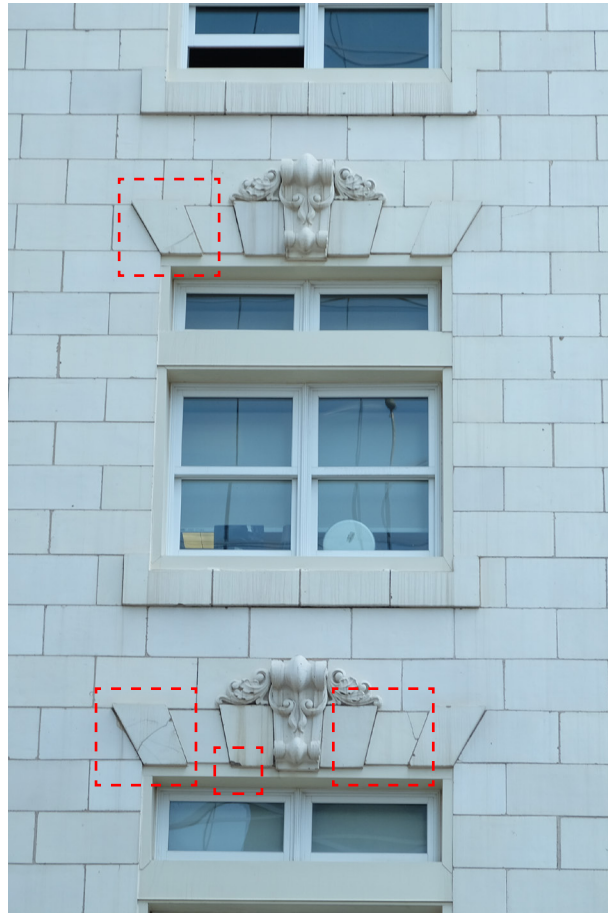
Figure 5.3.5 West terra cotta façade; outlining cracked and spalled terra cotta units

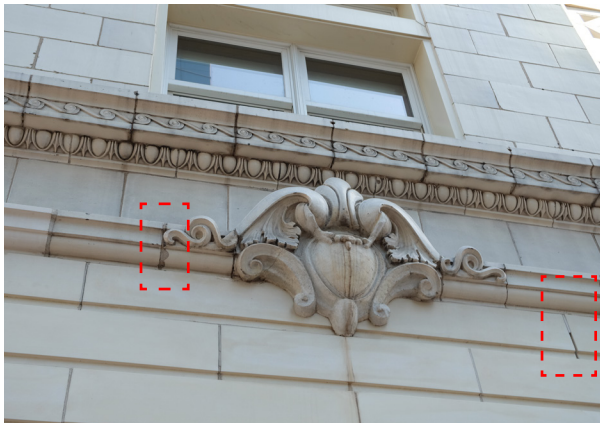
Figure 5.3.4 West terra cotta façade; outlining spalling, stained masonry, gaps and cracks in mortar

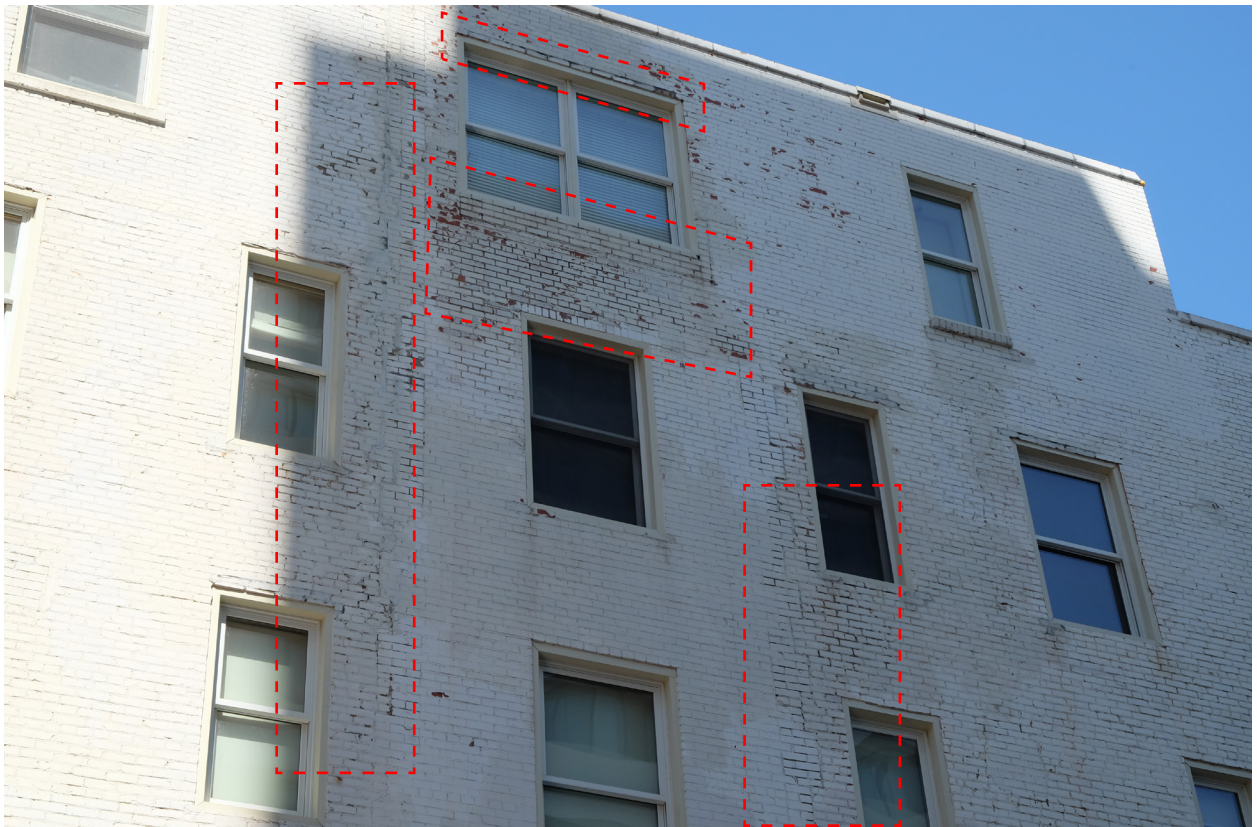
Figure 5.3.5 Mortar and brick cracking on south façade, particularly at the previously infilled portion (not limited to the areas outlines in red)

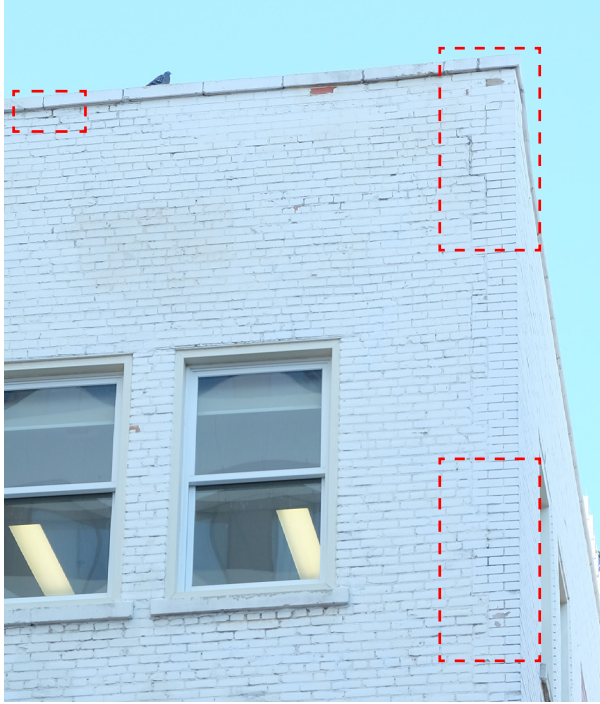
Figure 5.3.6 South façade; outlining instances of step cracking, spalling and mortar deterioration.

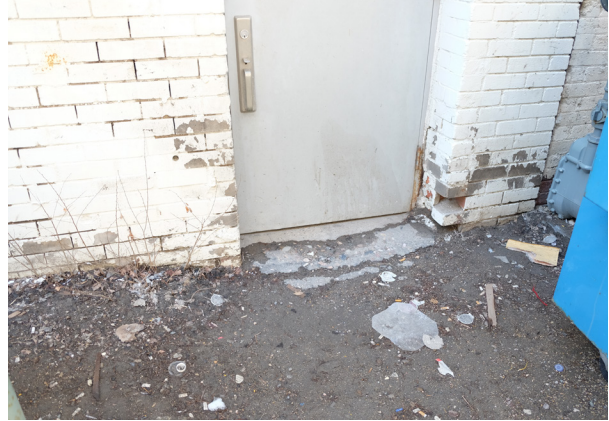
Figure 5.3.7 Discolouration and deterioration of brick masonry at the ground level.

- Weepholes in addition to vertical and horizontal control joints to be implemented.
- Remove paint off brick masonry at earliest possible opportunity using gentlest means possible.

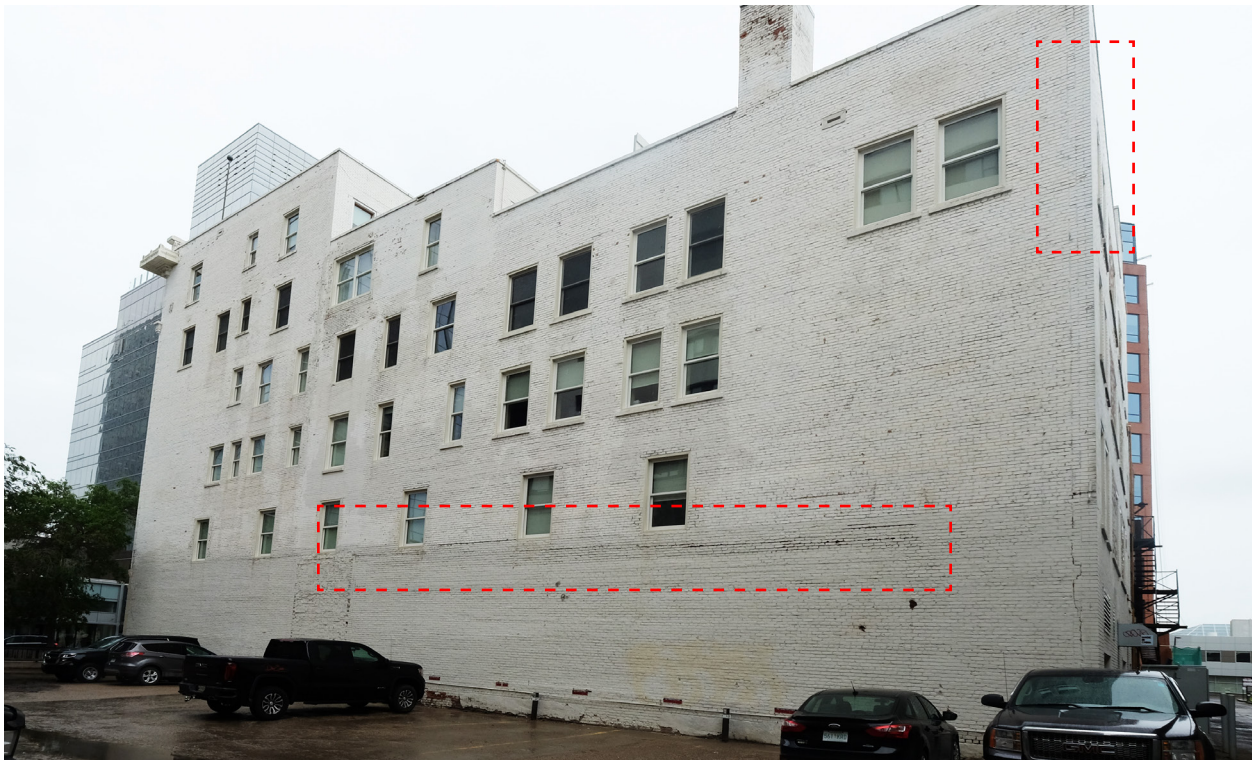
Figure 5.3.8 South brick façade, outlining areas of the façade where brick staggers vertically. Brick above windows at the southeast corner appears to be bowing and pulling away from the structure (right dashed outline)

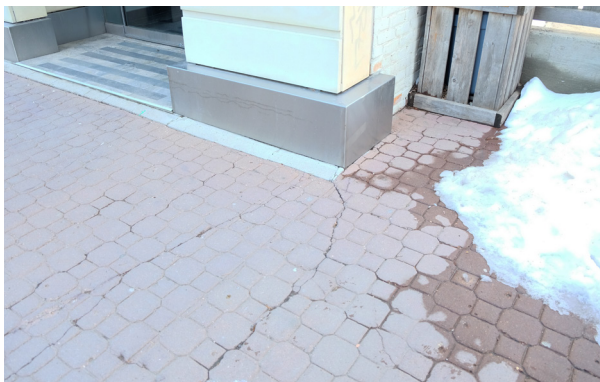
Figure 5.3.9 Cracking sidewalk at southwest entrance.

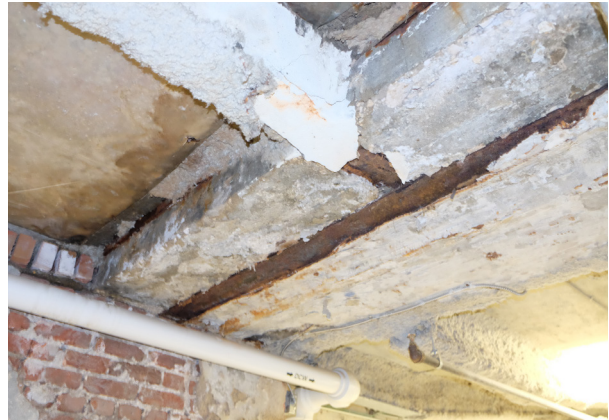
5.3.10 Concrete crumbling off of rusted steel beam

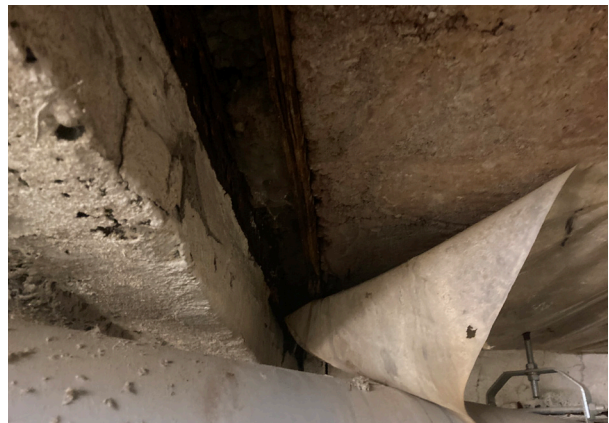
Figure 5.3.12 Membrane has peeled off of concrete slab, rusted steel beam exposed

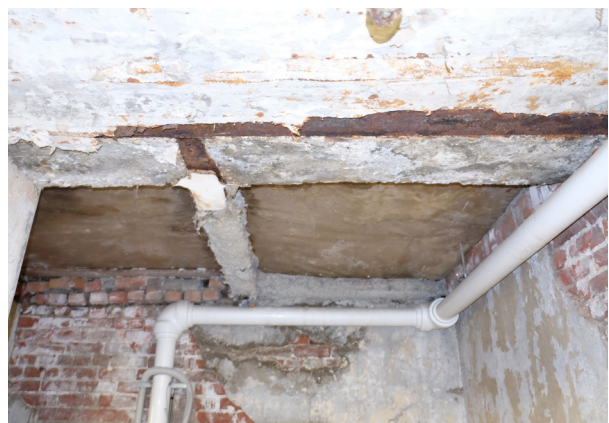
The existing northwest brick foundation walls are deteriorating due to water infiltration from the sidewalk above. It is critical to remediate and replace the deteriorated elements to prevent further damage to the structural integrity of the building.

Figure 5.3.13 Loose bricks at foundation wall (looking west), discolouration and deterioration due to water infiltration.

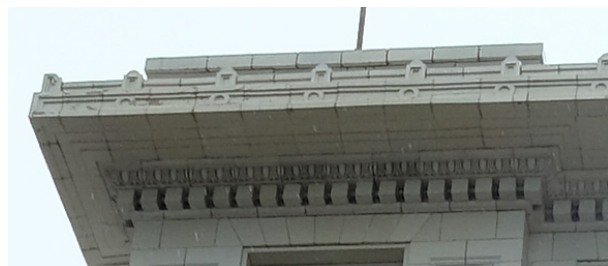
Currently, the west cornice is in poor condition as there is evidence of water infiltration through significant staining along the width, which also indicates its structural integrity could be compromised. The plan to remediate this is to remove and reconstruct the cornice as it is critical to stabilize its structure. The terra cotta on the parapet and cornice must be replicated and restored in the structural remediation to maintain the character-defining element of the building. The cornice is currently wrapped with mesh to prevent loose material from falling.

Figure 5.4.1 Ornamented cornice showing signs of water penetration

- Stabilize the deteriorated structure until the repair work is undertaken.
- Once scaffolding is erected, inspect the condition of masonry. Fully document the existing cornice and parapet and use the existing physical elements to accurately reproduce them.
- Create mock-ups of any recreated masonry elements prior to installation.
- Determine the cause of water infiltration.
- Improve any faulty details of roof elements that may be causing the water infiltration.
- Protect adjacent terra cotta elements from any accidental damage during repair work.

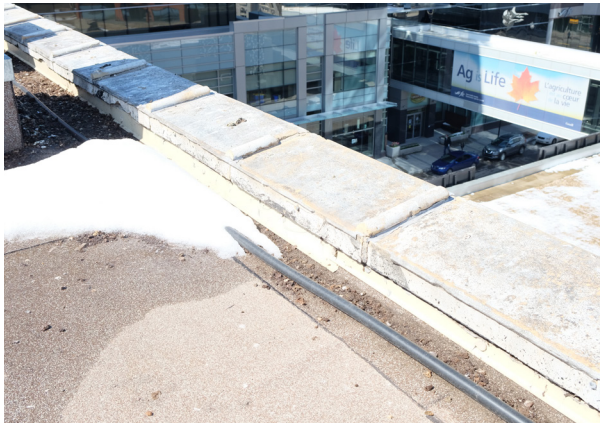
The east portion of the roof is now a patio for the residents of the building, with an exterior wood stair leading to the top storey of the front building via the centre portion of the roof. The general concrete parapets (figure 5.4.2) around the building are in fair condition, with a bit of surface staining. The east patio has an additional wall construction that is in poor condition and should be investigated and potentially redesigned as it could potentially be trapping water between it and the existing parapet.

Figure 5.4.2 Painted concrete parapet

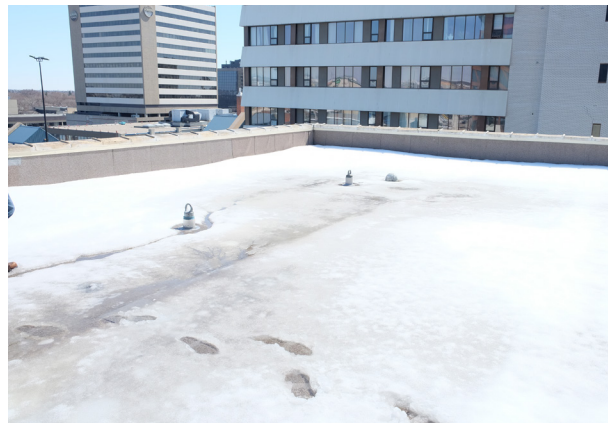
The Leader Building currently has three levels of flat roofs since the enclosure of the lightwell. The west and middle roofs are an SBS Modified Bitumen Roofing System, and the east roof is a raised paticblock over presumably an SBS system. The elevator shaft penthouse remains on the front building, with its east, south, and west façades clad in aluminum siding. Overall, the general roofing system is in fair condition. That being said, the roof appears to have an insufficient drainage system, and should be monitored for any failure throughout its remaining lifespan (approximately 5-10 years).

Figure 5.4.3 West SBS Modified Bitumen Roofing System

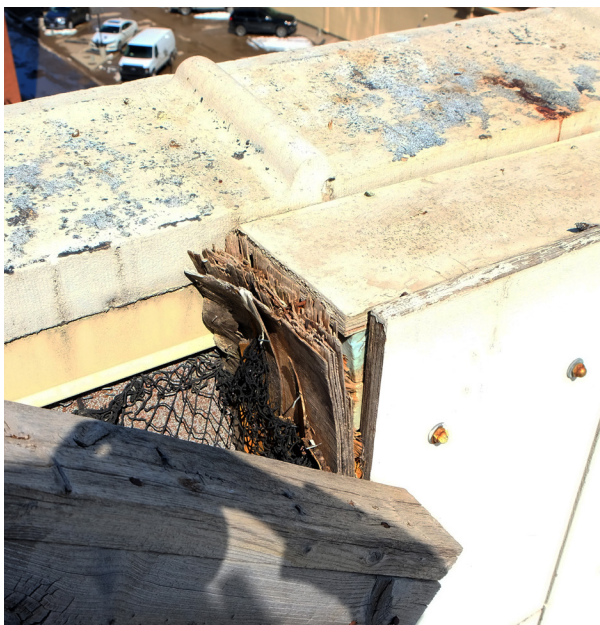
The parapets at the east roof patio should be investigated for potential water infiltration. The existing wall construction on the interior could potentially be trapping moisture between it and the parapet. Overall, the roofs are in fair condition but should be monitored for any failure.

Figure 5.4.4 Wall construction of the interior face of the parapet on the east side of the building

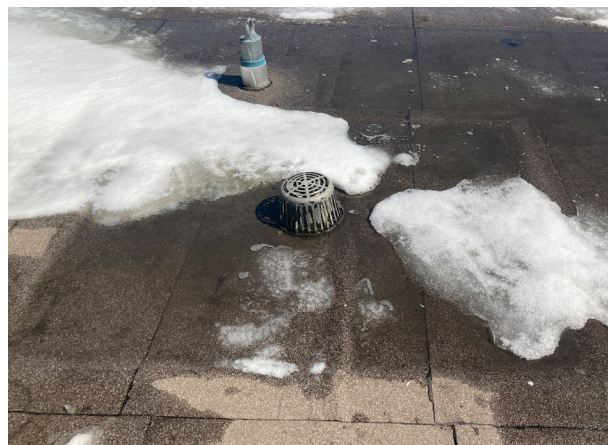
Figure 5.4.5 Roof drain is not located in the center of the roof which makes drainage less efficient. Ponding appears like it might be possible with ridges noticed in the top layer of the roofing.

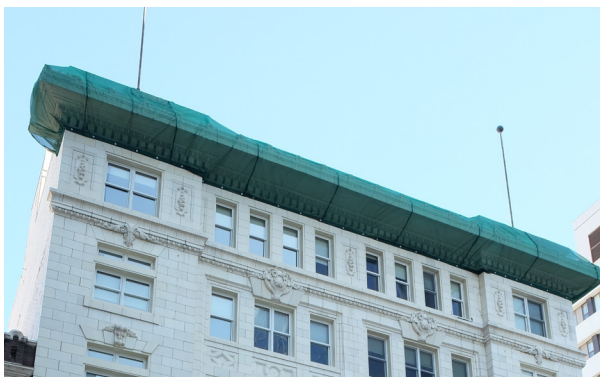
Figure 5.4.6 Cornice has been wrapped in netting as a preventative measure

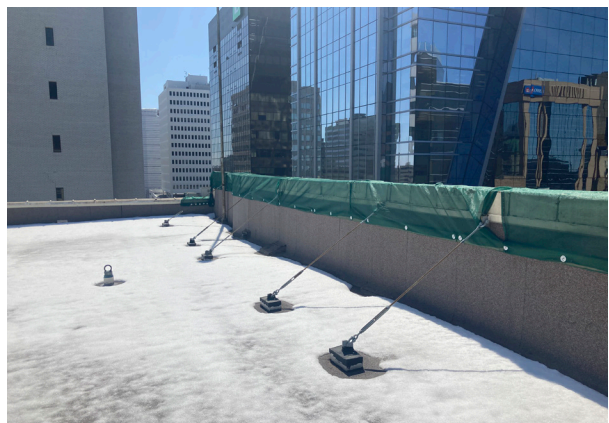
Figure 5.4.7 West parapet anchored onto roof

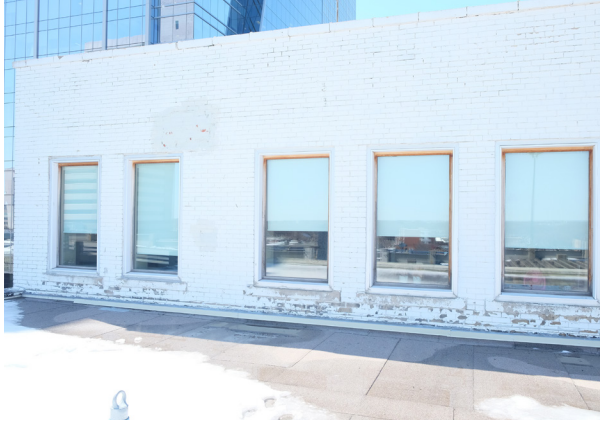
Figure 5.5.1 East elevation at the sixth level showing wood frame windows.

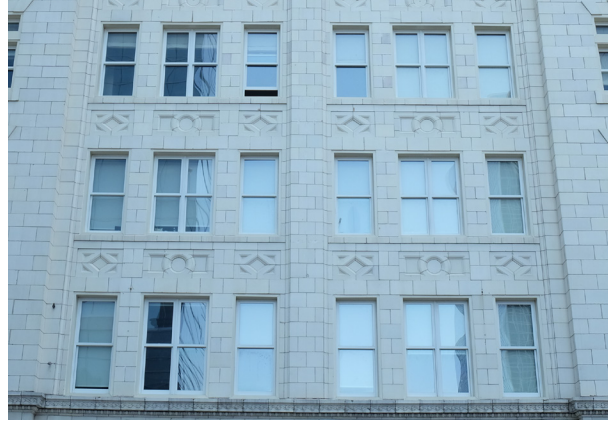
Figure 5.5.2 West elevation windows; levels 2-4. The majority of windows appear to be PVC (Polyvinyl Chloride) and should be replaced with wood windows when replacement is required.

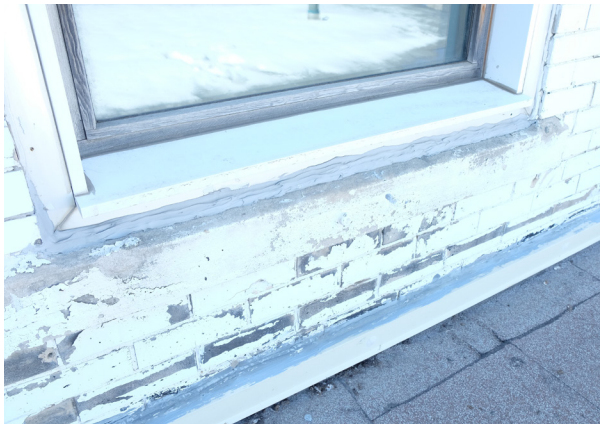
Figure 5.5.3 Some joints at the window sills on the upper east façade have been caulked over. Could mean that window replacement is required.

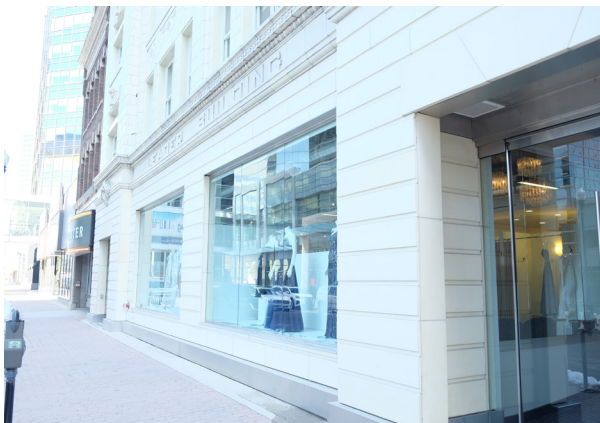
Figure 5.5.4 Storefront windows appear to be in good condition.

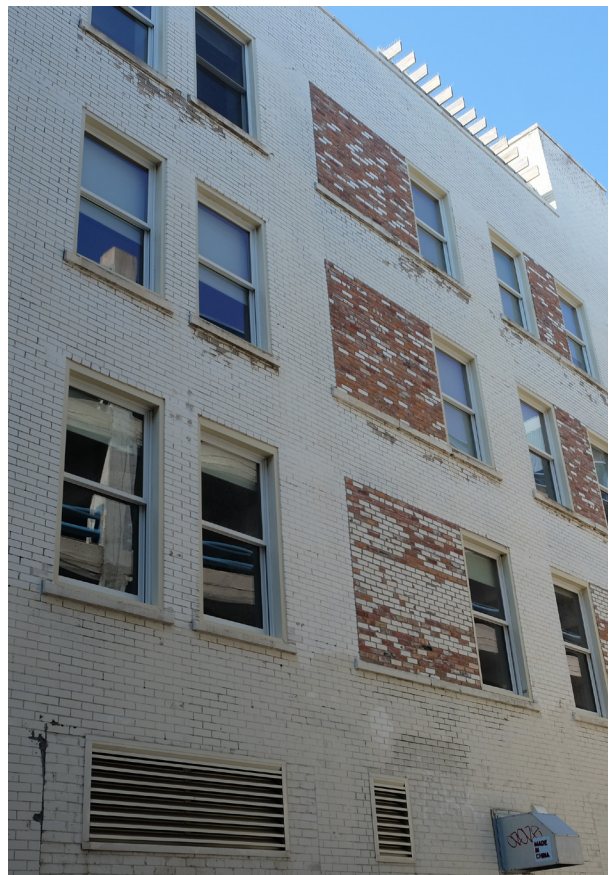
The window sills at the east façade are discoloured which means there is possible water infiltration occurring. This should be investigated further to determine if a full window replacement is required.

Figure 5.5.5 Potential water infiltration at the east elevation windows is evident from the discolouration at the concrete window sills.
