## Heritage Conservation Plan for Henderson Terrace, 3038-3060 18th Avenue, Regina, SK.

Prepared for: The City of Regina  
Prepared by: Jessica Gibson, Designer  
August 01, 2018  
Project Number: 1828

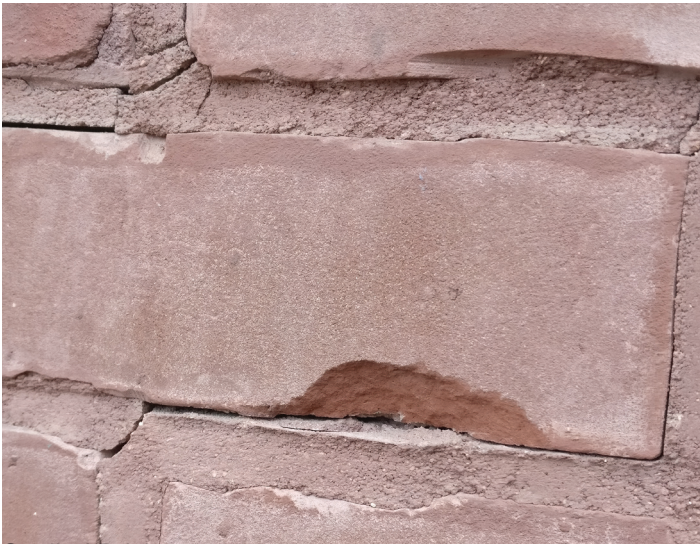
The existing brick on the east, west and south facades are in generally good to excellent condition with limited spalling, cracking or overall degradation. The few spalled bricks that exist have been face patched with mortar. Some small areas of brick have been painted a red colour that is close to the existing brick. There are signs of differential movement and cracking throughout all four facades, though the south-east corner shows the most movement. The brick on the south-west corner above the basement window was removed, repaired and replaced at some point in the past. This repair was done poorly and incorrectly, brick appears to be missing, the mortar joints are large and the overall visual is inconsistent.

Spalled Brick

Though the majority of the face brick is in relatively good condition there are a number of points where the masonry will require repairs in order to prevent further degradation of the facade. It is recommended that a structural engineer who specializes in historic masonry is consulted at the time of the masonry repair in order to ensure that the masonry is removed and repaired in a manner that is appropriate.

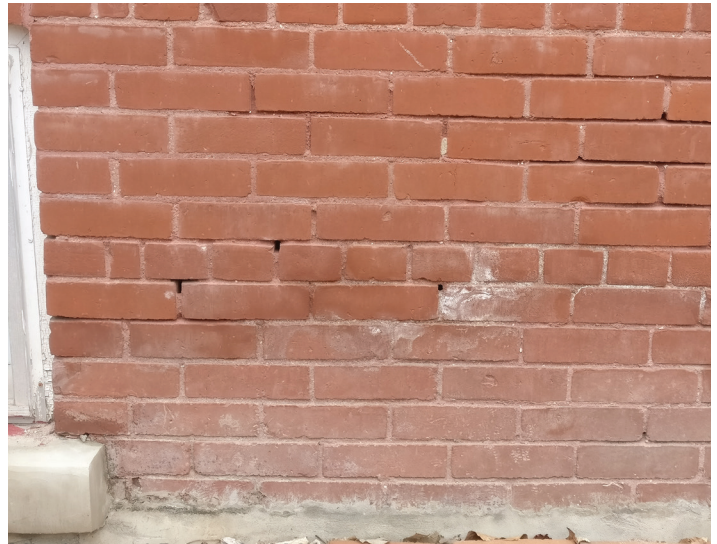
Missing and Degraded Mortar

Throughout the west and south facades the mortar was found to be deteriorated or missing in multiple locations. The mortars in these locations were also sandy to the touch and disintegrated easily. Multiple previous repointings were done with incorrect mortar types, some of the mortar appears to be of a portland cement mixture, while others appear to be of a much softer mortar type. A full repointing of all brick facades is recommended. Prior to repointing a third party mortar assessment and brick compression test is to be completed and submitted to the City of Regina Heritage Department for approval and review. An appropriate and matching mortar will be chosen for construction based upon the results of the mortar assessment. The new mortar shall match the original in strength, colour and tooling. All deteriorated and incorrect mortar types will be removed by hand raking, and a test panel will be completed by the contractor in order to demonstrate all aspects of the repair procedure for the repointing of the face brick.

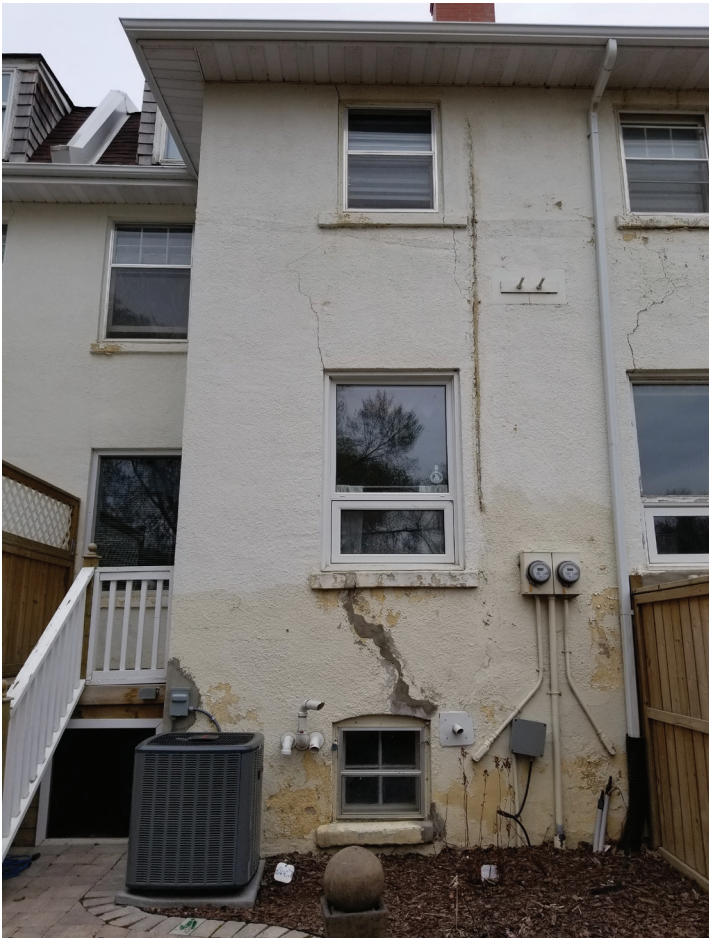
The north stucco has numerous cracks due to differential movement and settling of the building over the years. Multiple patches have been applied to the stucco, and do not match the colour or texture of the existing.

Stucco Cracking and Patching North Facade

The north facade brick was covered with a white stucco of an unknown age, and over the years the stucco has become a part of the heritage value of the building due to its inherent history. It is recommended that the stucco is retained and repaired appropriately. Over the years a number of patches have been conducted on the stucco to mitigate cracking, these patches do not match the original stucco in either type, texture or colour. The incorrect patches should be removed carefully in order to mitigate damage to the remaining stucco as well as the heritage brick below. It is recommended that the existing stucco on the north facade is assessed for composition, and new stucco patches should match the existing in strength, texture and colour.

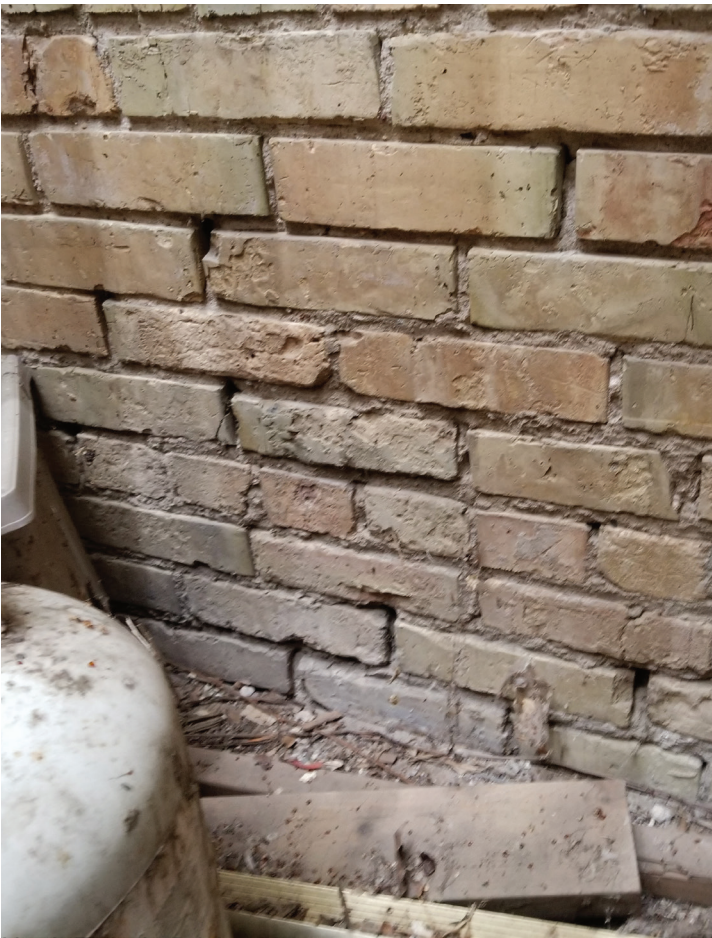
North Facade Brick

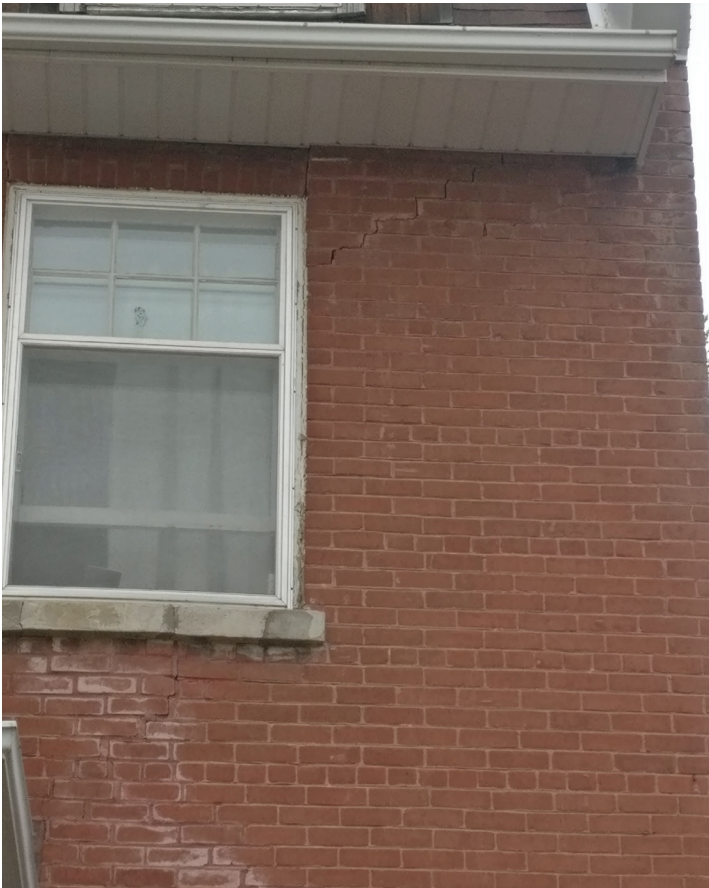
The south face of brick is experiencing some pushed face brick, primarily at window headers and at areas where the porch roof ties into the face brick. The majority of mortar joints have been re-pointed or repaired throughout the years with a variety of mortars. The re-pointed mortar was done poorly with mortar overlapping the top and bottom of the brick. On the west and south-west facades the mortar shows extensive degradation with multiple areas having mortar missing. The mortar was sandy to the touch, and was rubbed away easily.

Mortar Patching and Pushed Face Brick South Facade

Where the brick is showing pushed face brick, the brick will be removed carefully by hand and retained in order to reveal the cause of the pushed brick. The causation of the push brick should be determined by a structural engineer specializing in historic masonry. If the brick is pushed due to the rust jacking of the steel lintel or header this will require the removal of rusted areas, as well as potential replacement steel where required if the steel is deemed to be damaged for lasting repair. If the pushed brick is due to excessive compressive loading, or the brick is no longer securely attached to the backing structure then further investigation and solutions will be required in order to mitigate the issue. Retained brick will be reset with mortar that is compatible and matches existing historic mortar types that were utilized.

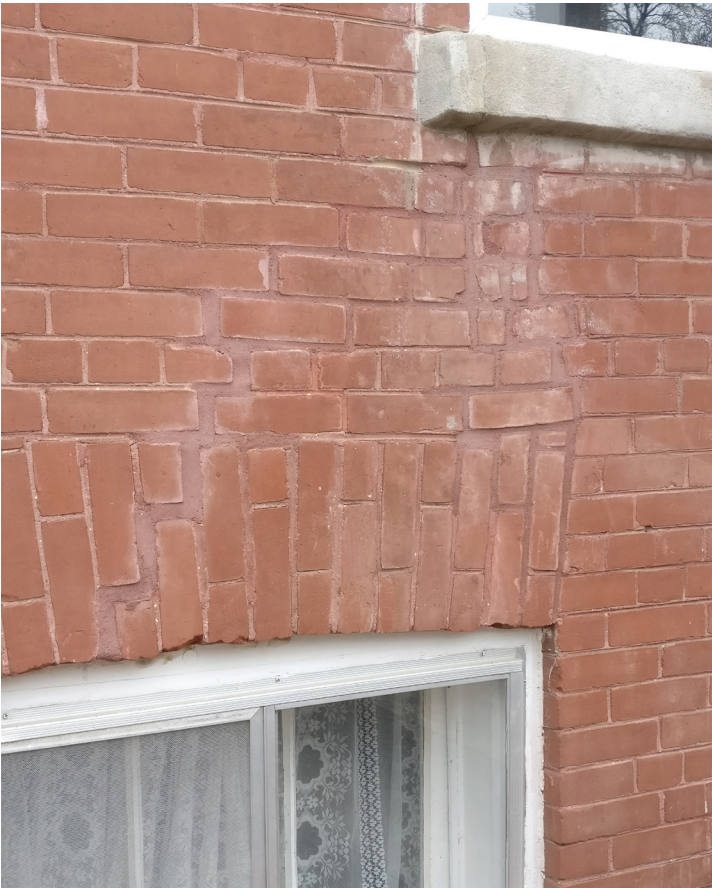
Incorrect Brick Repair South Facade

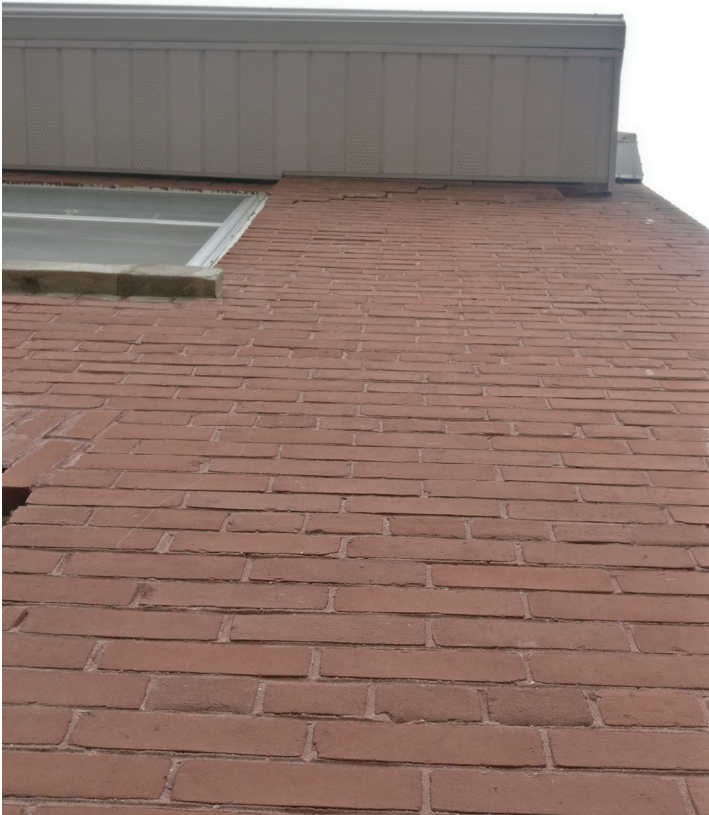
Pushed Face Brick

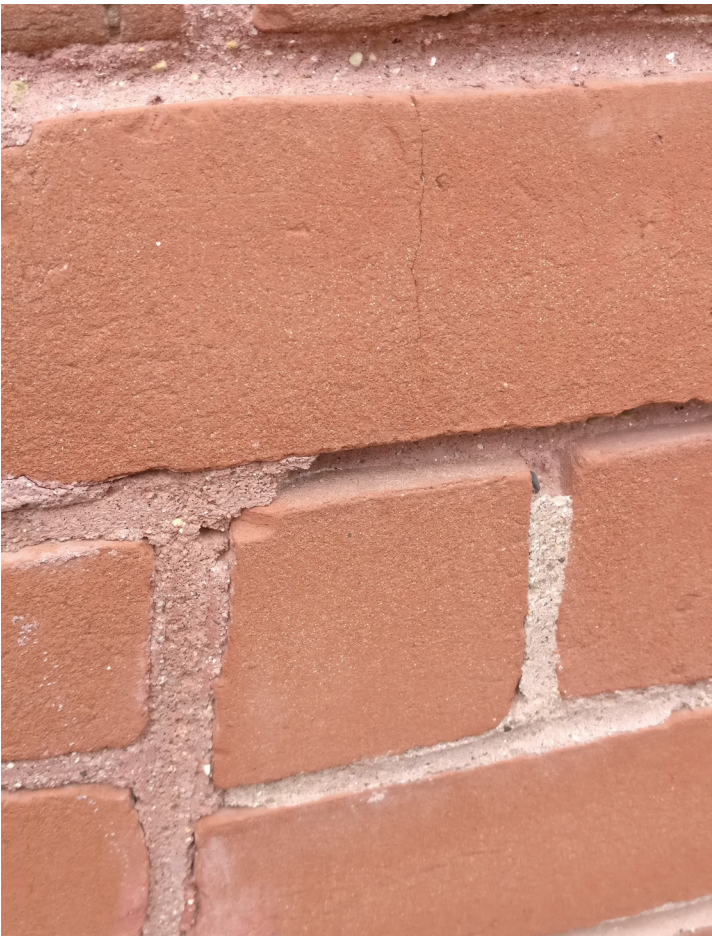
Repointing with Different Mortar Types

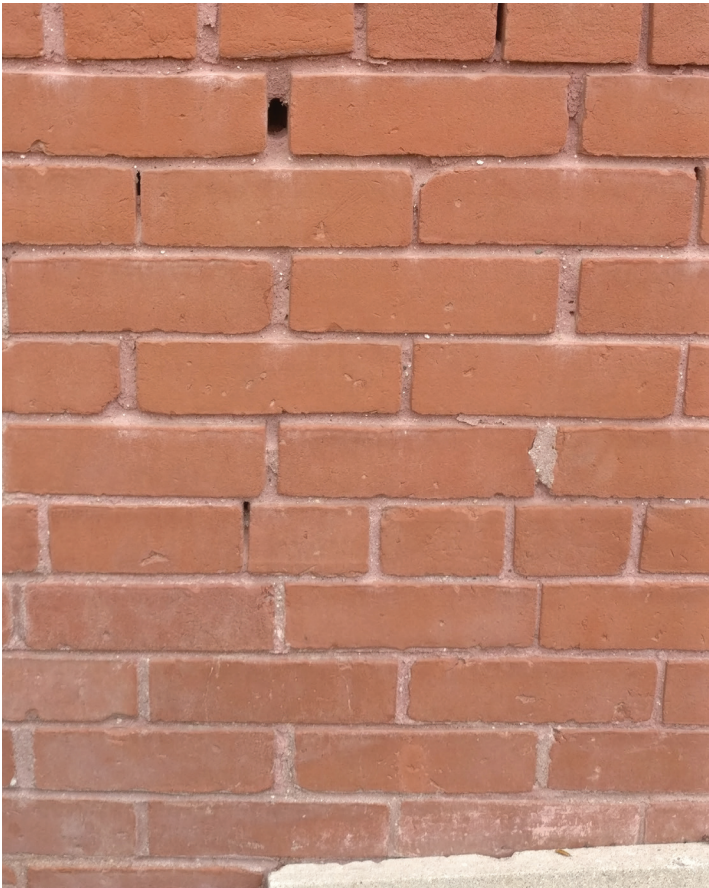
Repointing with Different Mortar Types and Missing Joints

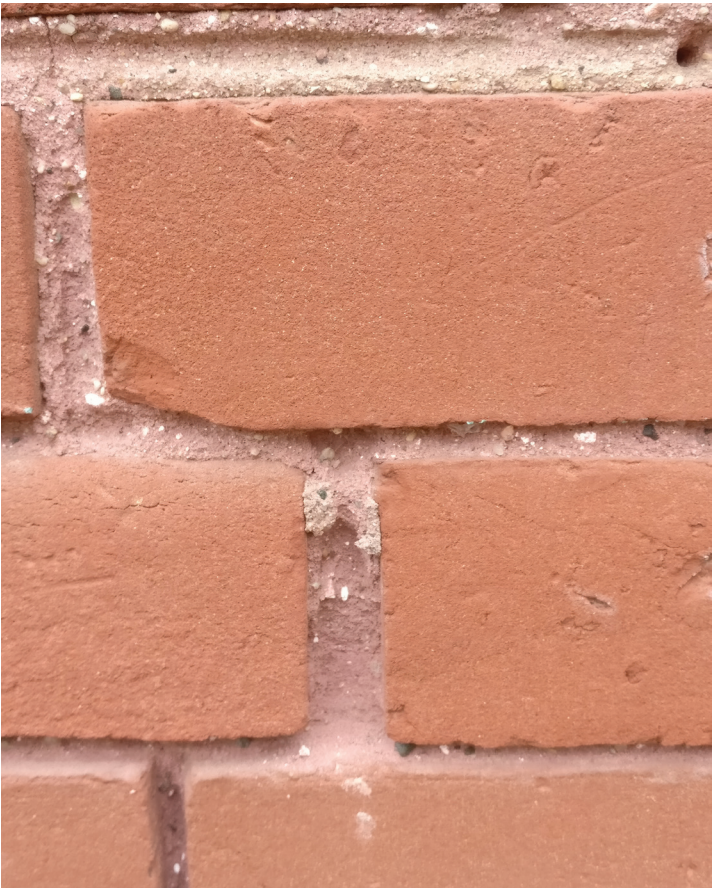
Mortar Sandy to the Touch

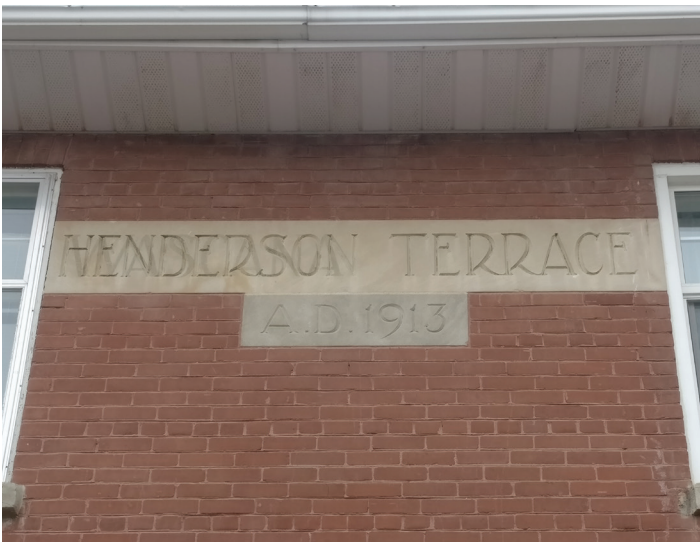
The sandstone nameplate on the south facade of the building is in good condition with limited visual wear. A previous inscription of 'Wascana' is visible to the eye under the name 'Henderson'. This does not affect the heritage value or state of the sandstone nameplate.

Sandstone Nameplate

The existing sandstone name and date plates are in good condition and no further remediation is recommended at this time.

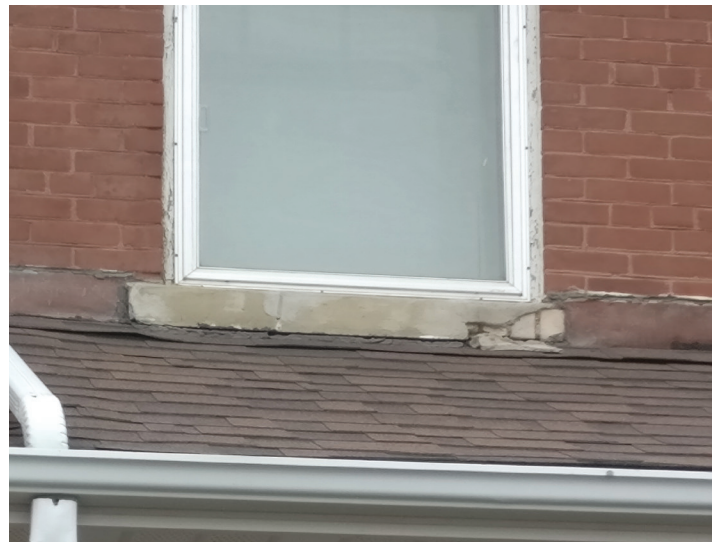
The initial heritage description of Henderson Terrace identified the window sills as being constructed of sandstone. As the years have progressed the sills have been identified as being brick with a concrete stucco overtop. This identification has occurred due to the degradation of the concrete stucco, which has cracked, chipped and spalled revealing the brick below. The brick sills are constructed of the same lighter coloured brick as the north facade and the basement. The existing sills are generally in moderate to poor condition, with the concrete stucco being cracked and in some places missing. The brick of the sills are in good condition and don't require extensive repair.

Missing Stucco on Sills

The masonry and stucco sills are in generally poor condition, with cracking, spalling and some missing pieces of stucco which have exposed the brick sill below. A full physical assessment of each sill is recommended in order to determine the full extent of damage. As cement stucco may have become unsound and partially delaminated from the brick, while visually appearing solid, it is imperative that each sill is inspected prior to repair. Third party stucco testing should be conducted in order to determine the original make up of the stucco. The new stucco shall match the original in strength, colour and tooling.

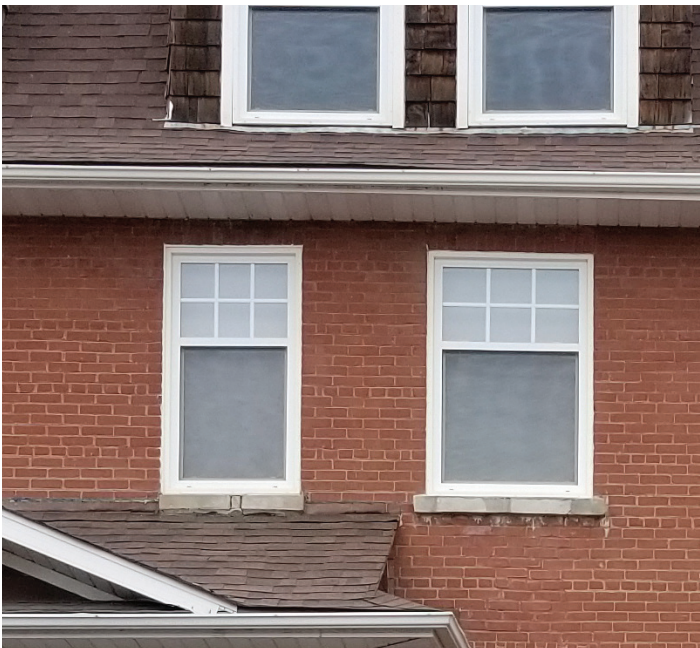
The original windows have been painted numerous times and are currently white. The new windows are predominantly white vinyl windows, some of which have decorative grilles to re-interpret the original 6 paned upper window. While the new windows are in general good condition they do not match the heritage intent.

New Second Floor Windows

The remainder of the second floor windows are replacement windows of varying ages and styles. Each window has a different lifespan, though most will not require replacement in the next 5-10 years. As windows are replaced it is recommended that the replacement windows are double pane window with either wood, or metal clad wood frames. If PVC or fiberglass windows are preferred, the supplier and window type should be approved by a heritage consultant, or by the City of Regina Heritage department in order to confirm conformity with the heritage intent of the building. The intermediary muntins on the window should be exterior muntins, internal decorative grilles are not acceptable alternatives.

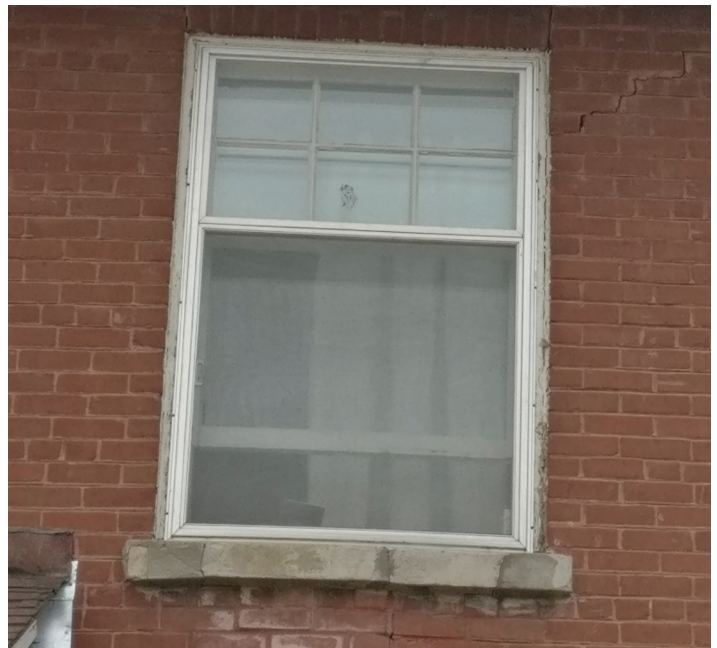
The second floor Windows are of varying ages and styles, with approximately 4 of the second floor windows being original. Vinyl storm windows have been installed on most of the second floor windows, including the four original. The original windows appear to be in good condition and operability, and consist of double hung windows with the lower window being a single pane of glass, and the upper window consisting of six panes with intermediary muntins.

Original Second Floor Window with New Storm Window

Approximately six of the existing second floor windows are original, four on the south facade and two on the north facade. Interior investigation of the windows was only available for one condominium unit, the remainder of the investigation was from the exterior of the building. The original windows that were inspected were in general good condition as the storm windows have helped protect the original frames and glazing. It is recommended that these windows are retained and repaired as necessary. In order to maintain these windows well into the future a full inspection by a contractor specializing in heritage windows is recommended, and a maintenance/repair cycle is determined at the time of inspection.

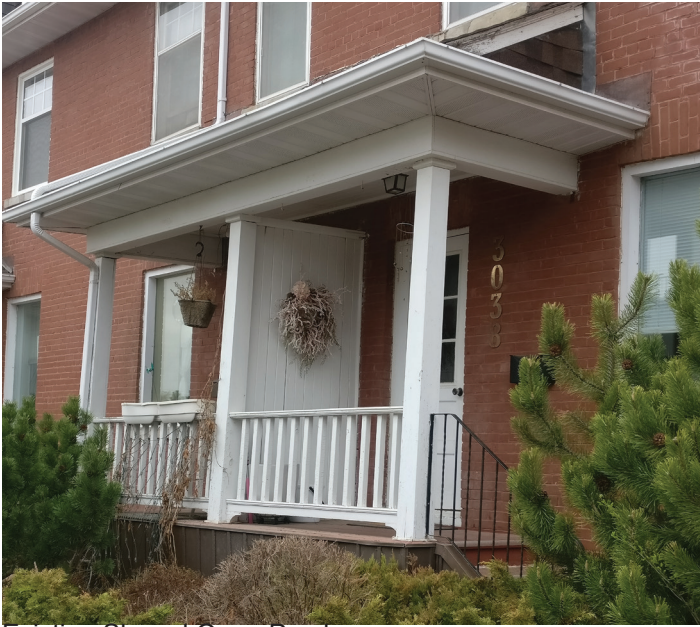
The existing shared, open porches are in generally poor condition and are pulling away from the face of the building, 1-2" of gapping was present at the time of inspection. The existing wood of the porch and railings are weathered with multiple layers of paint. Instability and rotting of the wood is present. The metal siding on the base of the porches is in general disrepair, and does not match the heritage intent of the building. The front doors are of varying ages, styles and materials.

Existing Shared Open Porches

Due to the movement of the porches away from the south facade of the building it is likely that the existing porches will have to be removed and re-built. In the instance that full replacement is required the original form and detailing of the existing porches are to be documented and the documentation is to be utilized as physical evidence as a model to reproduce the porches. Where feasible, elements such as the wooden railings should be retained, repaired appropriately, and re-utilized. A full assessment of materials and features that are to be retained and repaired is to be completed prior to removal. The replacement porches should utilize the same material palette of the existing, though it is preferable for the metal siding is replaced with wood in keeping with the historical material palette of the building.

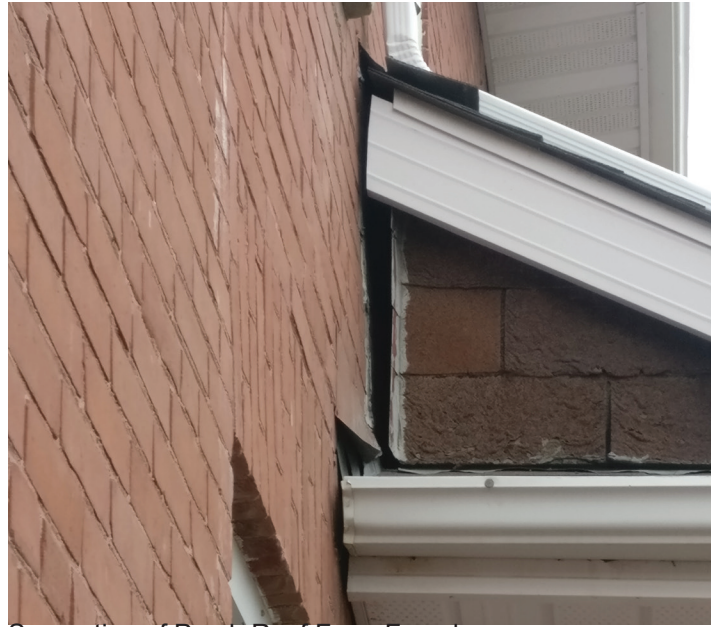
The porch roofs are in poor condition with multiple roofing, and flashing patches being done over the years. The existing shingles are in moderate condition, though the age of shingle is unknown. Based on a combination of archival photographic material of similar row houses in Regina, as well as on site investigation the porch roofs do not appear to have been original to 1913, and were potentially introduced in the 1970's. The original porches likely had no roof element, and the existing anchorage for the porch roofs is placing considerable pressure on the face brick of the south facade. The porch roofs appear to be contributing to the dispalcement of the face brick on the South facade, as the anchors and weight are pulling the face brick away from the structure.

Separation of Porch Roof From Facade

Though the existing porch roofs do not appear to be original to the 1913 building, they have overtime become a part of the heritage of the building and represent a substantial portion of Henderson Terrace History. The existing roofs require extensive investigation and repair work. It is recommended that a structural engineer who specializes in historic masonry is brought in to inspect the existing shared, open porches, the surrounding masonry, as well as the structural methods utilized to connect the porch roofs to the south facade. This inspection will help inform the methodologies required to stabilize and repair the surrounding masonry. A full report on the existing conditions and recommended remediation is to be carried out prior to repair. Architecturally it is recommended that the porch roofs are retained and repaired where possible. If the porch roofs are deemed to be beyond repair, or if the brick behind requires structural stabilization then the existing porches are to be fully documented and detailed prior to removal. In the instance that full replacement is required the original form and detailing of the existing porch roofs are to be documented and the documentation is to be utilized as physical evidence as a model to reproduce the replacement roof. The original material palette should be utilized, and the use of shakes as a roof cladding material should be considered.

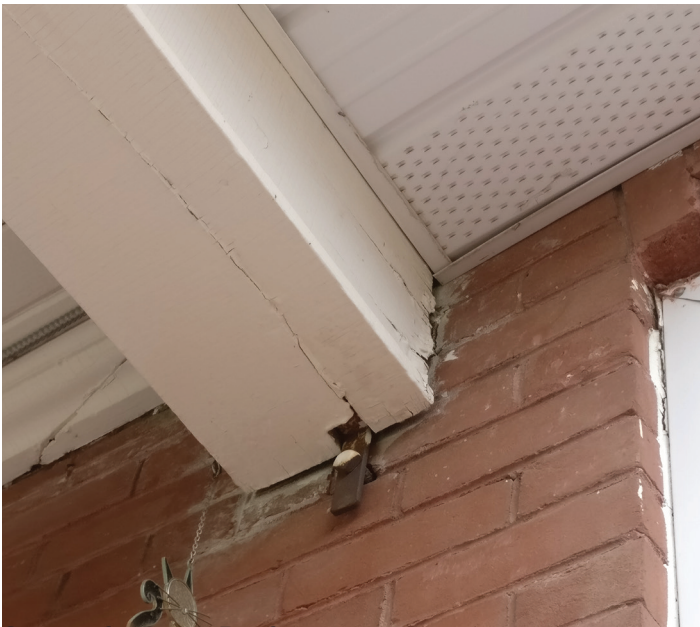
Support for Porch Roof

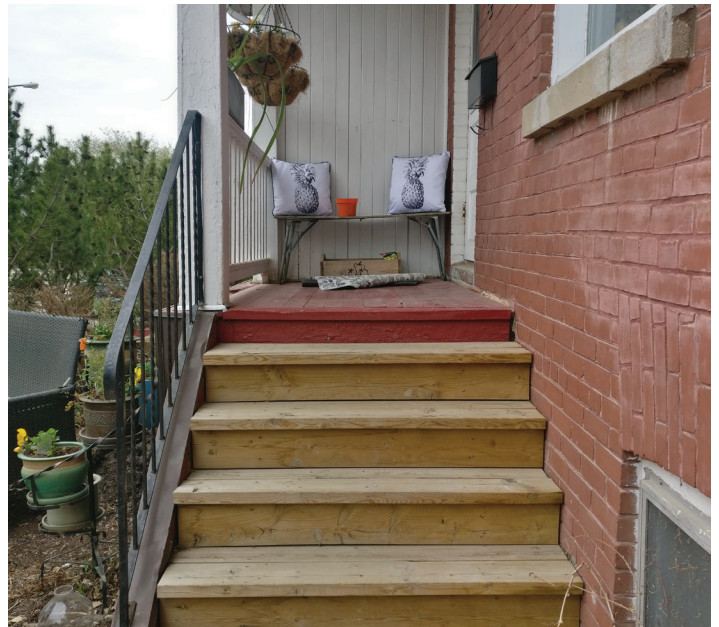
Stair Replacement

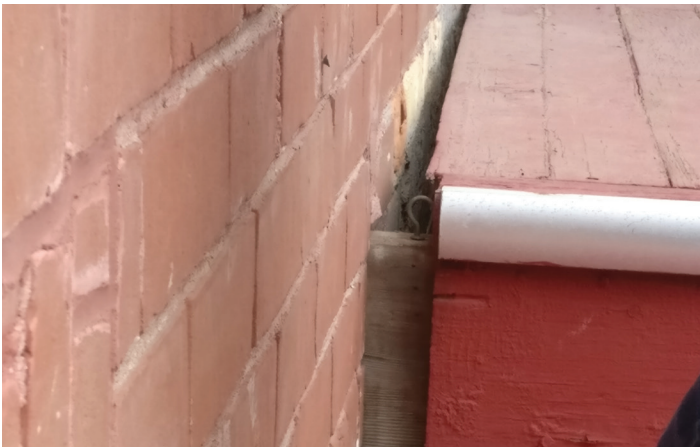
Separation of Porch From Facade

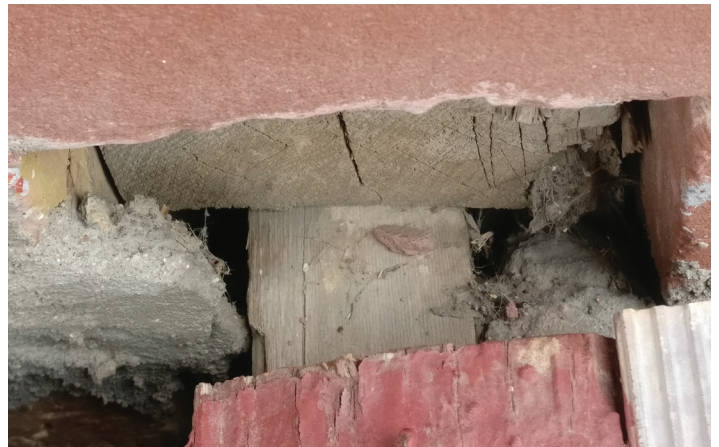
Existing Porch Support

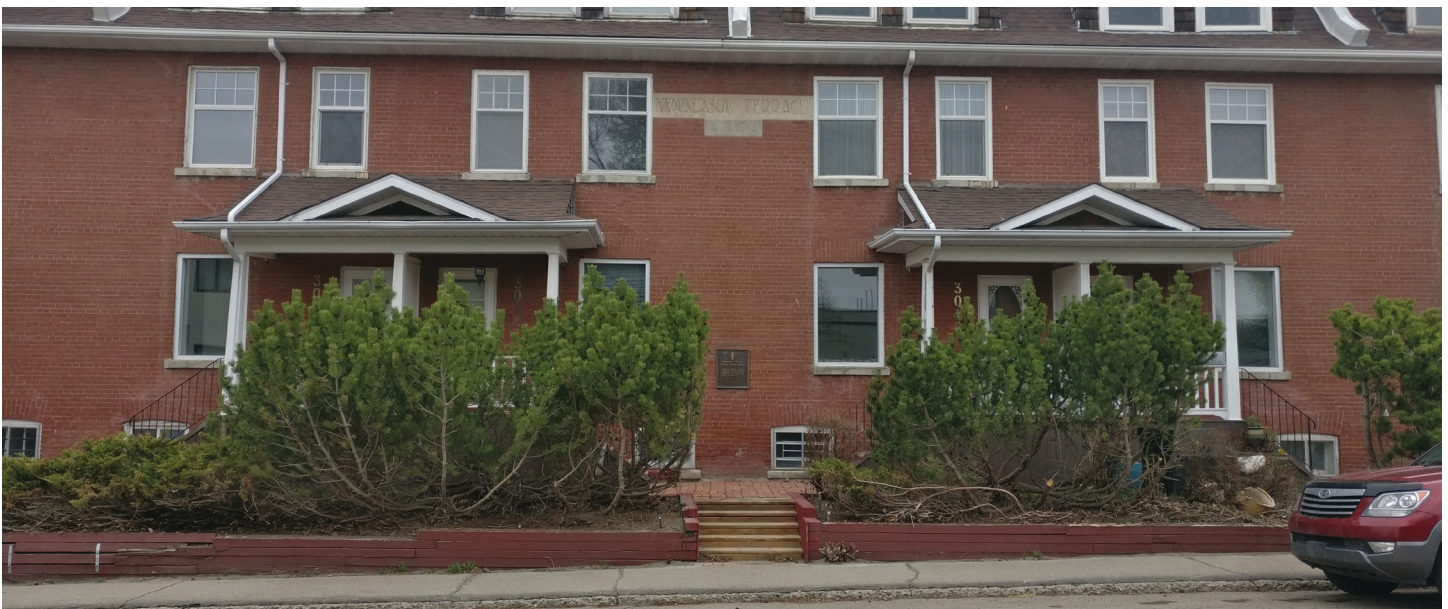
The existing landscaping of the south yards are varied in appearance with each unit creating it's own 'garden'. Much of the landscaping appears overgrown, with Mugo Pines and cedar shrubs being the dominant plants. Current landscaping was done in 1987. Earlier photographic documentation from the 1970's show a very simple landscape on the south facade, consisting primarily of lawn, with a few trees out front. Engineering reports from the 1990's recommended the removal of the trees on the east and west of the property due to the potential for structural damage of the basement masonry from tree roots. Trees to the south of the building were removed prior to 1988.

Existing Front Yard Landscaping

It is recommended that the existing landscaping is revitalized by appropriately trimming the existing plantings, and replacing any mugo pines that are too damaged to be trimmed and retained. Replacement shrubs should be considered in regards to the historical shrubs, ground cover and plants that would have been utilized for the Mawson Plan. It is not recommended to re-introduce trees to the front yards in order to continue to mitigate potential structural damage to the basement of Henderson Terrace.
