FINANCE AND ADMINISTRATION COMMITTEE

FA16-32 Heritage Building Rehabilitation Program Application for Tax Exemption - Frontenac Apartments 2022 Lorne Street

FRONTENAC

2022 LORNE STREET, REGINA, SK

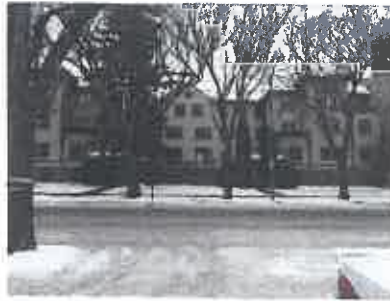
Condition Assessment		
Form, Scale & Massing	No significant alterations or additions have affected the building's form scale and massing and these aspects of the building are essentially original.

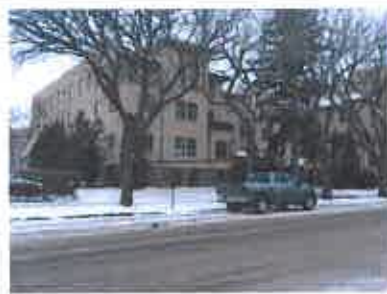
A low, flat-roofed two bay garage has been set within the north portion of the rear setback and is constructed of painted concrete masonry unit block. The base of the rear exit stair has been enclosed as a utility shed. These additions have not impacted the original building and could be removed in the future.

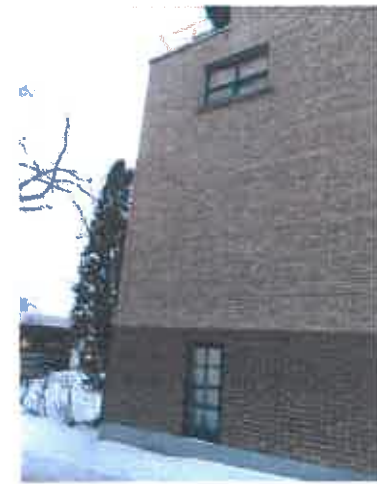
Front Façade Masonry

The original buff brick upper walls and red brick base masonry is in generally good condition, with some inappropriate tooling of joints evident in a few areas of past selective repointing.

Very minor rust jacking of some window steel shelf angle lintels is evident in the slightly expanded shelf angle bedding joint.

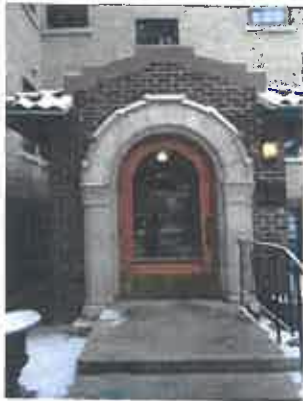
The major masonry issue is the foundation differential settlement which is or has occurred at the north projecting block, resulting in diagonal shear cracking at the northeast corner at the lane, at some window sill and headers on the east elevation and below the balcony on the interior courtyard elevation. The diagonal cracking is wide and suggests the foundation settlement is active. This structural instability will need to be remediated in the near future.

The projecting salient at the northeast corner of the building has differentially settled, resulting in significant and active shear cracks at stress concentration points, typically at corners of windows and top corners of the block. The structural engineers overseeing this aspect of the rehabilitation feel that this unstable foundation condition will continue if not remediated through a system of foundation underpinning. The diagonal shear cracks in the exterior wall will eventually undermine the structural integrity of the wall. The diagonal shear cracking in the exterior wall is obviously problematic from a water ingress perspective.

J.C. Kenyon Engineering Inc. have undertaken an assessment and remediation design (Appendix 1) and planned for a system of mini-piles beneath the existing northeast salient to arrest any further settlement. The diagonal cracking will then be repointed.

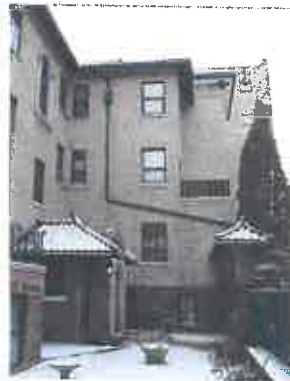
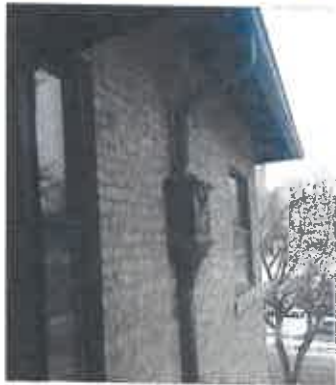
<p>The Tyndal Stone trim at doorways, window surrounds and sills is in good condition.</p> <p>There is evidence of some water ingress at the balconies; a new membrane surface at the balcony deck is required to address this.</p> <p>The buff brick masonry is not soiled in areas of high water run-off, below sills for instance, and is acceptably clean in its current state.</p>

<p>Sheet Metal/ Ornamental Iron Work</p>	<p>The roof drainage system, consisting of gutters, spigots, ornamental/functional conductor boxes, and downpipes have been kept in excellent working order with no leakage or blockages evident now or in the past. Past roof drainage failure is indicated by staining, efflorescence, and brick mortar joint deterioration at the area of a leak or blocked conductor box/down pipe. Some of the conductor heads require a preparation and painting.</p> <p>The original ornamental wrought iron railings on the upper and lower balconies are in good condition. One has been sheeted in with wood, but this detracting condition is easy to remedy through removal.</p>

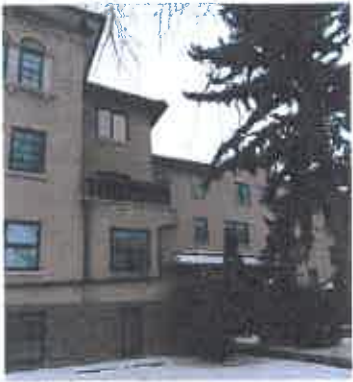
Red Tile Roof	The red clay tile roof surface is a distinctive feature of the building and in excellent condition.

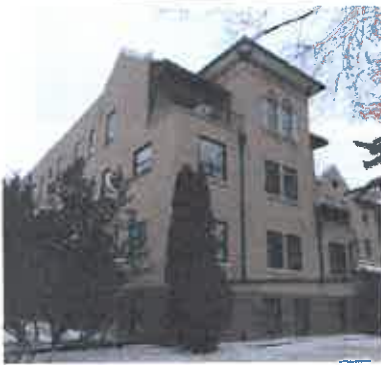
Wood Elements	The exterior wood elements include the wood roof soffit and associated wood soffit brackets, the upper balcony exposed wood framed roof and the expressive outboard exposed roof bracket and the sloped roof fascia boards. All of these elements have good weather-coats of paint and are in good condition.

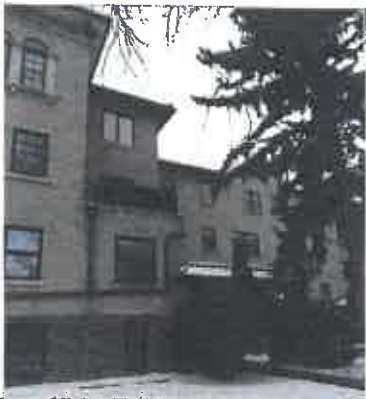
Front Façade Windows	Approximately half of the original wood muntined double hung and casement windows are intact and in fair condition. The sash joints in some sash have deteriorated over time from water ingress and exposure to the elements, resulting in loose joints and warping sash, but a most are in fair condition with some service life remaining. All of the original sash are protected with winter storm sash which have served to extend their service life and provide a higher level of winter season occupant comfort. Approximately 40% of the existing original wood sash will require replacement in the medium term. The existing wood frames are robust, painted and in good condition.

<p>Approximately 50% of the original wood windows on the front elevation, principally at the end blocks, have been changed out to new contemporary wood windows with double glazing. The window change-out has occurred within the last five years. They provide a higher level of occupant comfort and energy performance, but lack the heritage character of the muntined original wood windows. They are a blend of single-hung or lower slider operation.</p>

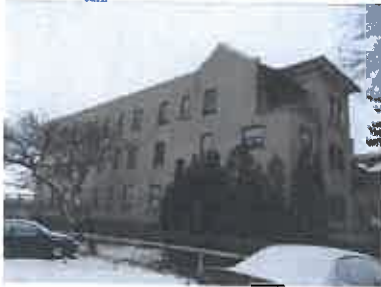
<p>South/North Windows</p>	<p>Approximately 50% of the south and north elevation windows are original wood muntined double hung or casement windows have been replaced with contemporary new windows, similar to the front elevation. The existing wood south elevation windows take more summer exposure and are in worse condition than the north elevation original windows. Approximately 55% of the south original window sash require replacement in the medium term and 30% of the north original windows require replacement in the medium term.</p>

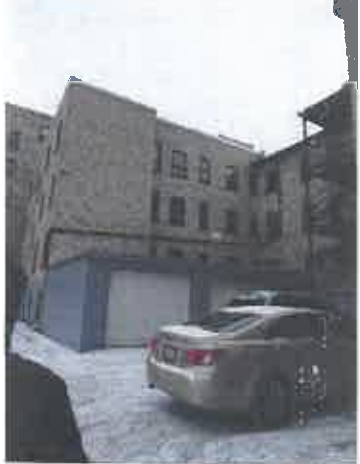
<p>Rear (west elevation) Windows</p>	<p>Approximately 30% of the rear elevation windows are original wood muntined double hung or casement windows have been replaced with contemporary new windows, similar to the front elevation. Approximately 35% of the rear elevation original window sash require replacement in the medium term.</p>

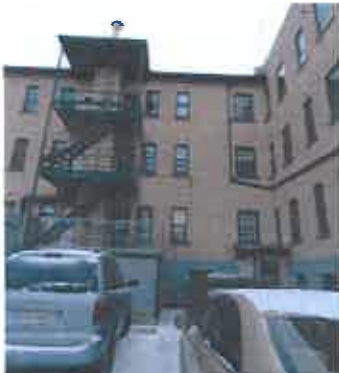
Rear Exit	The original wrought iron fire escape has been replaced with a newer vintage steel exit stair with a roof cover.

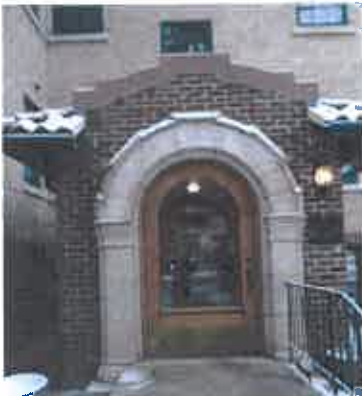
Entrances	The original residential entry vestibule pavilions set within the entry forecourts, clad in red brick and red roof tiles and trimmed in cut Tyndal Stone, are in good condition. The original varnished white oak round-arched exterior and interior doors with original hardware (pulls, kick-plate, hinges) are in good condition. A contemporary guardrail along one side of the entry landing is not strictly required by code, but is useful, especially for some of the aging residents.

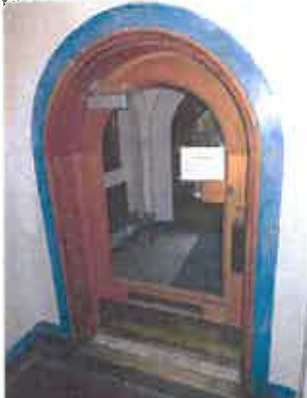
Entrances (cont'd)	Original tiled vestibule floor surfaces have survived in excellent condition. Small arched wood windows with original leaded lights and a vaulted plaster ceiling provide an interesting welcome to building visitors.

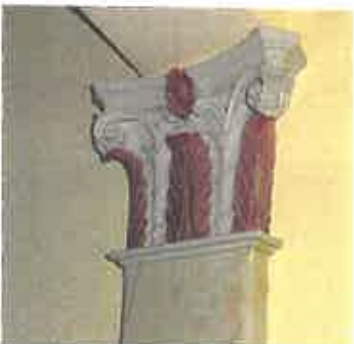
<p>Corridor arched bulkheads are supported by ornamental pilasters with Corinthian influenced capitals. The piers have been marbelized and the pier colour scheme suggests that the capitals may well be the original colour scheme.</p>

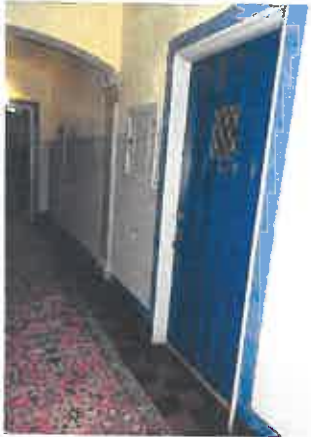
<p>The original heavy panel suite entry doors featuring diamond leaded glass lights have survived, as have all of the milk delivery closets, albeit built-in.</p> <p>The original unglazed tile corridor floor surfaces have survived in good condition.</p>

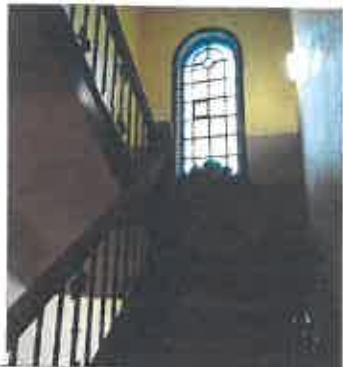
<p>The original wood and decorative wrought iron stairs have survived at both the north and south residential entries in excellent condition.</p>

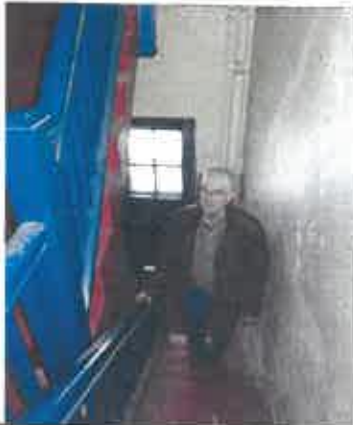
<p>The secondary extd stairs have also survived in good condition.</p>

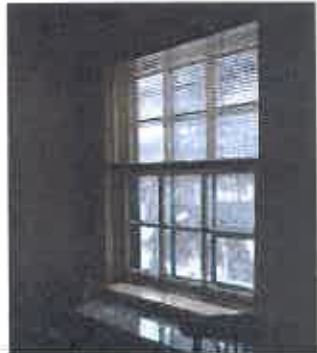
Interior view of an original wood muntined 6 over 6 double hung window with exterior wood storm sash with the same muntin pattern. Note the original widow casings and stool.

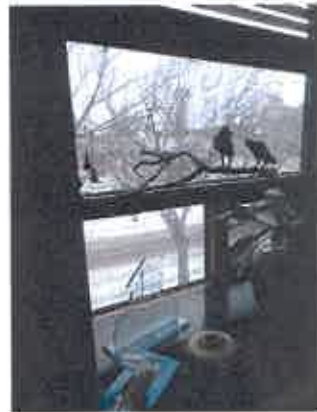
Interior view of a new contemporary wood window replacement set at the plane of the storm sash. This provides a useful deep stool at the interior, but results in a shallower rough opening at the exterior.

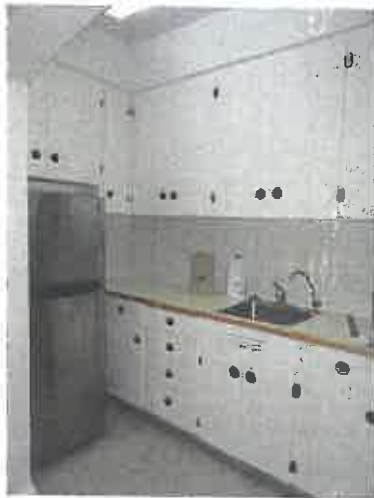
Typical Suite Finishes	Many residential unit kitchens have been modernized over time and are of good quality.

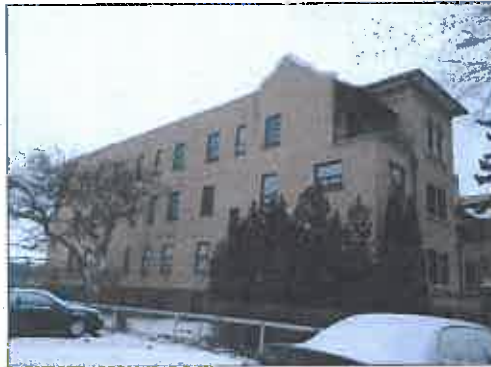
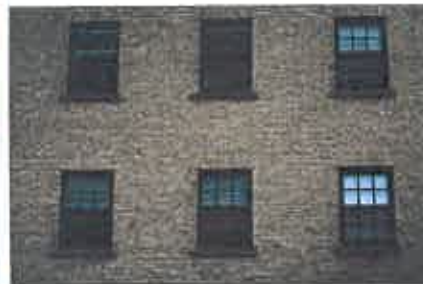
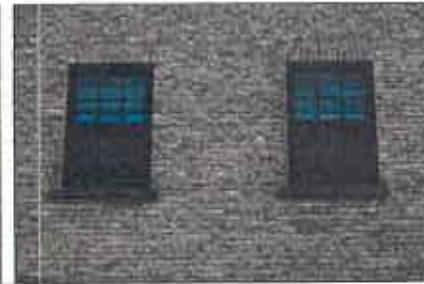
brick soldier course has been repointed w/ hard portland cement mortar

minor rust jacking of some window steel shelf angle lintels is evident.

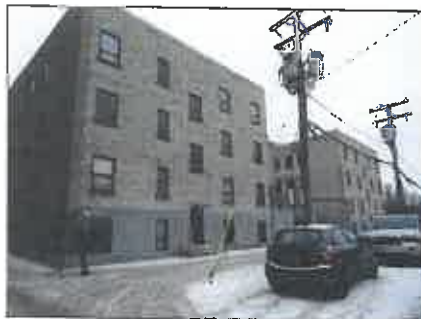
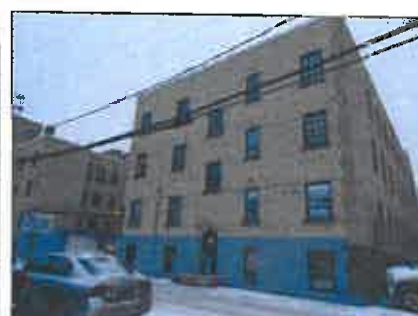
upper wall buff masonry in good condition with some inappropriate tooling of joints in past repointing

brick sills are in good condition

minor rust jacking of some window steel shelf angle lintels is evident.

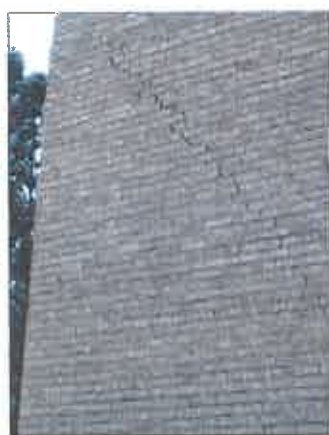
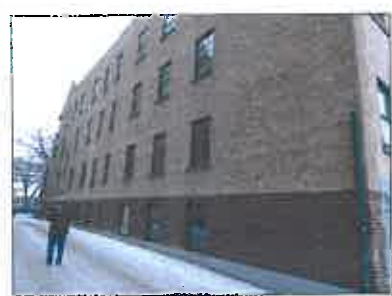
foundation differential settlement of the north
 projecting block resulting in diagonal shear
 cracking at the northeast corner

upper wall buff masonry in good
 condition with some inappropriate
 tooling of joints in past repointing

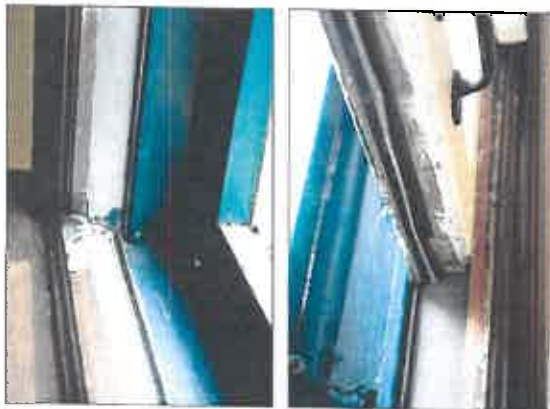
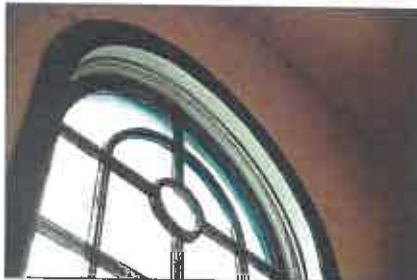
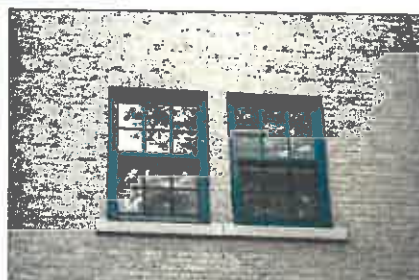
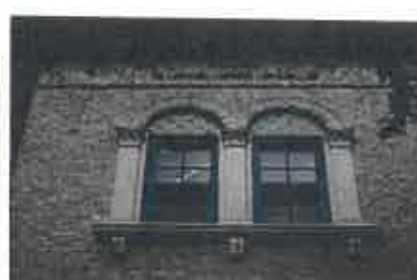
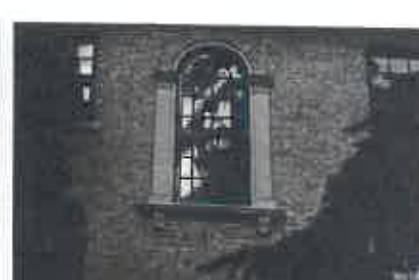
- LOWER SASH SHOWING OPEN & DETERIORATED LOWER RAIL JOINTS TO BE REPLACED WITH NEW WOOD, SINGLE GLAZED, MUNTINED SASH HAVING THE IDENTICAL PROFILE, WOOD SPECIES/ QUALITY, OPERATION. EXISTING SPRING BALANCE MECHANISM TO BE RETAINED, REFURBISHED & ADJUSTED FOR EASE OF OPERATION. NEW NEOPRENE BULB WEATHERSTRIPPING TO BE INSTALLED AT LOWER SASH TOP RAILS & BRASS SPRING WEATHERSTRIPPING TO BE INSTALLED AT LOWER STILES. (5 ORIGINAL WINDOWS REQUIRE LOWER SASH REPLACEMENT)

- PREPARE & PAINT FRAMES, SASH & STORM SASH
- ADJUST SPRING BALANCES FOR EACH OF OPERATION
- REPLACE BOTTOM SASH RAIL NEOPRENE BULB WEATHERSTRIPPING w/NEW. REPLACE PLASTIC SPRING VERTICAL WEATHERSTRIPPING AT LOWER SASH w/ BRASS SPRING WEATHERSTRIPPING

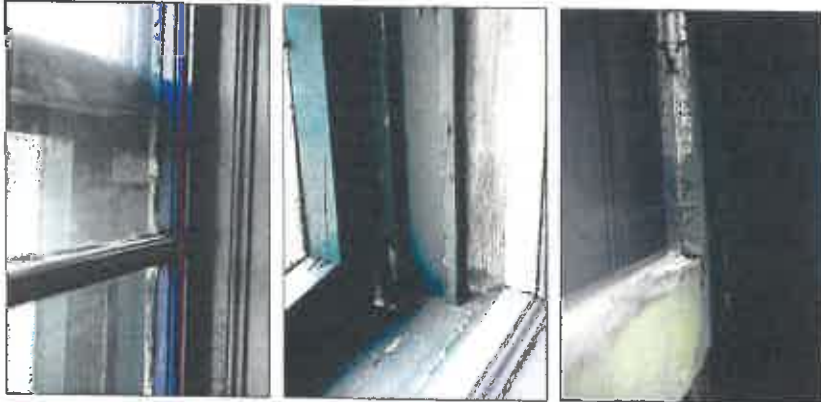
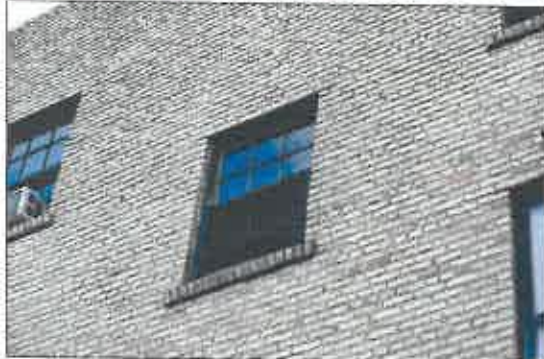
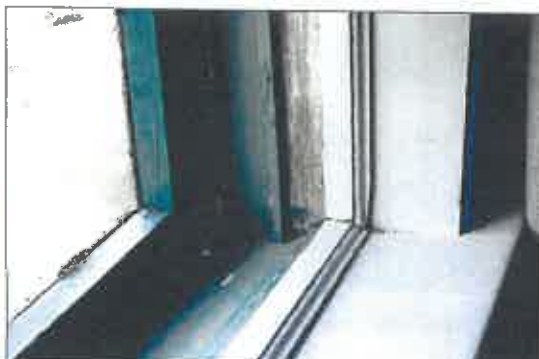
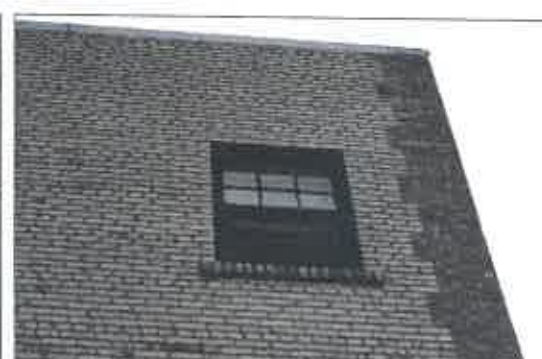
- LOWER SASH SHOWING OPEN & DETERIORATED LOWER RAIL JOINTS TO BE REPLACED WITH NEW WOOD, SINGLE GLAZED, MUNTINED SASH HAVING THE IDENTICAL PROFILE, WOOD SPECIES/ QUALITY, OPERATION. EXISTING SPRING BALANCE MECHANISM TO BE RETAINED, REFURBISHED & ADJUSTED FOR EASE OF OPERATION. NEW NEOPRENE BULB WEATHERSTRIPPING TO BE INSTALLED AT LOWER SASH TOP RAILS & BRASS SPRING WEATHERSTRIPPING TO BE INSTALLED AT LOWER STILES. (7 WINDOWS REQUIRE LOWER SASH REPLACEMENT)

- PREPARE & PAINT FRAMES, SASH & STORM SASH
- ADJUST SPRING BALANCES FOR EACH OF OPERATION
- REPLACE BOTTOM SASH RAIL NEOPRENE BULB WEATHERSTRIPPING w/NEW. REPLACE PLASTIC SPRING VERTICAL WEATHERSTRIPPING AT LOWER SASH w/ BRASS SPRING WEATHERSTRIPPING

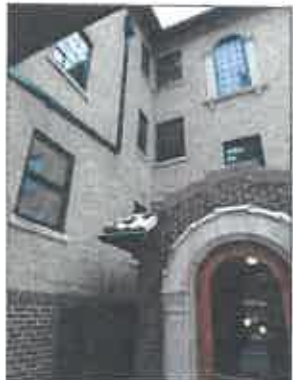
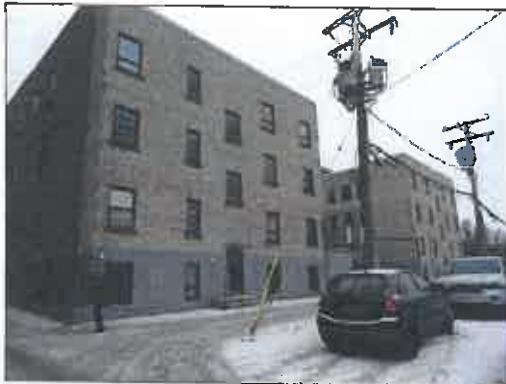
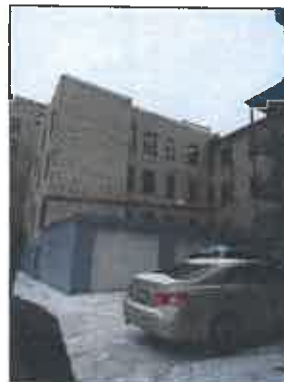
- LOWER SASH SHOWING OPEN & DETERIORATED LOWER RAIL JOINTS TO BE REPLACED WITH NEW WOOD, SINGLE GLAZED, MUNTINED SASH HAVING THE IDENTICAL PROFILE, WOOD SPECIES/ QUALITY, OPERATION. EXISTING SPRING BALANCE MECHANISM TO BE RETAINED, REFURBISHED & ADJUSTED FOR EASE OF OPERATION. NEW NEOPRENE BULB WEATHERSTRIPPING TO BE INSTALLED AT LOWER SASH TOP RAILS & BRASS SPRING WEATHERSTRIPPING TO BE INSTALLED AT LOWER STILES. (4 WINDOWS REQUIRE LOWER SASH REPLACEMENT)

- PREPARE & PAINT FRAMES, SASH & STORM SASH
- ADJUST SPRING BALANCES FOR EACH OF OPERATION
- REPLACE BOTTOM SASH RAIL NEOPRENE BULB WEATHERSTRIPPING w/NEW. REPLACE PLASTIC SPRING VERTICAL WEATHERSTRIPPING AT LOWER SASH w/ BRASS SPRING WEATHERSTRIPPING

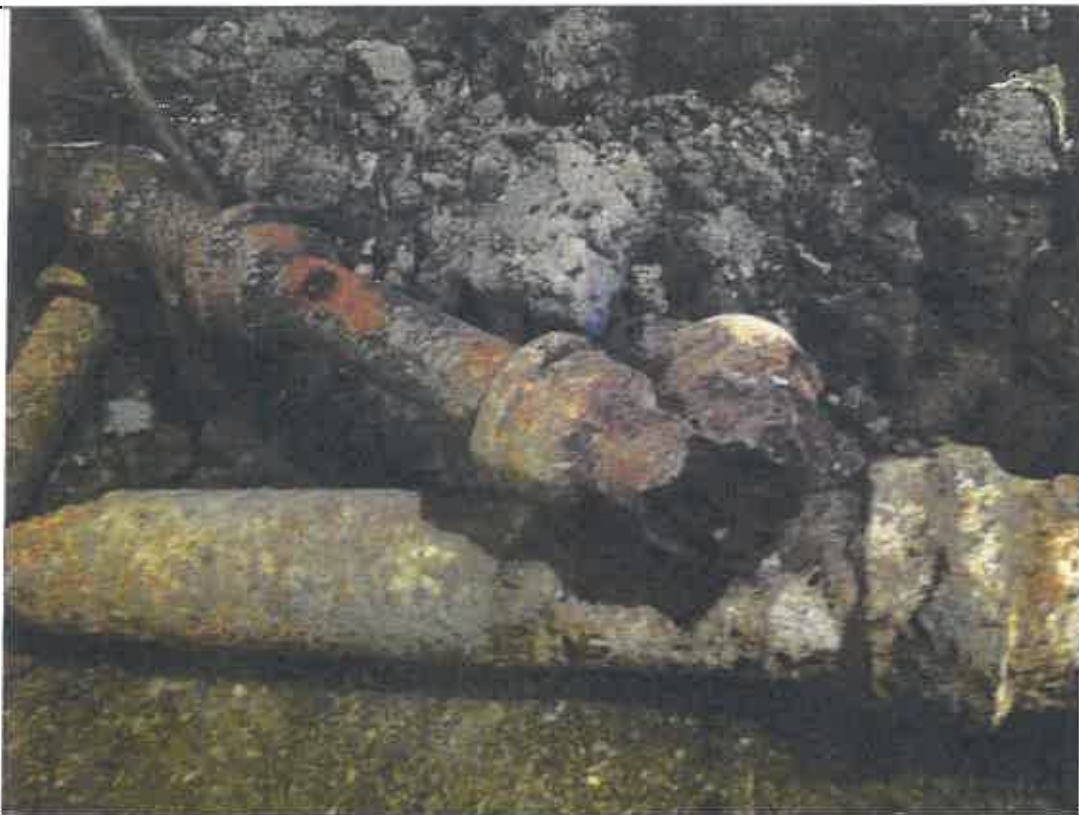
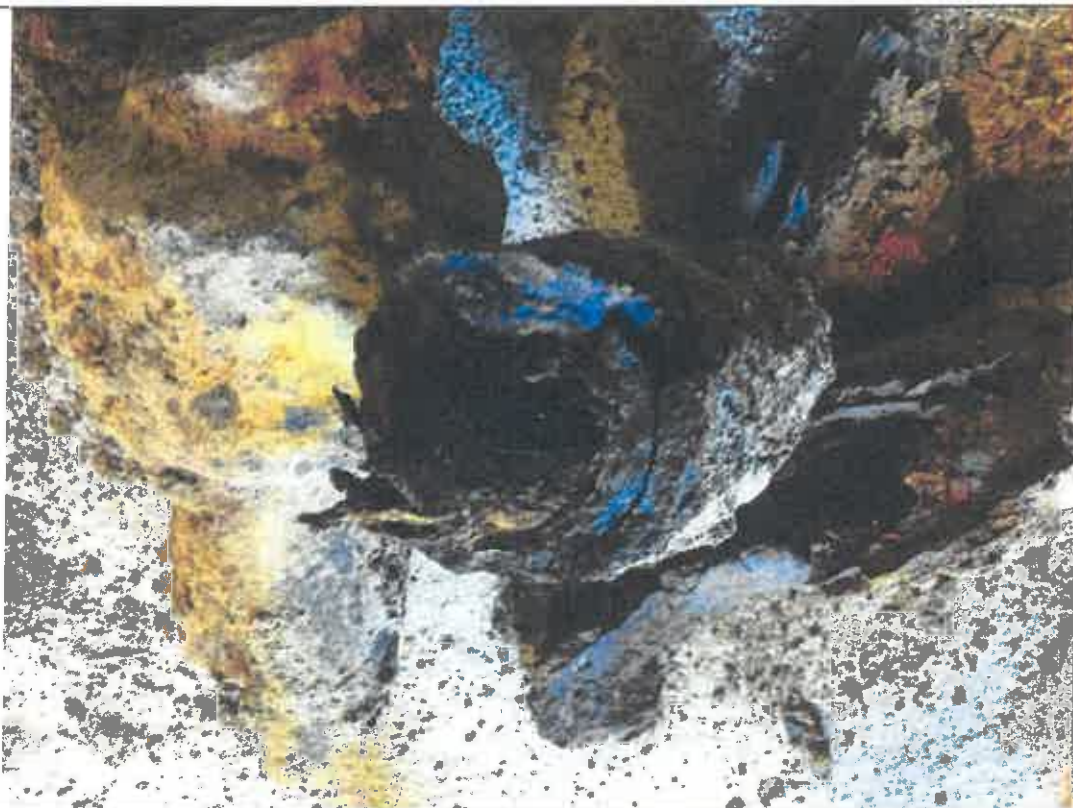
Based on sewer back-up history at the basement and confirmed through extensive video investigation, the sanitary sewer lines beneath the basement slab have experienced extensive delaminating interior corrosion, reducing the interior cross sectional areas available to sewer flow, and resulting in the frequent sewer back-ups and blockages in the basement. The stacks are in reasonable condition, given their age, but as the lines transition to sloped horizontal flow beneath the basement slab, it is clear the lines are no longer functional and have reached the end of their service life.

Before – Condition of Plumbing

The cast iron sewer lines beneath the basement concrete slab require replacement to restore full functionality and code compliance.

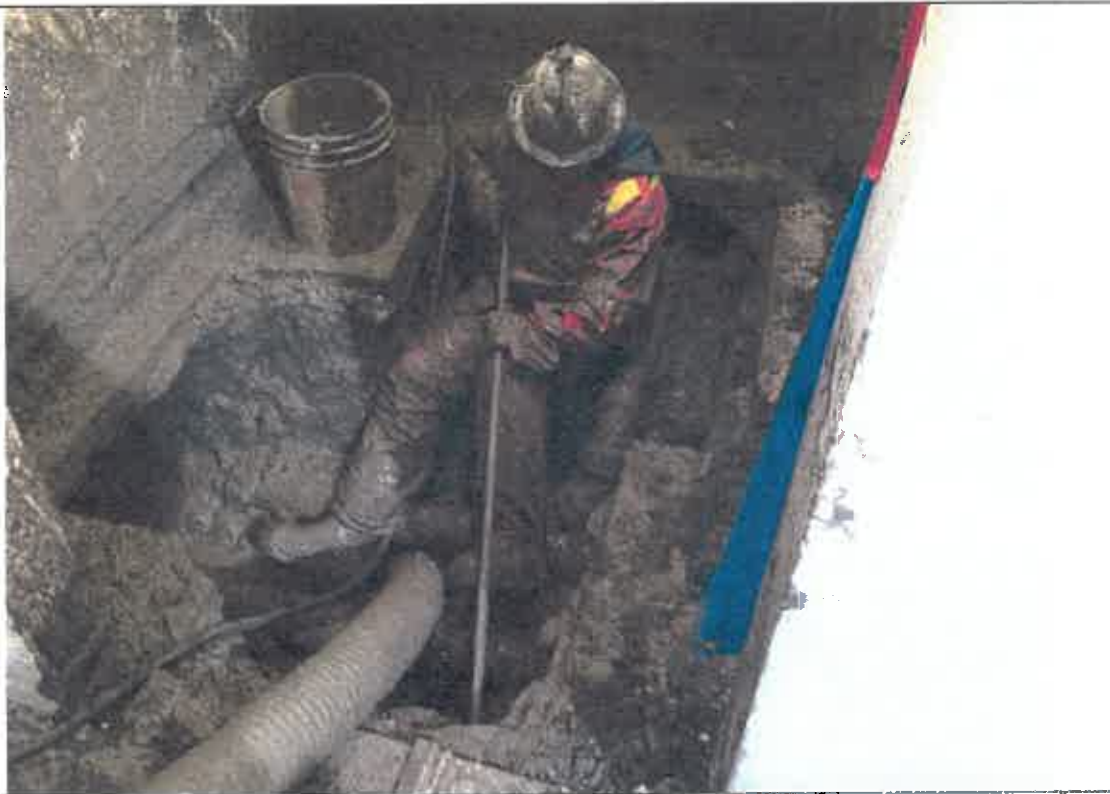
During Construction – Hydrovacing

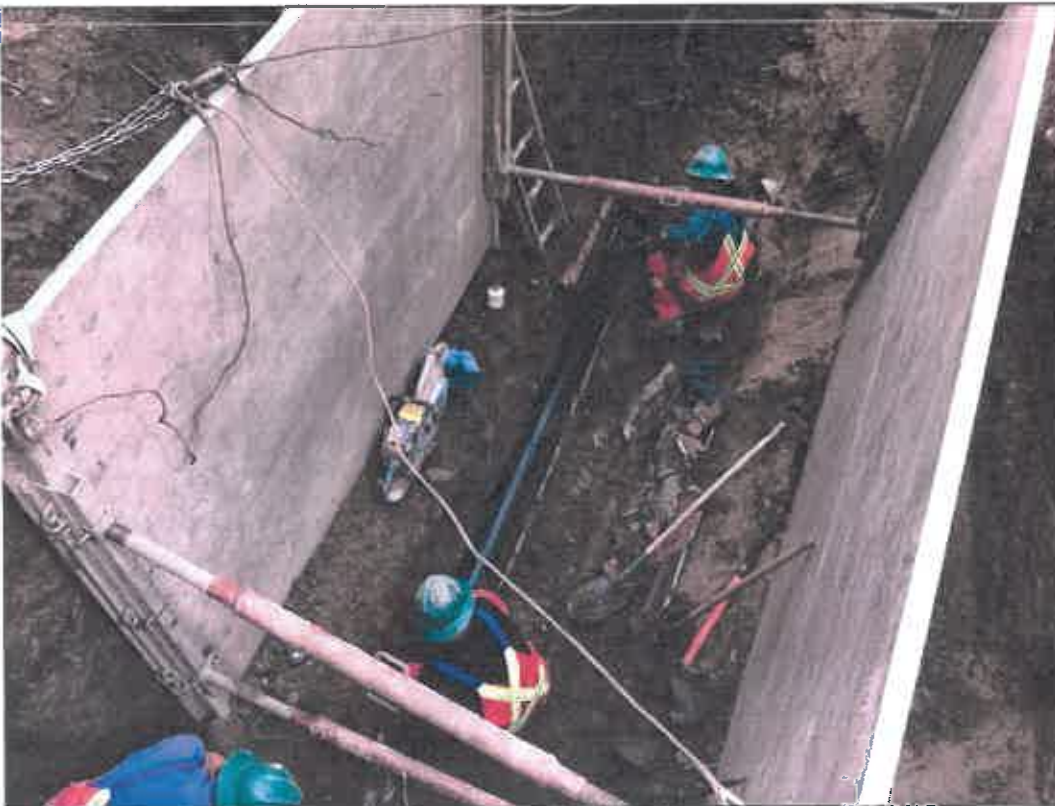
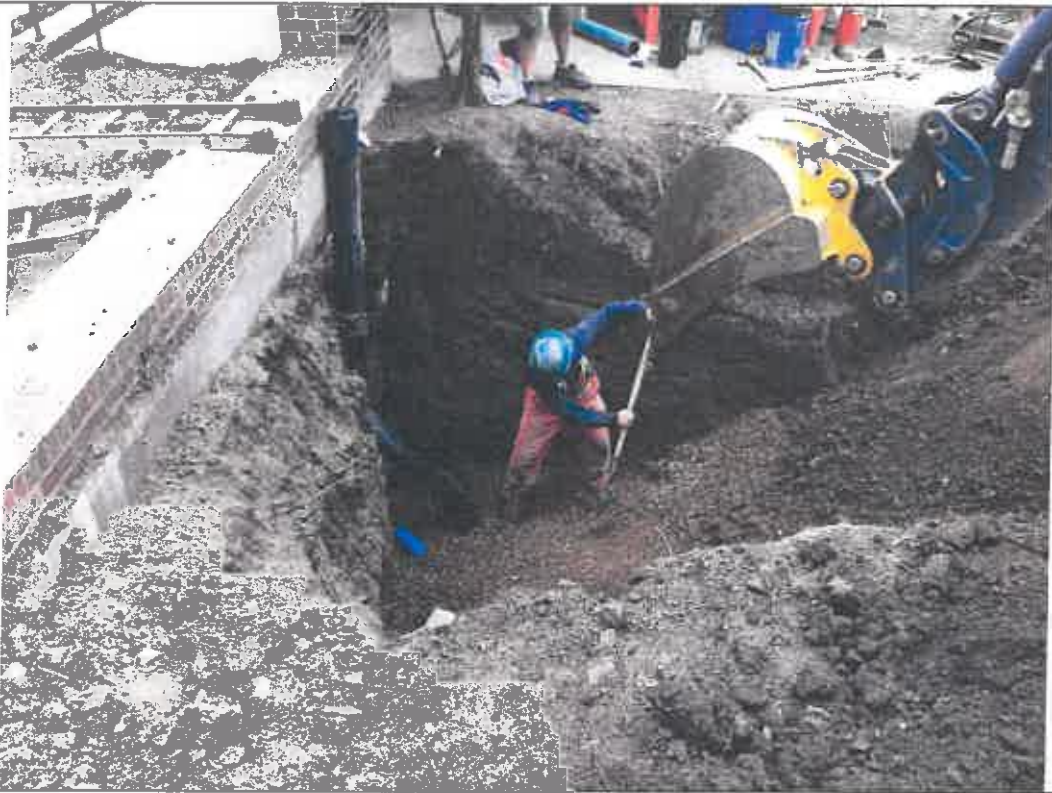
During Construction – Outside Plumbing Replacement

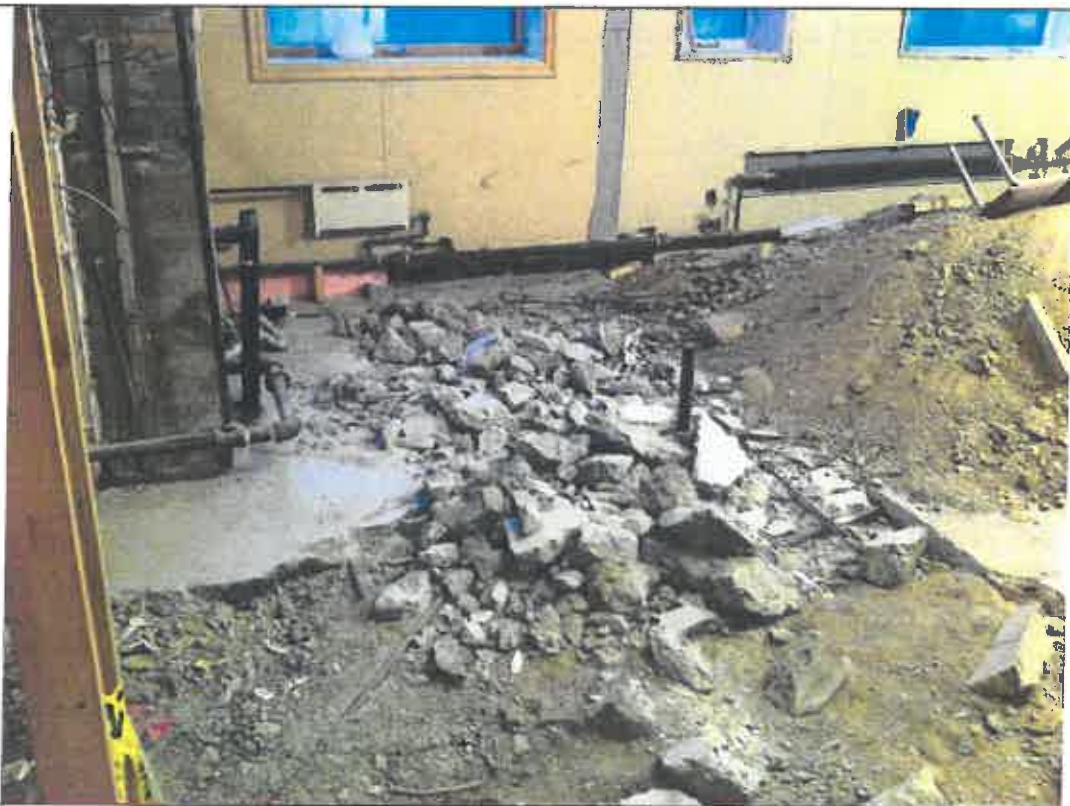
During Construction – Demolition of the slab
