LOUIS RESIDENCE

1431 VICTORIA STREET, REGINA, SK

CONSERVATION PLAN

MARCH 2018

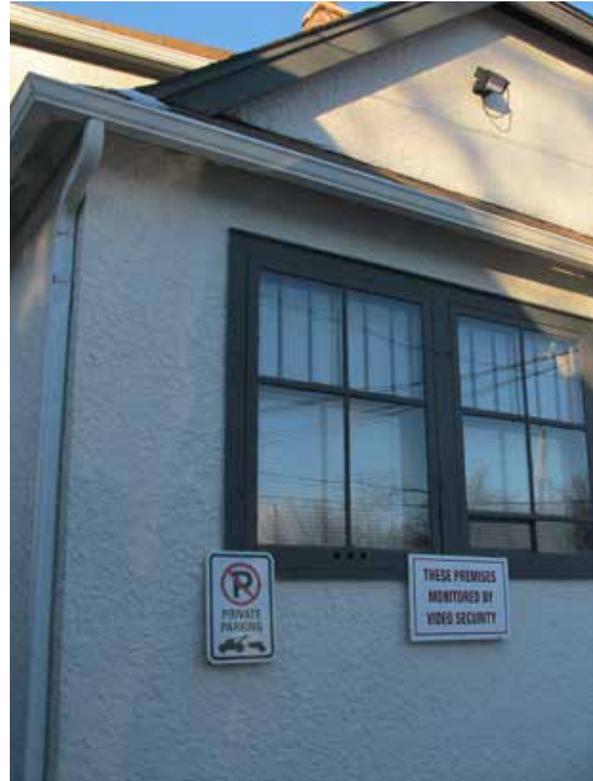
The Louis Residence features storybook design elements, including a jerkinhead roofline with open soffits and pointed vergeboards, shed-roofed front wall dormer, a projecting front entry with a steeply-pitched gable roof, recessed niche above entry, stucco cladding, rounded entry arch, eave brackets, window aprons, and multi-paned window assemblies. Existing exterior wood-frame walls and character-defining elements will be preserved.

- Due to the integrity of wood frame structure, the exterior walls should be preserved through retention and in-situ repair work.
- Preserve the original wood-frame structure of the historic building.
- Design any necessary future structural or seismic upgrades so as to minimize the impact to the character-defining elements.

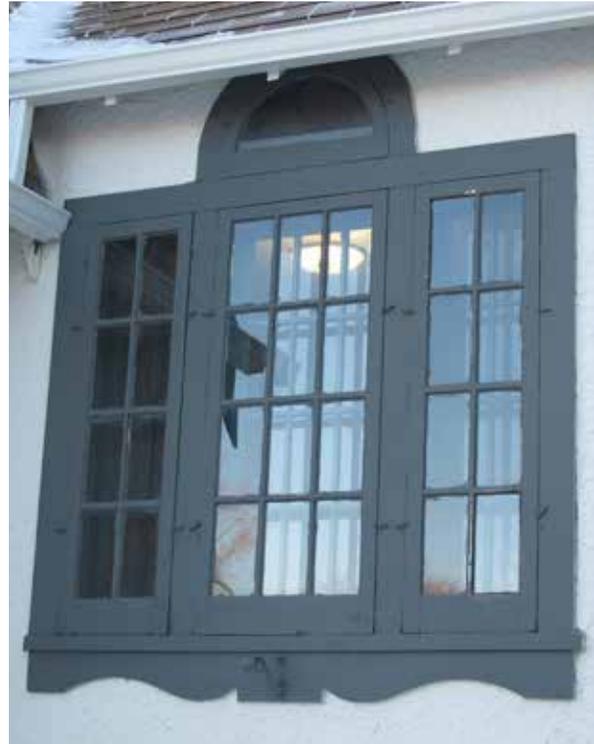
12-paned casement Palladian windows in the Living Room, 9-paned round windows in the side gables, and 6-over-1 double hung windows at the rear. Window openings also feature exterior storm windows in varying degrees of condition, and should be inspected for full condition report.

- Inspect for condition and complete detailed inventory of both windows and storm windows to determine extent of recommended repair or replacement.
- Retain existing window sashes; repair as required; install replacement matching sashes where missing or beyond repair.

- Preserve and repair as required, using in kind repair techniques where feasible.
- Overhaul, tighten/reinforce joints. Repair frame, trim and counterbalances.

- Each window should be made weather tight by re-puttying and weather-stripping as necessary.
- Replace deteriorated storm windows. New storm windows to be wood-sash and match interior configuration and design.

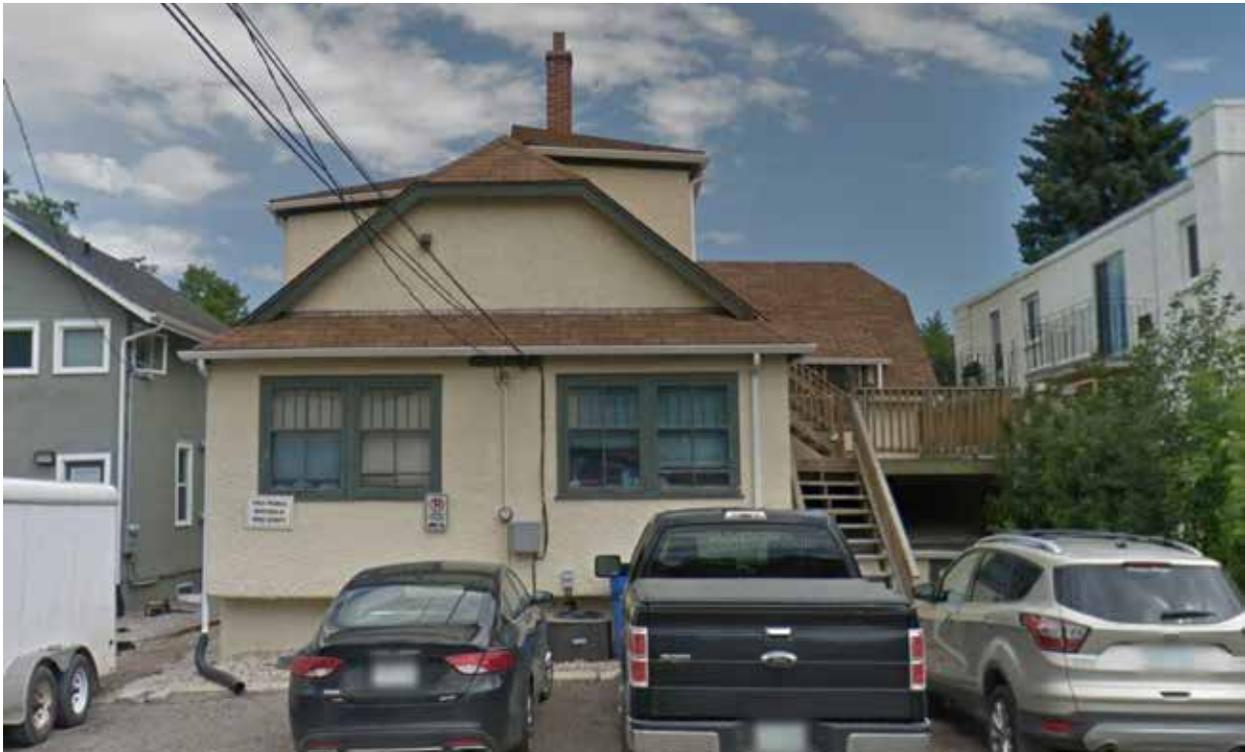
Rear elevation, Google Street View. Accessed March 15, 2018.
