FINANCE AND ADMINISTRATION COMMITTEE

FA16-32 Heritage Building Rehabilitation Program Application for Tax Exemption - Frontenac Apartments 2022 Lorne Street

FRONTENAC

2022 LORNE STREET, REGINA, SK

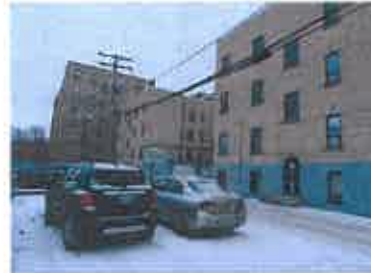
Front Façade Masonry

The original buff brick upper walls and red brick base masonry is in generally good condition, with some inappropriate tooling of joints evident in a few areas of past selective repointing.

Very minor rust jacking of some window steel shelf angle lintels is evident in the slightly expanded shelf angle bedding joint.

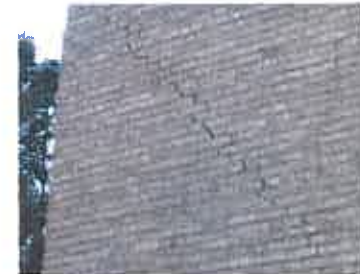
<p>The Tyndal Stone trim at doorways, window surrounds and sills is in good condition.</p> <p>There is evidence of some water ingress at the balconies; a new membrane surface at the balcony deck is required to address this.</p> <p>The buff brick masonry is not soiled in areas of high water run-off, below sills for instance, and is acceptably clean in its current state.</p>

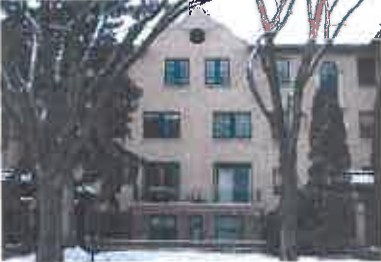
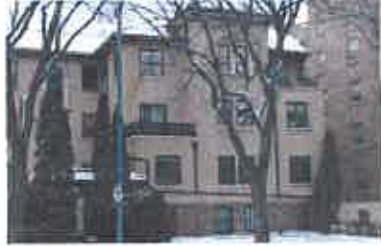
Front Façade Windows	Approximately half of the original wood muntined double hung and casement windows are intact and in fair condition. The sash joints in some sash have deteriorated over time from water ingress and exposure to the elements, resulting in loose joints and warping sash, but a most are in fair condition with some service life remaining. All of the original sash are protected with winter storm sash which have served to extend their service life and provide a higher level of winter season occupant comfort. Approximately 40% of the existing original wood sash will require replacement in the medium term. The existing wood frames are robust, painted and in good condition.

<p>Approximately 50% of the original wood windows on the front elevation, principally at the end blocks, have been changed out to new contemporary wood windows with double glazing. The window change-out has occurred within the last five years. They provide a higher level of occupant comfort and energy performance, but lack the heritage character of the muntined original wood windows. They are a blend of single-hung or lower slider operation.</p>

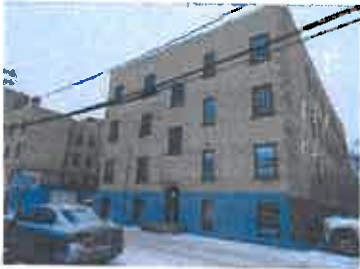
<p>Rear (west elevation) Windows</p>	<p>Approximately 30% of the rear elevation windows are original wood muntined double hung or casement windows have been replaced with contemporary new windows, similar to the front elevation. Approximately 35% of the rear elevation original window sash require replacement in the medium term.</p>

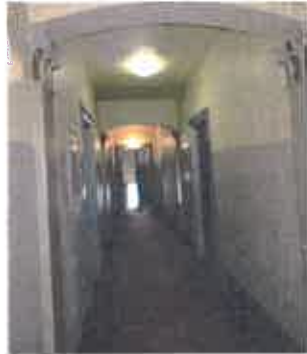
<p>Corridor arched bulkheads are supported by ornamental pilasters with Corinthian influenced capitals. The piers have been marbelized and the pier colour scheme suggests that the capitals may well be the original colour scheme.</p>

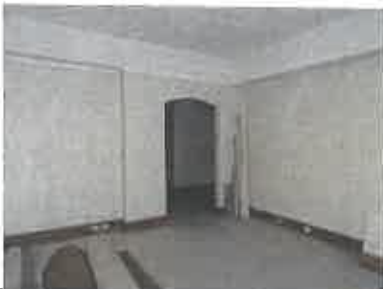
Some original fireplace mantle and molded baseboards survive and are interesting interior features.

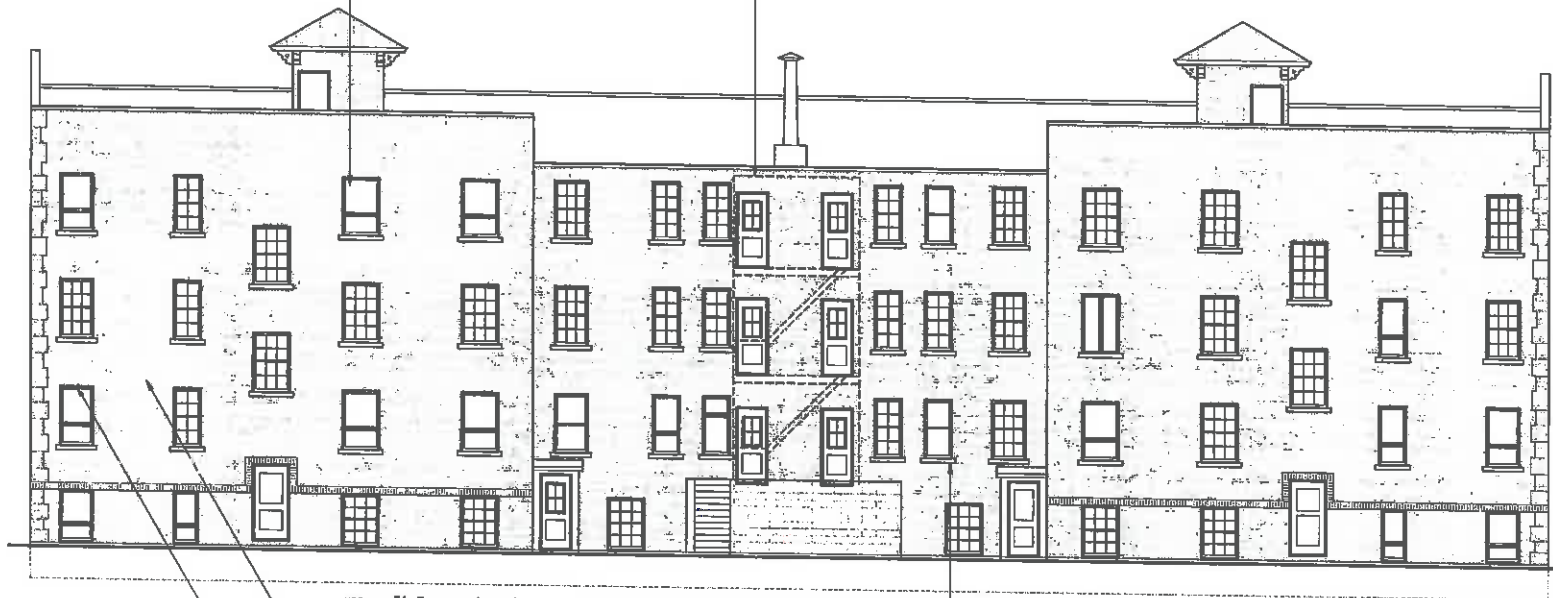
The west facade original windows that remain are intact and in fair condition - the frames/sash require rehabilitation and some lower sash have reached the end of their service life and require replacement.

The contemporary wood windows that have replaced original single-glazed wood windows lack heritage character, but provide higher level of occupant comfort.

the original wrought iron fire escape has been replaced with a newer steel exit stair with a roof cover

upper wall buff masonry in good condition with some inappropriate tooling of joints in past repointing

brick sills are in good condition

minor rust jacking of some window steel shelf angle lintels is evident.

Refer to rehab drawings/schedules for window conservation actions.

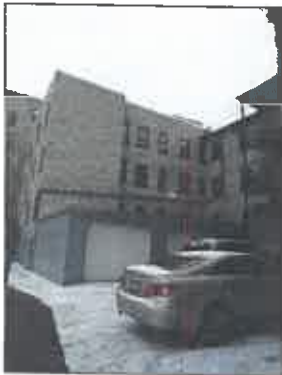
approx. half the front facade windows are
intact and in fair condition, approx. 40% of
existing original window sash require
replacement; the windows that have been
changed out lack heritage character, but
provide higher level of occupant comfort.

upper wall butt masonry in good
condition with some inappropriate
tooling of joints in past repointing

minor rust jacking of some window
steel shelf angle lintels is evident.

the tyndall stone sills are in good condition

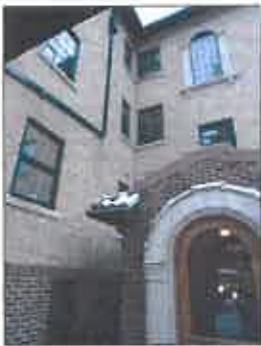
approx. half the front facade windows are intact and in fair condition. approx. 40% of existing original window sash require replacement: the windows that have been changed out lack heritage character, but provide higher level of occupant comfort.

upper wall buff masonry in good condition with some inappropriate tooling of joints in past repointing

the tyndall stone coorways, window surrounds and .ills is in good condition

minor rust jacking of some window steel shell angle: Entels is evident.

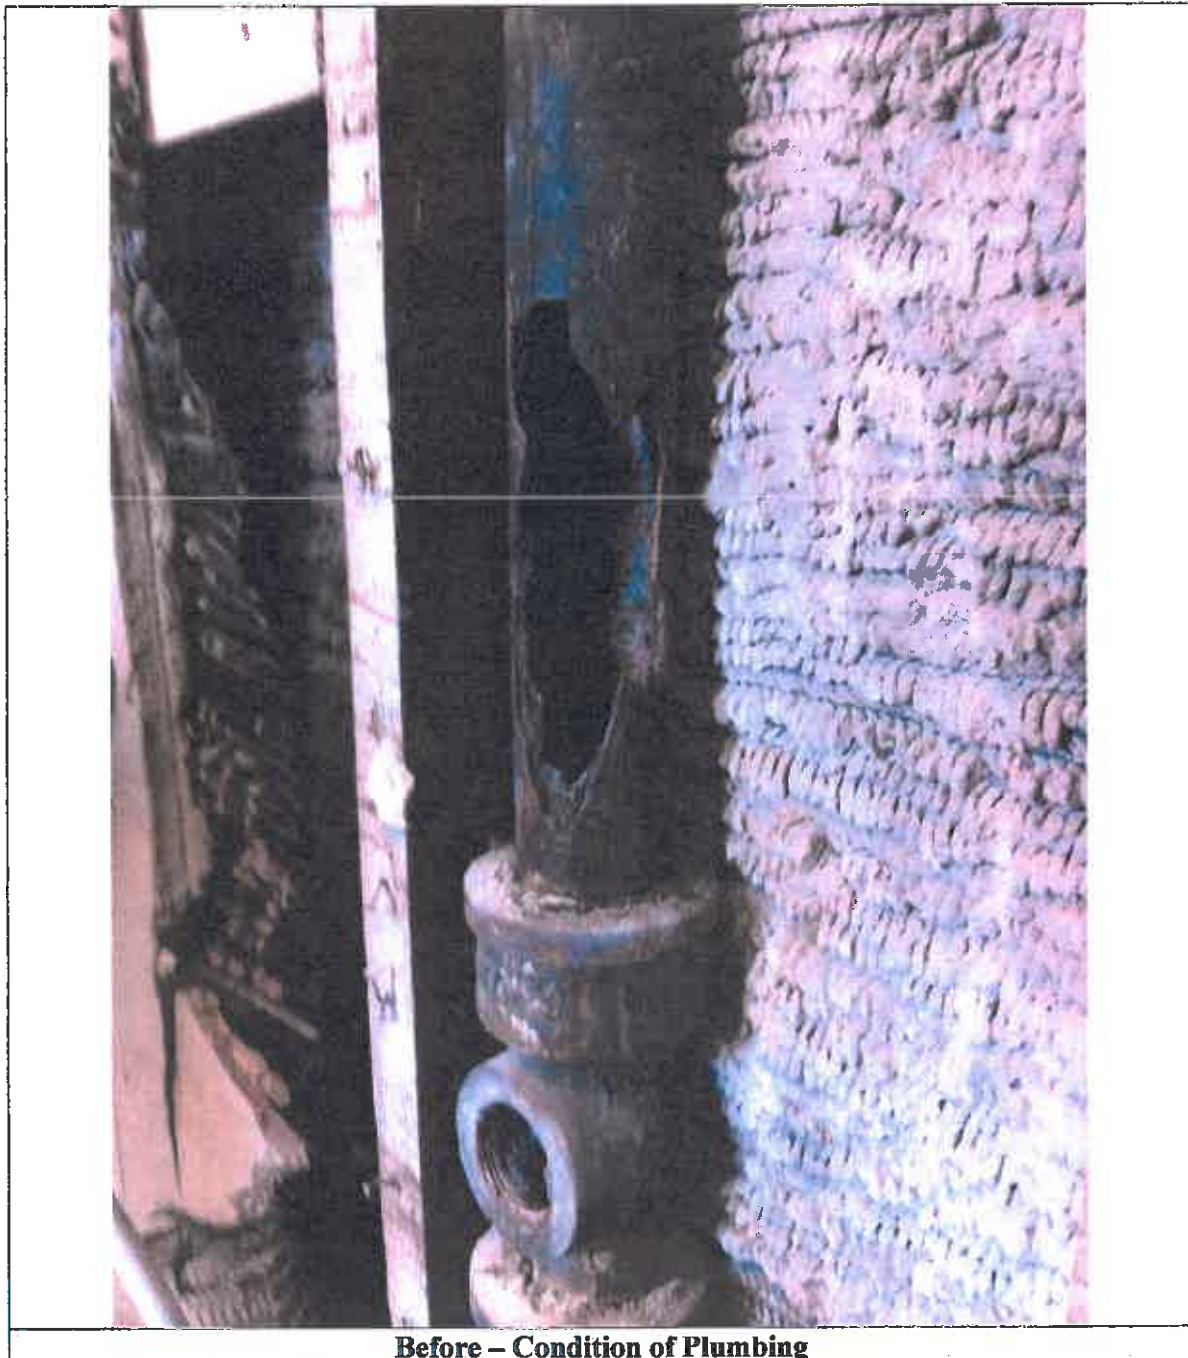
Before – Condition of Plumbing

To retain as much of the exiting basement's character, we selectively removed the floor slabs to facilitate trenching for the new waste and water lines. The trenching was completed using a combination of hydrovac techniques and hand trenching. This allowed us to trench under walls and corridor slabs, thus leaving the interior character defining elements of the building largely undisturbed.

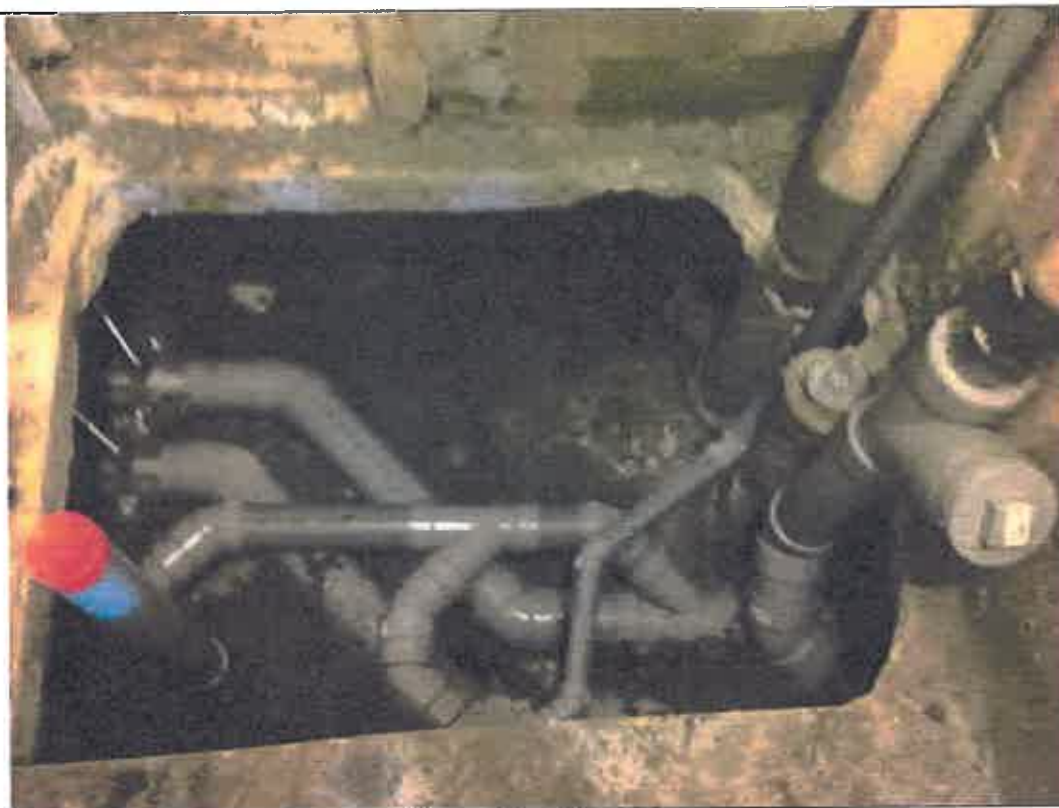
After - New Plumbing

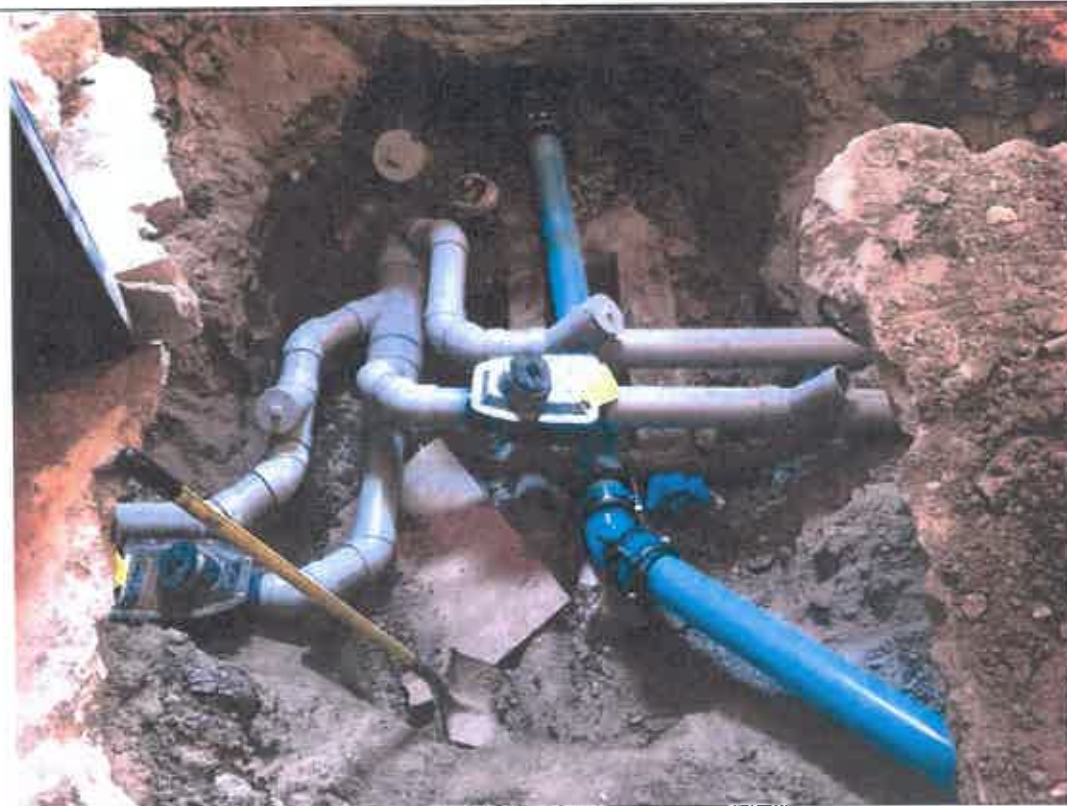
After - New Plumbing
