Heritage Conservation Plan for St. Chad's Chapel and College.

Prepared for: The City of Regina

Prepared by: Jessica Gibson, Designer

February 15, 2018

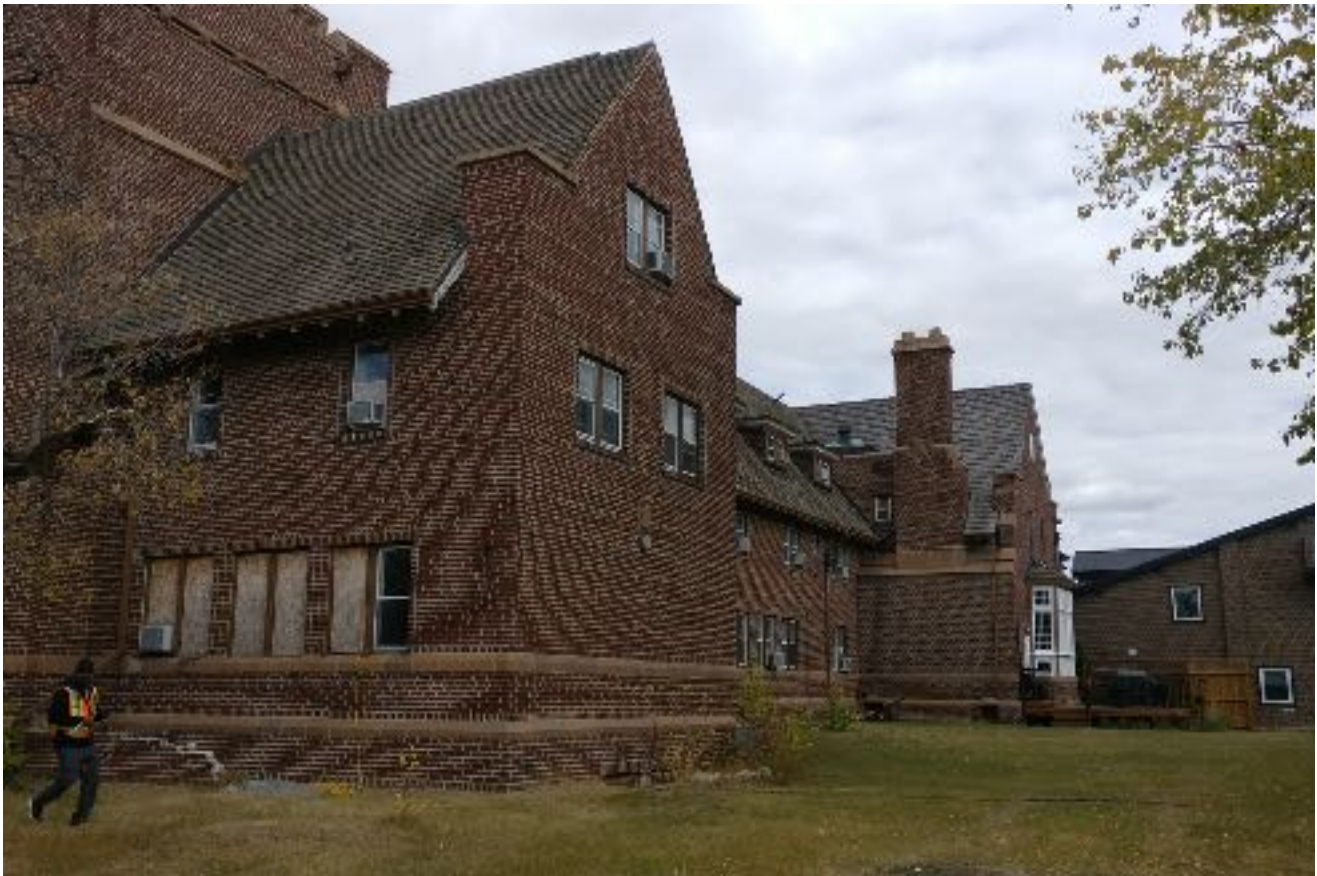
St. Chad's Chapel and College building as of 2017. Exterior conditions have continued to deteriorate over the years.

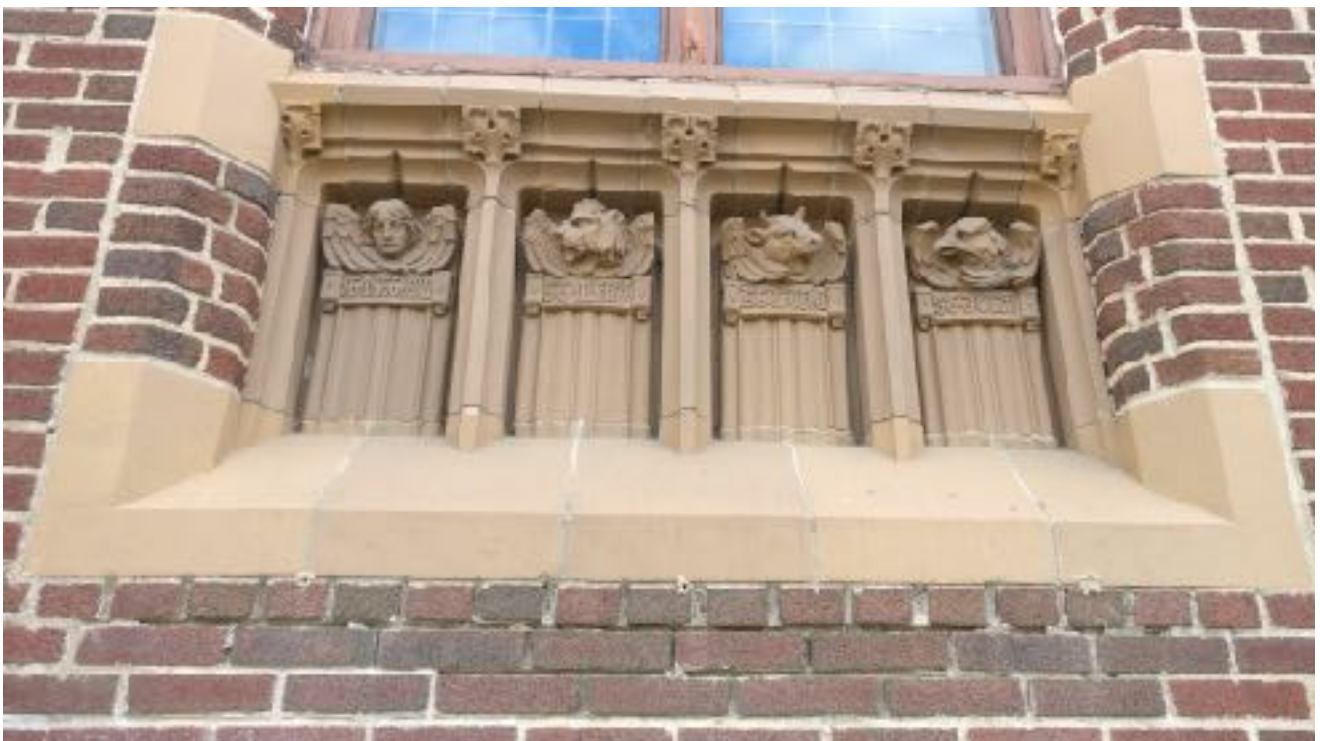
The terra-cotta ornamental components such as the lintels, archways, scrollwork, angels, shields, animals, and ornamental accents are original (1913) character-defining elements of the Collegiate Gothic design of the chapel. At this time they are relatively intact and are mostly undamaged. Many of the terra-cotta elements on the North and East facade of the building are in excellent condition.

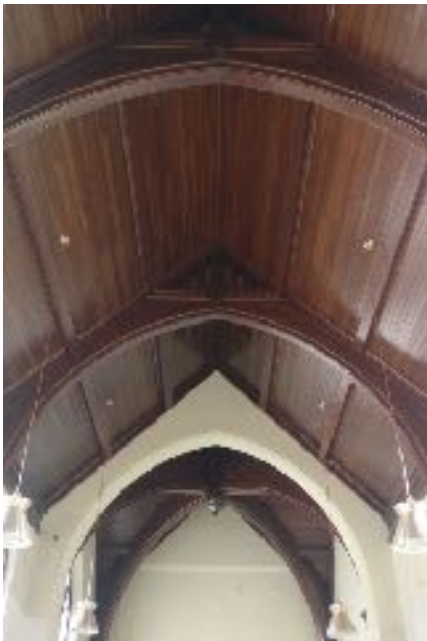
The vaulted ceiling of St. Chad's chapel is arched in a way that is reminiscent of the Collegiate Gothic style and is a very important heritage element of the Chapel. The wooden ceiling is in excellent condition showing very little wear or water damage.

Chapel ceiling and arches.
