CATHEDRAL COURTS

Conservation Report
2018-04-05

The following Conservation Plan for the Cathedral Courts building, located at 3225 13th Avenue in the City of Regina has been prepared for Academy Housing by SEPW Architecture with the sub-consultant KGS for structural items.

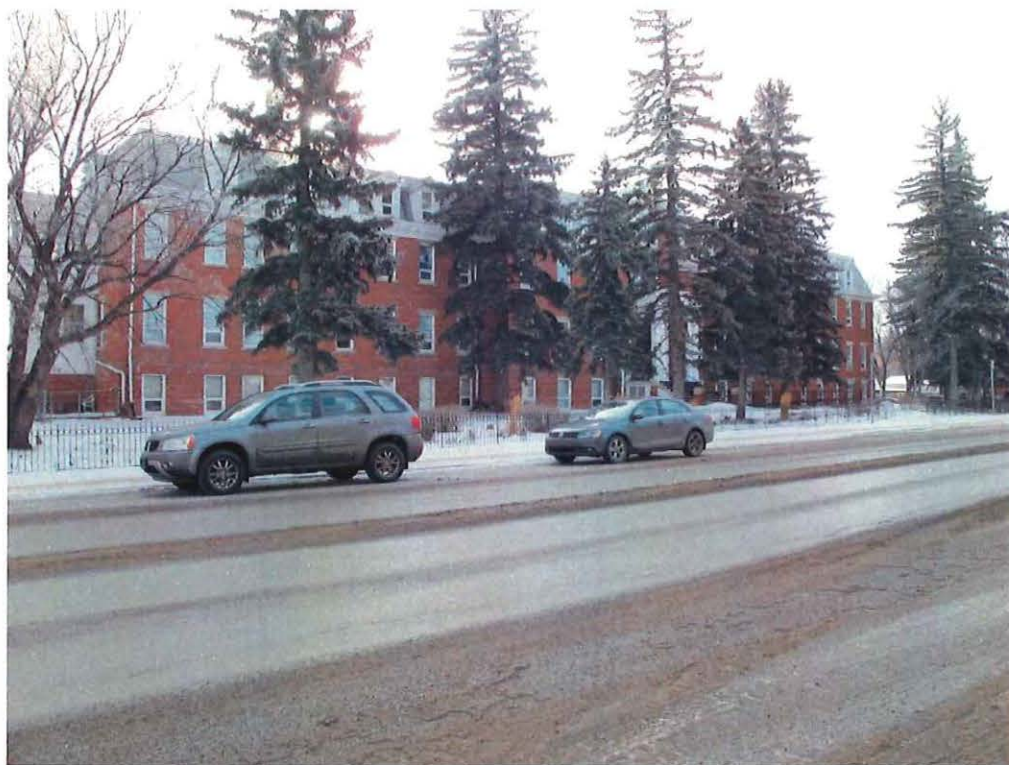
Figure 3 – North façade along 13th Avenue showing line of mature spruce. 1909 portion on left side of photo.

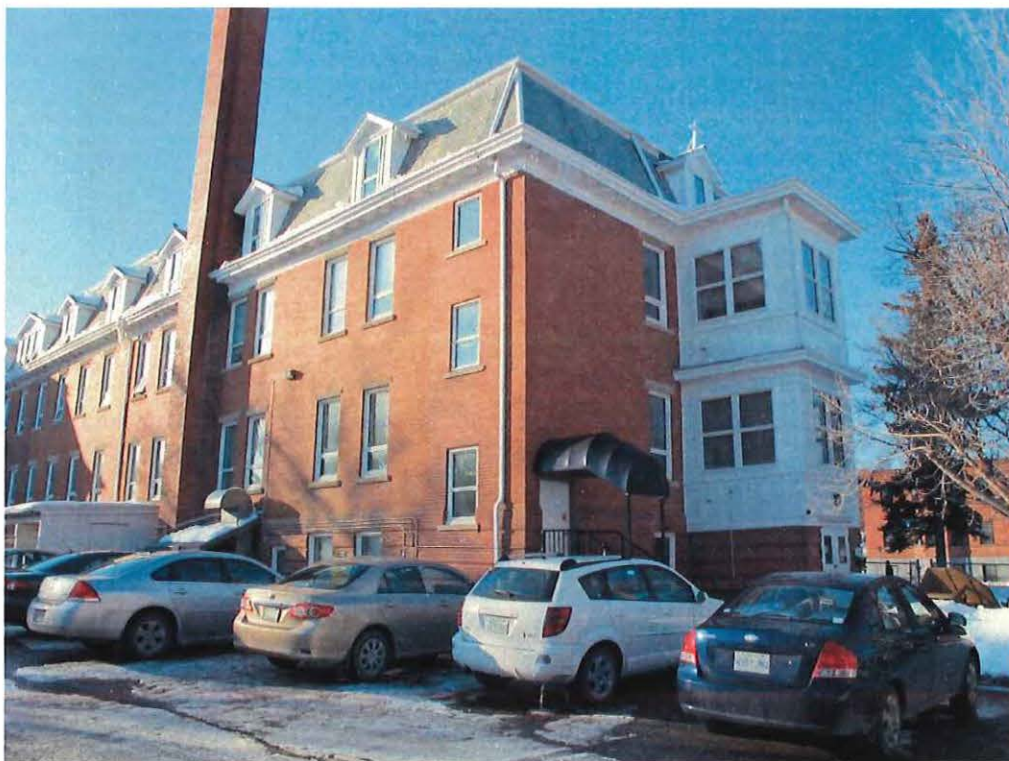
Figure 4 – South façade. 1909 portion

Hard surfacing and lack of positive grading along the south side of the building is contributing to wetting of the bricks through splashing of rain and melting snow, and wicking up of moisture into the brick masonry wall, evidenced by the staining pattern below windows on this façade.

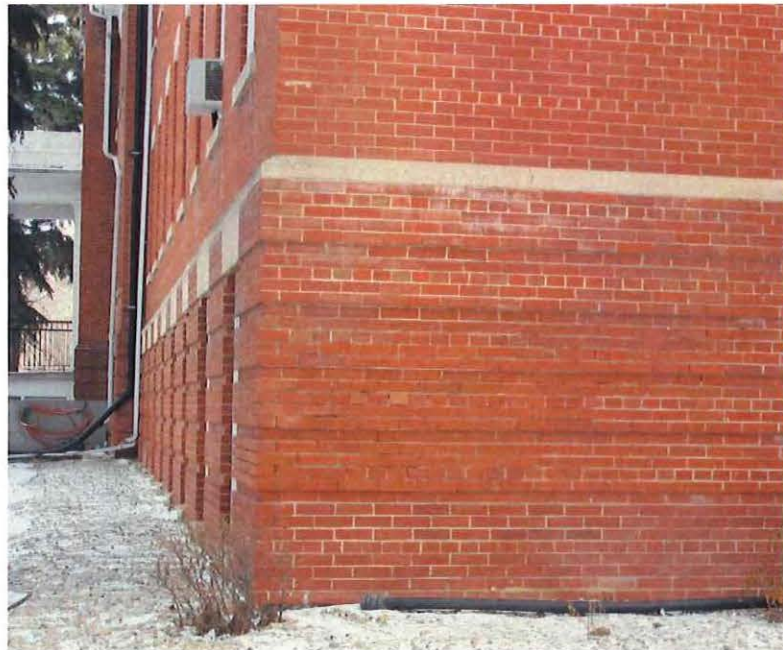
the lower portion of the wall. On the 1924 portion of the building this terminates at a dressed Tyndall Stone belt course. On the remainder of the building this terminates at double projecting brick courses. In general this area of the wall has experienced deterioration due to weathering, rising damp, movement, and moisture from deteriorated mortar joints at the top, projecting brick courses.

Figure 7 – Rusticated brick masonry on the 1924 portion with sloped Tyndall Stone belt course

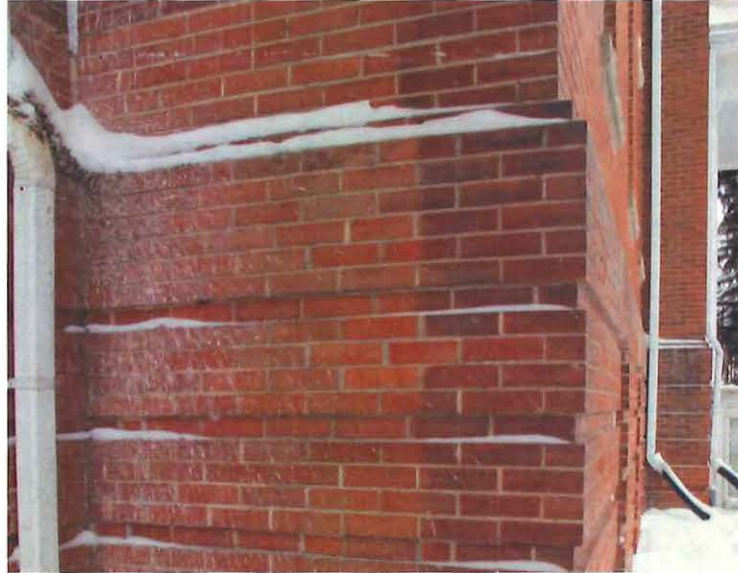
Figure 8 – double projecting brick courses at top of rustication on 1909 and 1914 portions
