CATHEDRAL COURTS

Conservation Report
2018-04-05

The following Conservation Plan for the Cathedral Courts building, located at 3225 13th Avenue in the City of Regina has been prepared for Academy Housing by SEPW Architecture with the sub-consultant KGS for structural items.

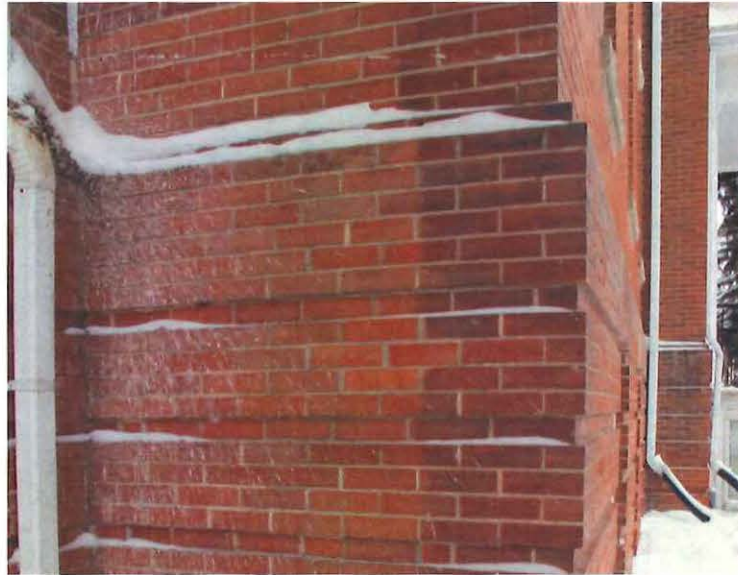
the lower portion of the wall. On the 1924 portion of the building this terminates at a dressed Tyndall Stone belt course. On the remainder of the building this terminates at double projecting brick courses. In general this area of the wall has experienced deterioration due to weathering, rising damp, movement, and moisture from deteriorated mortar joints at the top, projecting brick courses.

Figure 8 – double projecting brick courses at top of rustication on 1909 and 1914 portions
