## CONSERVATION PLAN

### ST. MATTHEW ANGLICAN CHURCH PROPERTY - REGINA

Original: July 2017 Amended: August 2019  
Author: Mae Boa, St. Matthew Anglican Church  
With the assistance of J.C. Kenyon Engineering Inc.  
Owner: The Diocese of Qu'Appelle

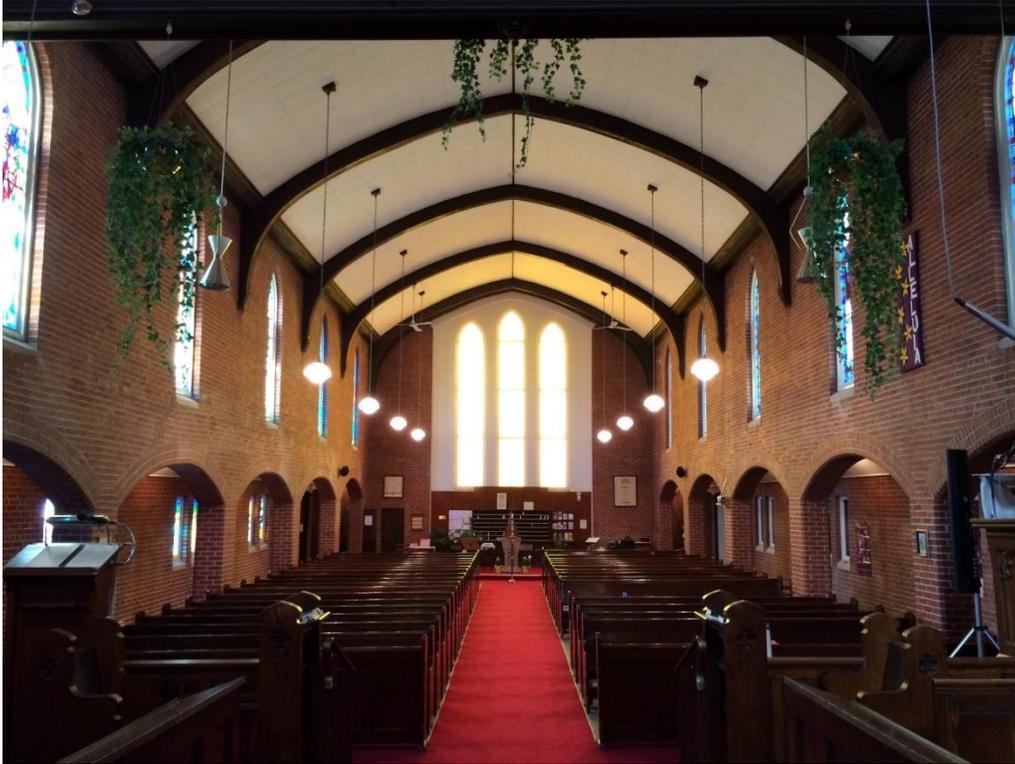
Main Church area - note the brick archways and columns. View is looking from the front of the worship area. Far end of the carpeted walkway is the baptismal font.
