## Heritage Conservation Plan for Henderson Terrace, 3038-3060 18th Avenue, Regina, SK.

Prepared for: The City of Regina  
Prepared by: Jessica Gibson, Designer  
August 01, 2018  
Project Number: 1828

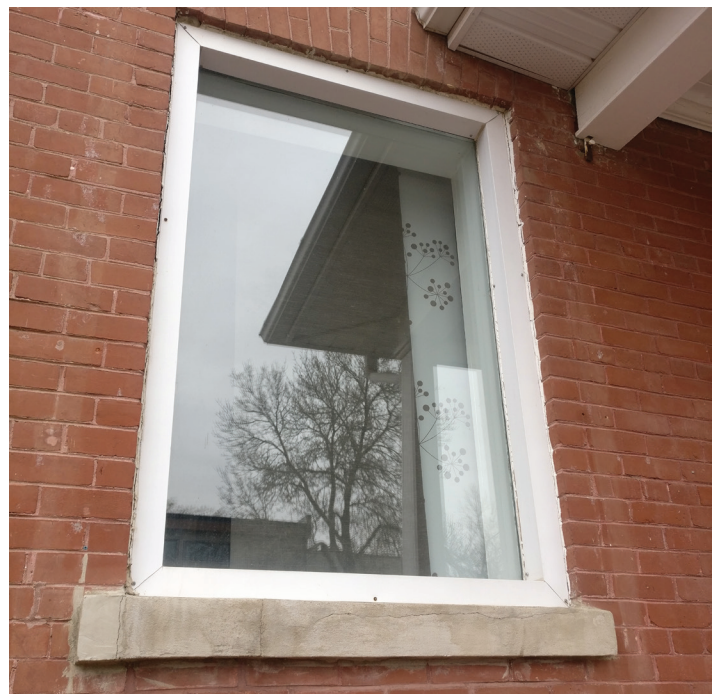
The ground floor windows are of an undetermined age with aluminum casing and are a single solid pane of glass. It is unlikely that these windows are original, and would have been double hung windows with the upper window being composed of multiple panes of glass and muntins. At this time the existing ground floor windows are generally in good condition, and all windows are of a similar style and finish.

The existing windows are in good condition at this current time, we estimate the lifespan of the windows to be approximately another 5 years. Due to the limited degree of historical information on the missing architectural details of the ground floor windows, rehabilitation must be utilized as certain design assumptions must be made in their replacement.

Photographic evidence of the north face of the ground floor shows a double hung window typology. The lower pane of glass appears to have been a single pane of glass, while the upper pane of glass shows a six pane split with intermediary muntins. There are no existing photographs of the south face showing the original window typology, but based on other historical window typologies in the area at this time the south windows were likely a double hung window. It is recommended that the south facade utilize the same window composition as the ground floor windows on the north facade.

In order to comply with current and future building codes and regulations, as well as conformance to environmental and energy conservation standards it is recommended that the new ground floor windows be a double pane window with either wood, or metal clad wood frames. If PVC or fiberglass windows are preferred, the supplier and window type should be approved by a heritage consultant, or by the City of Regina Heritage department in order to confirm conformity with the heritage intent of the building. The intermediary muntins on the window should be exterior muntins, internal decorative grilles are not acceptable alternatives.

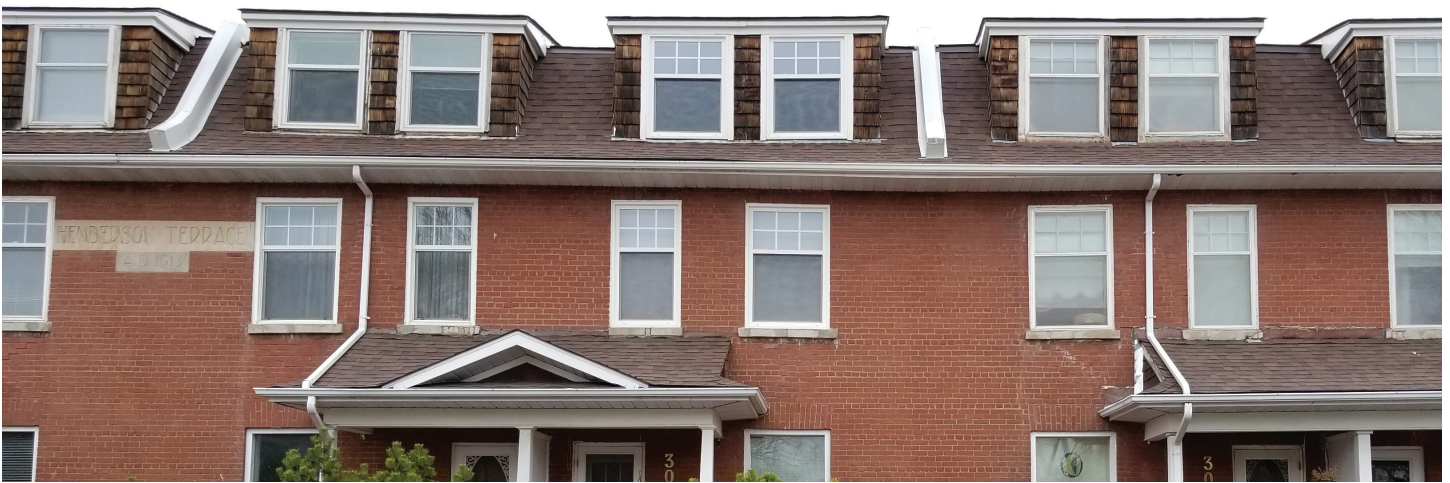
The existing gambrel roof is in good condition with new asphalt shingles, and newer metal caps and flashing on the firewall penetrations. The asphalt shingles, caps and flashing were replaced in 2013. The existing shingles are dimensional shingles in a medium brown colour, and extends from the gambrel roof onto the shed roof dormers. The estimated lifespan of the existing roof is 15 years. The fascia, soffit and eaves were repalced in 1989, and are in need of replacement in the next 5-10 years.

The existing brick chimneys were rebuilt in 2017. The new brick is similar in colour and type to the original brick, and largely indistinguishable from the original. The new chimneys will not require significant repair or replacement in the next 20 - 50 years.

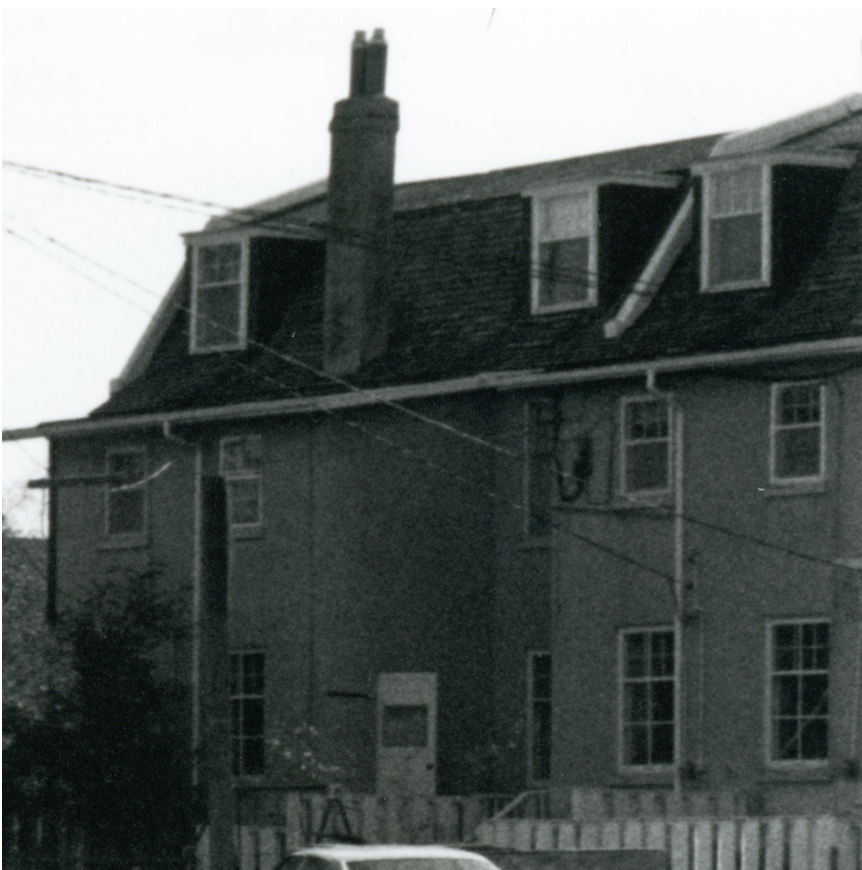
Original Ground, Second and Third Floor Windows

The second floor Windows are of varying ages and styles, with approximately 4 of the second floor windows being original. Vinyl storm windows have been installed on most of the second floor windows, including the four original. The original windows appear to be in good condition and operability, and consist of double hung windows with the lower window being a single pane of glass, and the upper window consisting of six panes with intermediary muntins.

The original windows have been painted numerous times and are currently white. The new windows are predominantly white vinyl windows, some of which have decorative grilles to re-interpret the original 6 paned upper window. While the new windows are in general good condition they do not match the heritage intent.

The replacement second floor windows shall replicate the original windows in the subsequent locations. They shall be double hung windows, with the lower pane being a single panel and the upper pane being six panes with intermediary muntins. Replacement windows shall match the existing windows in profile and size with all measurements being confirmed on the existing original windows, to within 1/8". The replacement windows shall have matching trim and muntin profiles as the existing.

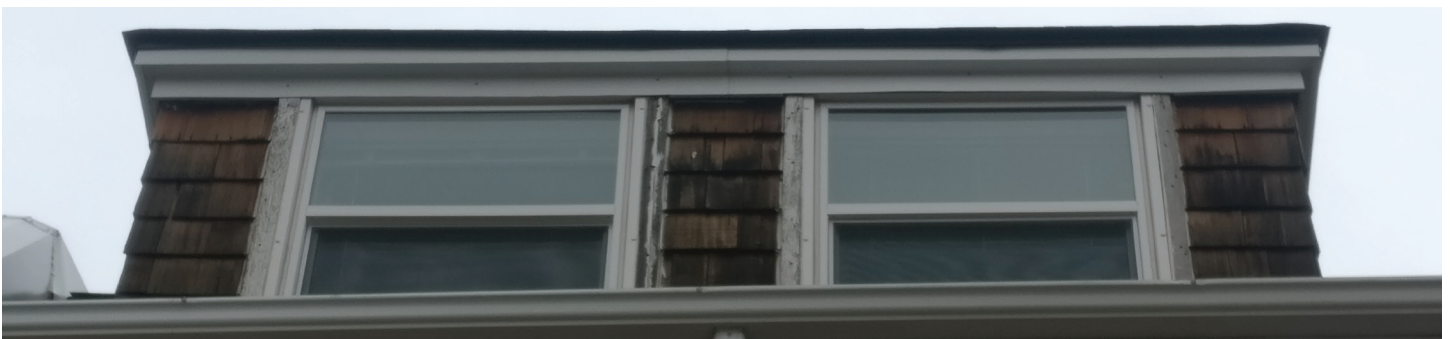
The dormer walls are clad in wooden shakes, most of which are in good condition with some water staining on the south facade dormers, and sun bleaching on the north facade dormers. The shakes were installed in 1989, and appear to be a standard cedar shake varying 5-10" in width, and approximately 18" long. Full documentation of the shakes width, depth and height shall be conducted prior to removal and replacement.

The dormer walls are clad in wooden shakes which are generally in good condition. The expected lifespan of the existing shakes is 5-10 years. It is recommended that the existing shakes are treated with a water-repellant preservative (WRP), or water-based stain within the next two years in order to extend the lifespan of the existing shakes. When replacement is necessary it is recommended that the existing cedar shakes are replaced in kind. The replacement shakes should be red cedar, matching the existing shake dimensions and depth.

In the instance that red cedar shakes are unavailable, or are not desirable for replacement due to the differences in durability from traditional old growth cedar shakes to new second growth cedar shakes, alternative options may be utilized. An acceptable alternative option would be the EnviroShake composite roof tile product. If replacing with Enviroshakes it is recommended that the 'Aged Cedar' colour palette is utilized. As the Enviroshake product is available in 8 different shake profiles, with all bundles pre-shuffled in order to include a mixture of profiles it reproduces the variances found in natural cedar shakes. Enviroshake comes in a standard dimension of 20" long, 12" wide, with a the thickness at the butt of the shake being 1/2" and the tip being 1/8".

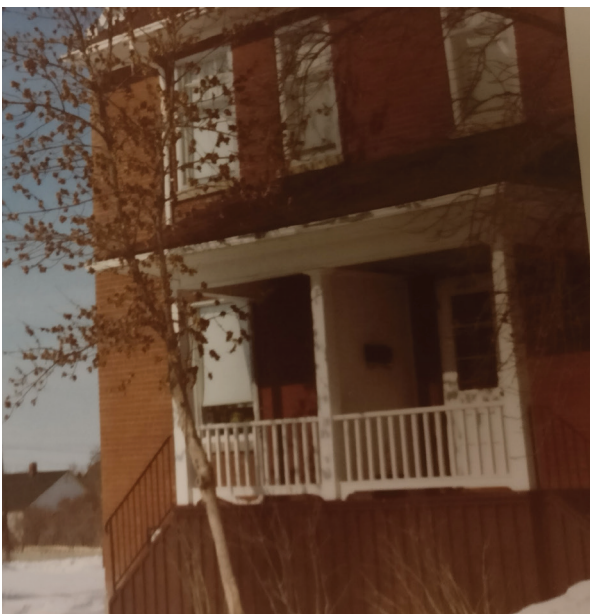
Photograph from the 1970's of the Porches

The earliest documentation of the existing porches are from the 1970's, and were likely constructed around that time. Unfortunately no images prior to 1970 of the south facade of Henderson Terrace were available at the time of this report.

Due to the movement of the porches away from the south facade of the building it is likely that the existing porches will have to be removed and re-built. In the instance that full replacement is required the original form and detailing of the existing porches are to be documented and the documentation is to be utilized as physical evidence as a model to reproduce the porches. Where feasible, elements such as the wooden railings should be retained, repaired appropriately, and re-utilized. A full assessment of materials and features that are to be retained and repaired is to be completed prior to removal. The replacement porches should utilize the same material palette of the existing, though it is preferable for the metal siding is replaced with wood in keeping with the historical material palette of the building.

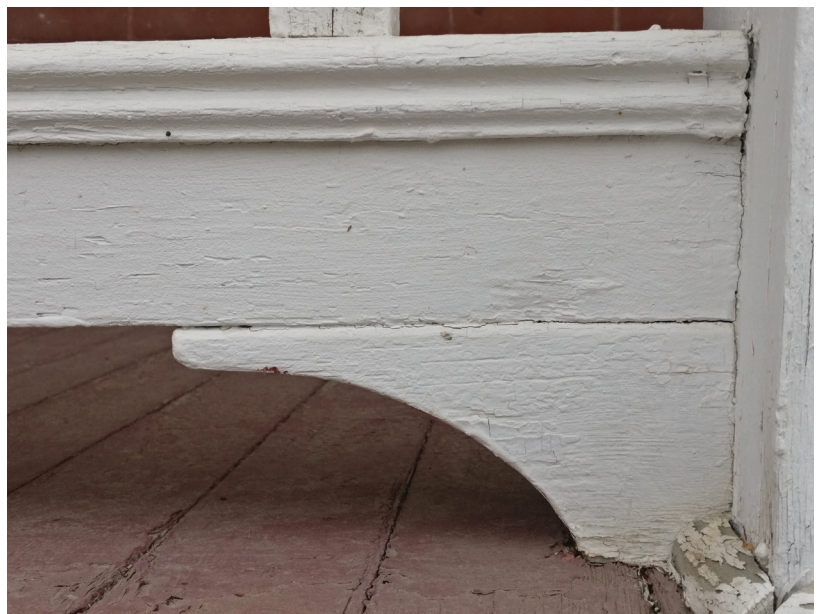
Existing Profiles of Wood Railings and Features

The existing shared, open porches are in generally poor condition and are pulling away from the face of the building, 1-2" of gapping was present at the time of inspection. The existing wood of the porch and railings are weathered with multiple layers of paint. Instability and rotting of the wood is present. The metal siding on the base of the porches is in general disrepair, and does not match the heritage intent of the building. The front doors are of varying ages, styles and materials.

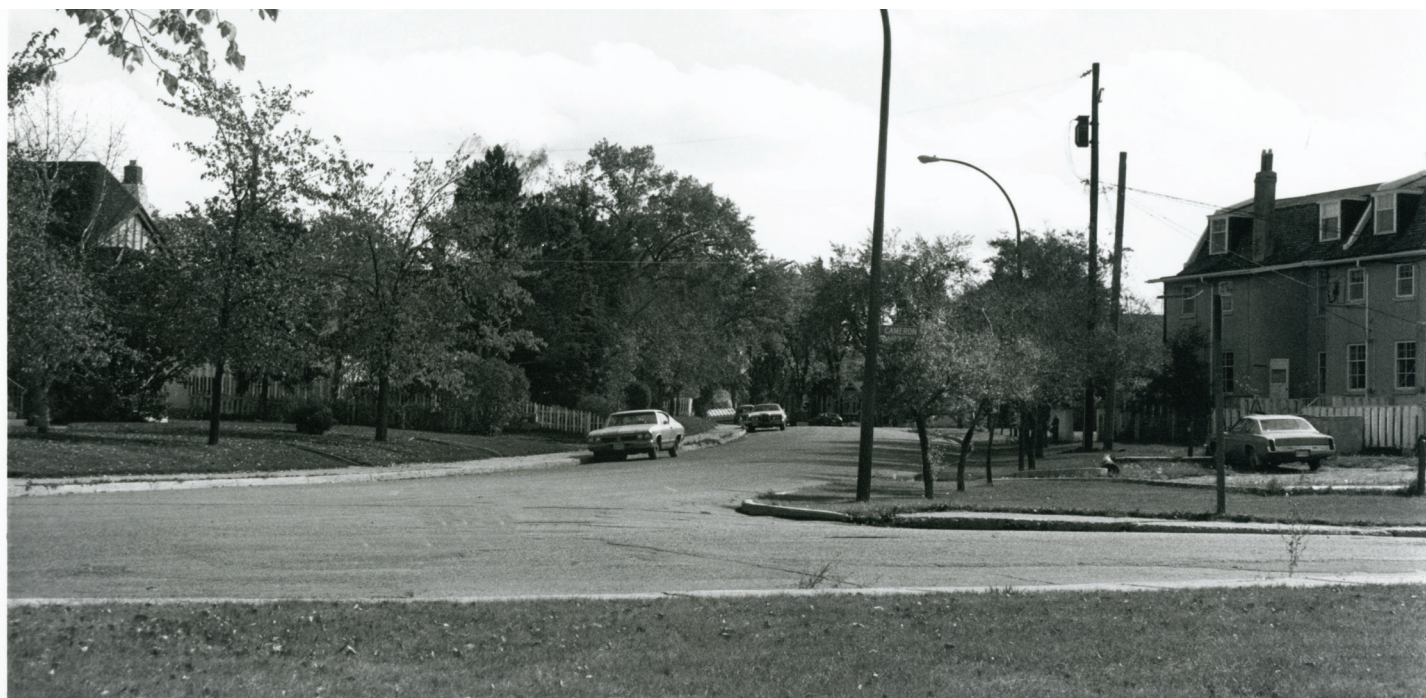
Landscaping of the Crescents, Henderson Terrace on the Far Right

The existing landscaping of the south yards are varied in appearance with each unit creating it's own 'garden'. Much of the landscaping appears overgrown, with Mugo Pines and cedar shrubs being the dominant plants. Current landscaping was done in 1987. Earlier photographic documentation from the 1970's show a very simple landscape on the south facade, consisting primarily of lawn, with a few trees out front. Engineering reports from the 1990's recommended the removal of the trees on the east and west of the property due to the potential for structural damage of the basement masonry from tree roots. Trees to the south of the building were removed prior to 1988.

It is recommended that the existing landscaping is revitalized by appropriately trimming the existing plantings, and replacing any mugo pines that are too damaged to be trimmed and retained. Replacement shrubs should be considered in regards to the historical shrubs, ground cover and plants that would have been utilized for the Mawson Plan. It is not recommended to re-introduce trees to the front yards in order to continue to mitigate potential structural damage to the basement of Henderson Terrace.
